**South Road Tram Overpass Shared
Path Bridge**

Incident Investigation Report

**Department of Planning, Transport and
Infrastructure**

**18 February 2017
Revision: 1
Reference: 255258**

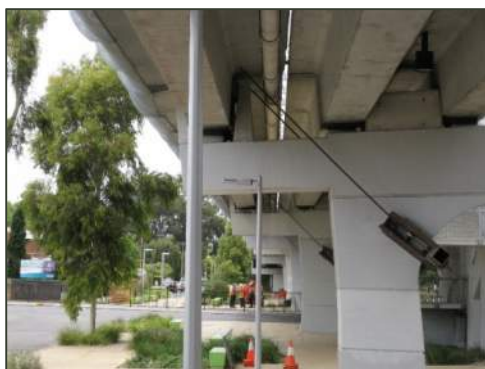
Figure 1 Temporary stabilising tiebacks

On 18 January 2017 DPTI became aware of girder dislodgement to two spans of the South Road Shared Path Bridge. As a result of the incident, South Road was temporarily closed to traffic whilst stabilisation of the structure was installed. As a short term measure only, the girders have been restrained using temporary tiebacks to the piers as shown in Figure 1. Following this temporary tie arrangement South Road was reopened to traffic, however the Shared Path Bridge remains closed to pedestrians and cyclists due to the gross misalignment of the footpath sections and the hazards presented by the temporary support anchors installed in the pathway

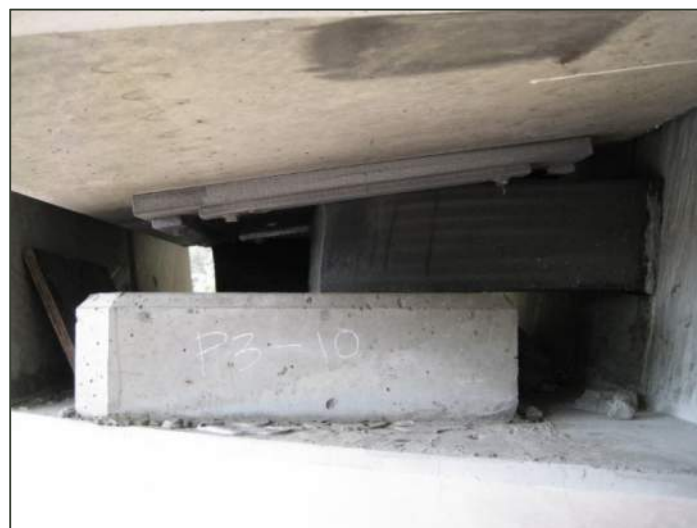
Figure 8 Typical Bearing Movement: Pier 3

Inspection revealed that girder dislodgement occurred in Spans 4 and 5, between Piers 3 and 5 of the Shared Path Bridge which resulted from a loss of support caused by a gross transverse movement of each of the four main elastomeric bearings from beneath the girder soffit. Refer Figure 8. The two girders of Spans 4 and 5 subsequently became unstable and have tilted about their longitudinal axis. Fortunately reinforced concrete keeper walls have acted to restrain the girders, and have in fact prevented the girders from falling off the piers.

As seen in Figure 8, it is evident that the laminated elastomeric bearing has travelled under the restraint bar on the bearing attachment plate and gradually moved or “walked” to the south, until it has eventually been arrested by the adjacent keeper wall. The excessive girder tilting caused by the resultant loss of support has also resulted in the underside of the top flange of the girder bearing vertically down on the top of the outer keeper wall, essentially stabilising the girder. Cracking at the ends of the headstocks, immediately under the affected keeper walls, has been observed. This cracking is both horizontal – at the tooled construction joint between the main headstock and the keeper wall, and vertical – propagating from the inside corner of the keeper wall/headstock interface as illustrated on Figure 9.

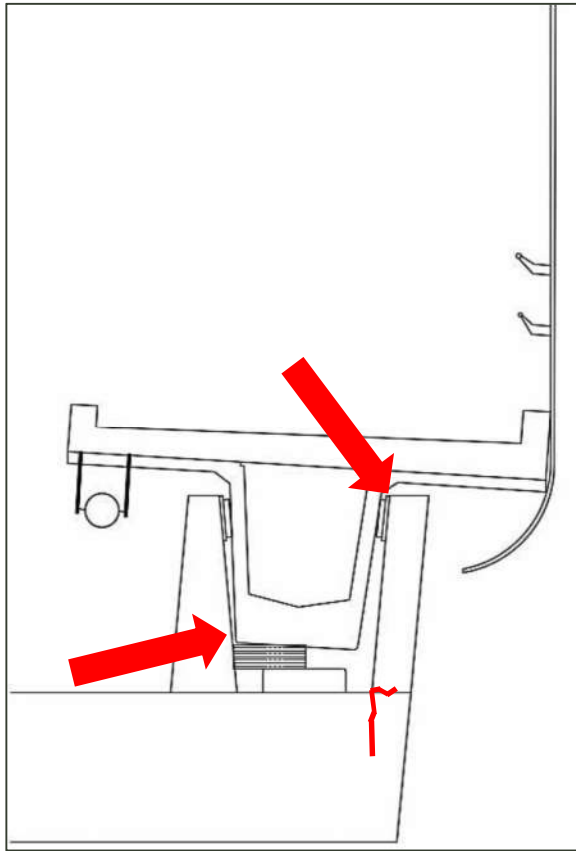
Figure 9 Girder now bearing on keeper wall

Thus the girders of the Shared Path Bridge have attained a new equilibrium system, in a manner that was clearly not part of the original design.

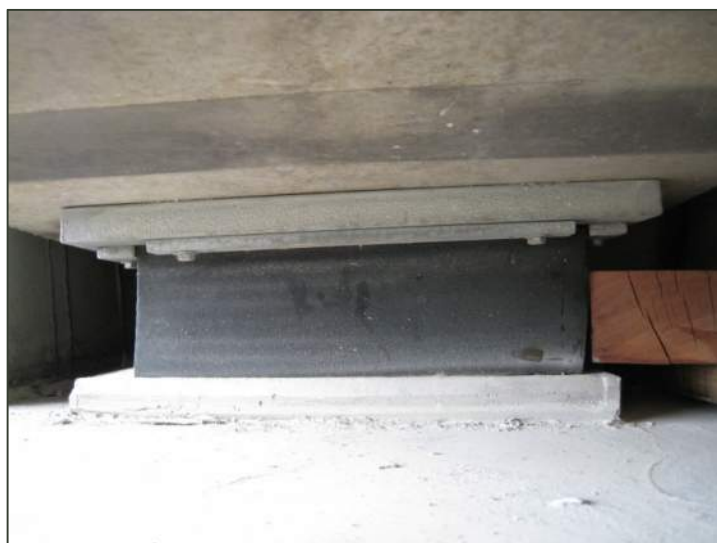
Figure 10 Bearing at Abutment A

As can be seen from the adjacent photo (Figure 10) the deformation of bearings is occurring even at the abutments. Separation of the bearing from both the beam attachment plate at its top surface and the mortar pad underneath is evident. The photo also shows the hardwood chocks that have been recently placed to restrain the bearings, following the recent girder dislodgement incident.

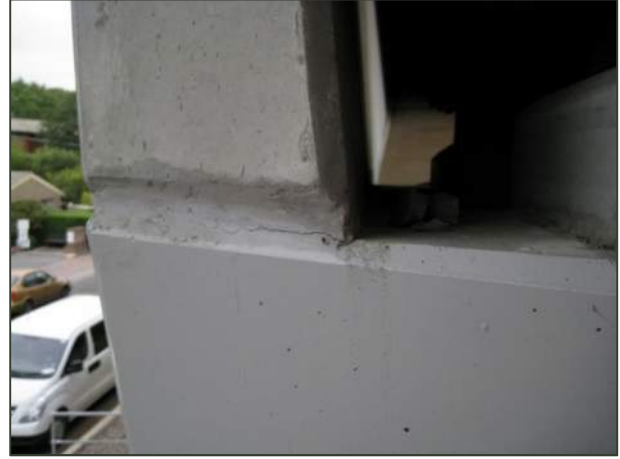
Figure 11 Cracking at keeper wall

Figure 11 shows a horizontal crack at the construction joint between the keeper wall and the headstock at Pier 1. This crack is consistent with over-loading of the keeper wall in bending, as a result of a horizontal load being applied to the side bearing pad. This cracking is evident at the outer keeper walls of all piers.

4. Repair of the damaged concrete headstocks should be undertaken, along with upgrade and replacement of failed outer keeper walls at all piers.

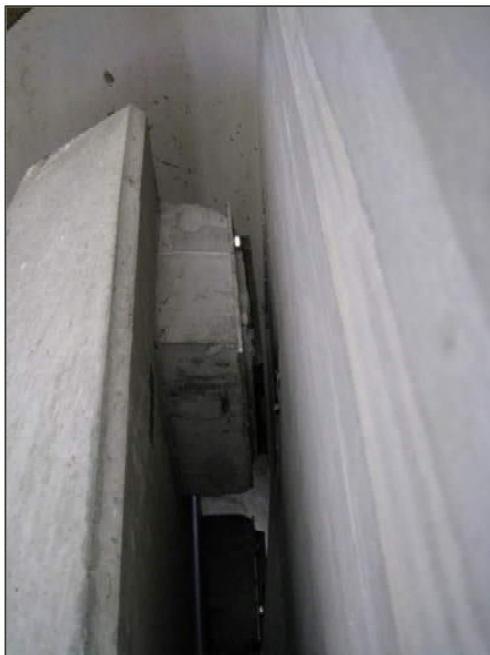
Figure 13 Side bearing separation

Figure 13 shows a typical side bearing. At all piers, the Shared Path Bridge girders have rotated to the north, such that a clear gap is observable between the girder web and the pads fixed to the southern, or inner, keeper walls, certainly more than the 5mm design gap.

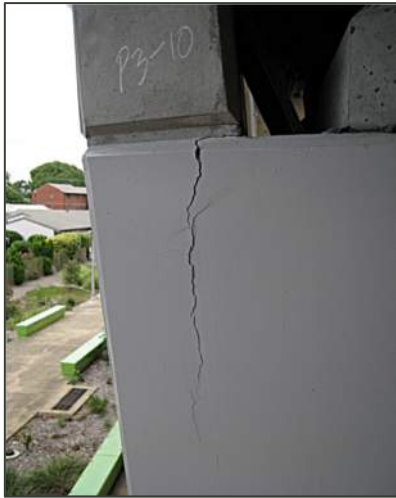
Figure 14 Cracking to pier headstocks

In addition to the phenomena noted above at the other piers (bearing movement/deformation and horizontal cracking) the extreme bearing movement shown in Figure 15 and the vertical cracking of the main headstock shown in Figure 14 were typically observed.

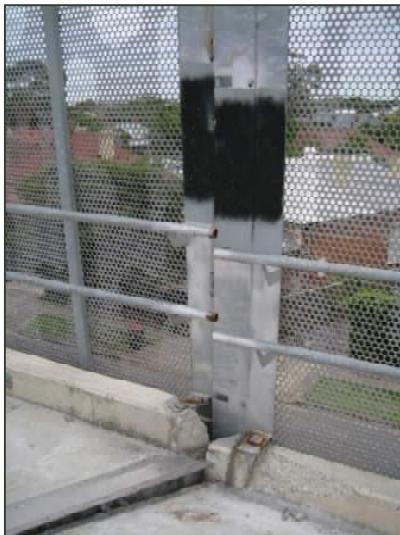
Figure 16 Handrail misalignment

Inspection of the Shared Path Bridge girders from the deck surface was also undertaken. Figures 16 and 17 show the typical damage experienced at the deck joint and handrail at Piers 3 and 5.

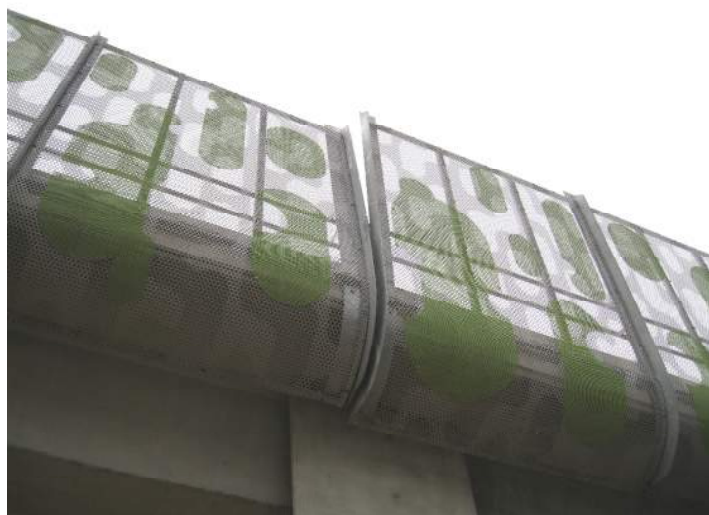
Figure 18 Architectural pattern on anti-throw screen

Inspection of the anti-throw screen revealed that its gross area is approximately 45% solid. It is noted that an architectural pattern is applied to spans 3, 4 and 5 using an additional perforated plate fixed to the outside of the screen which further adds to its solid area, thus increasing the wind load on these spans compared to the rest of the structure.

1. The anti-throw screens should be removed from the Shared Path Bridge, in order to reduce the lateral loading on the bearing system for Spans 1, 2, 3, 6, 7 & 8. It is noted that there is no need to remove screens from the southern side of the adjacent Tram Bridge.

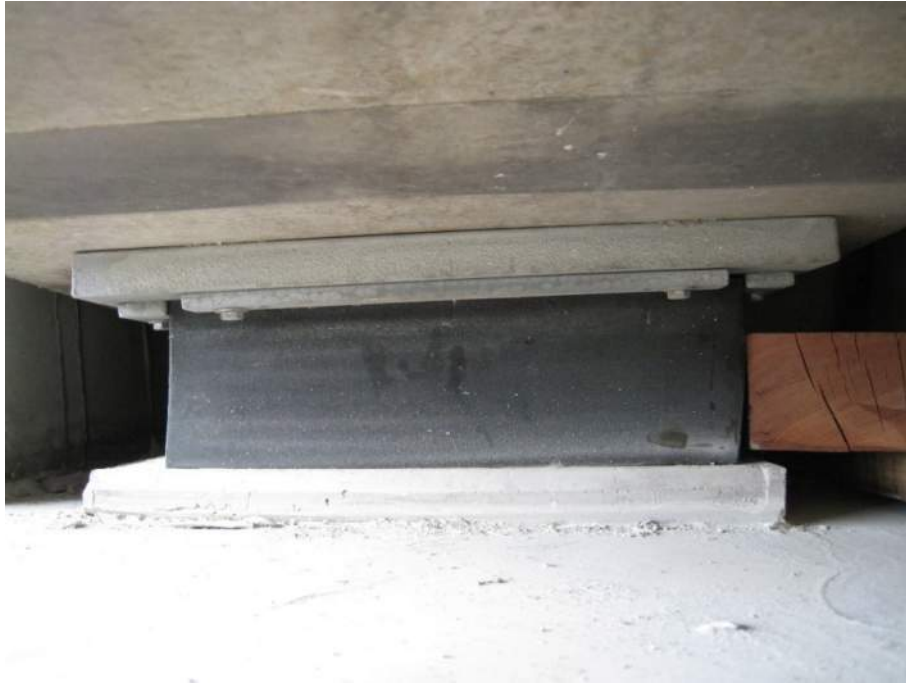
Abutment A Bearing Elevation

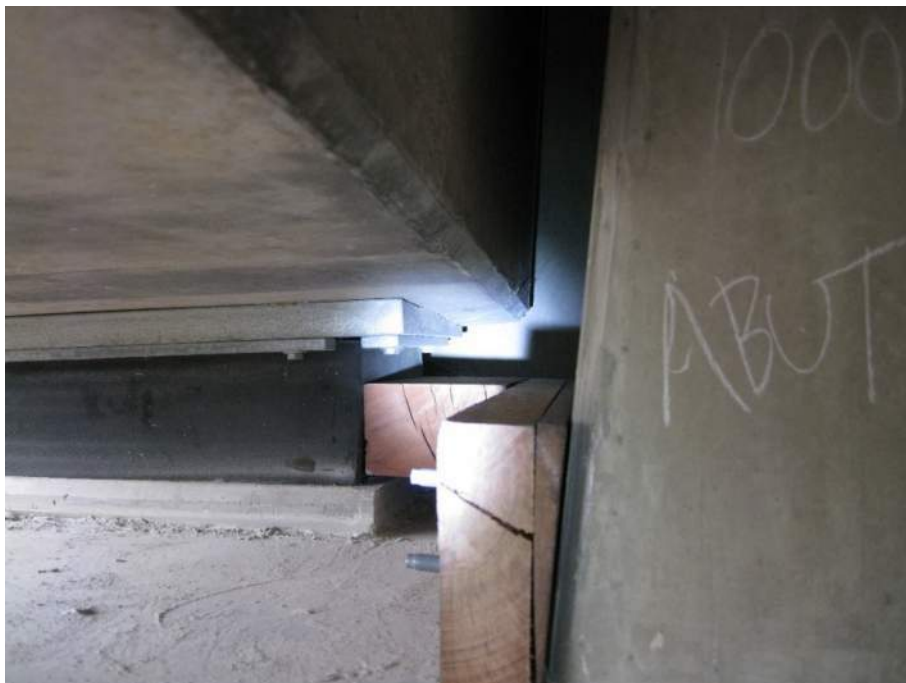
Abutment A Bearing Rotation

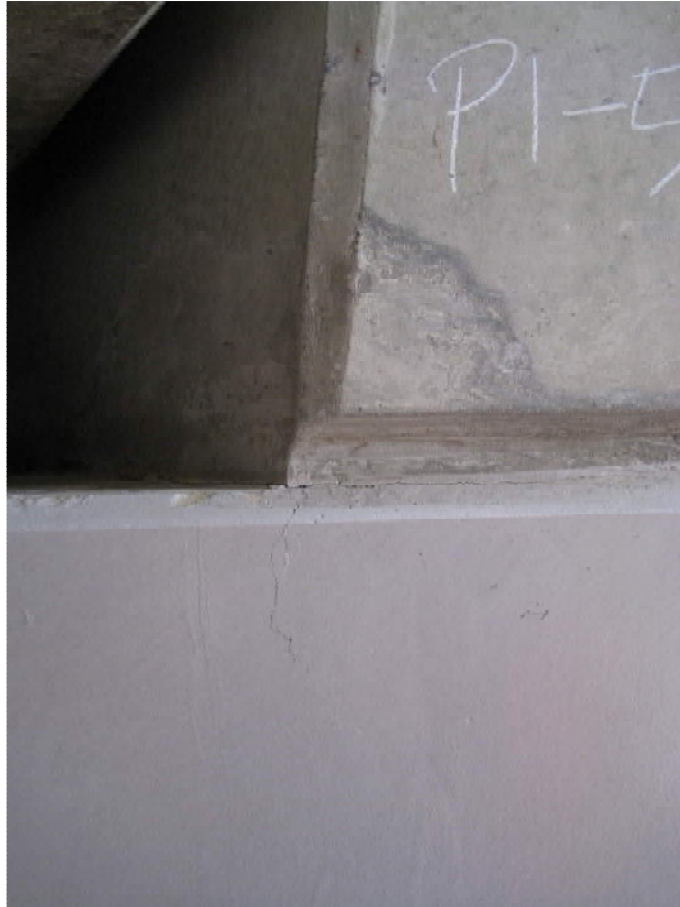
P1 East Wall Cracking

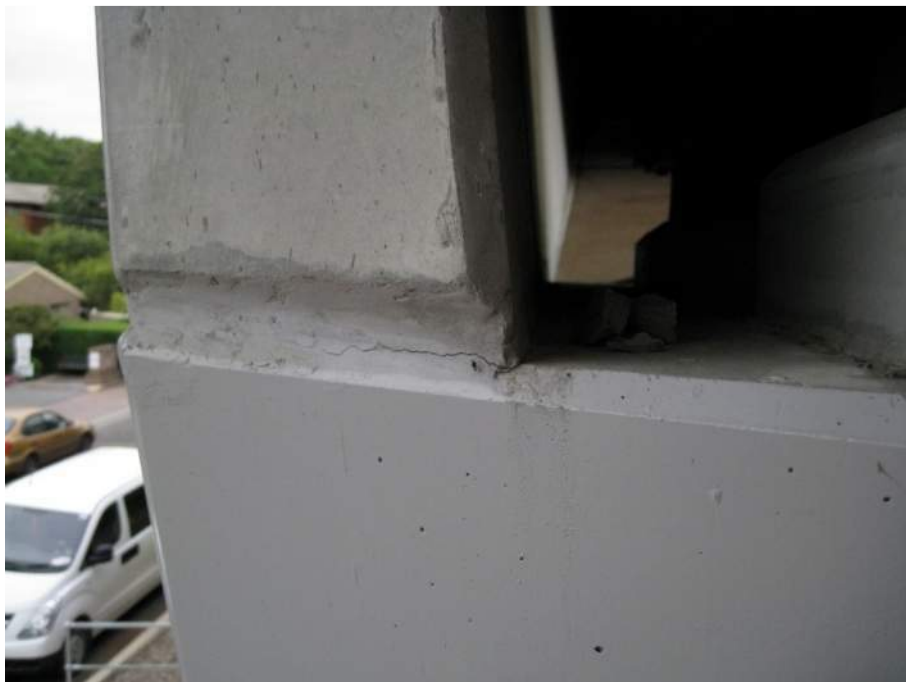
P1 West Wall Cracking

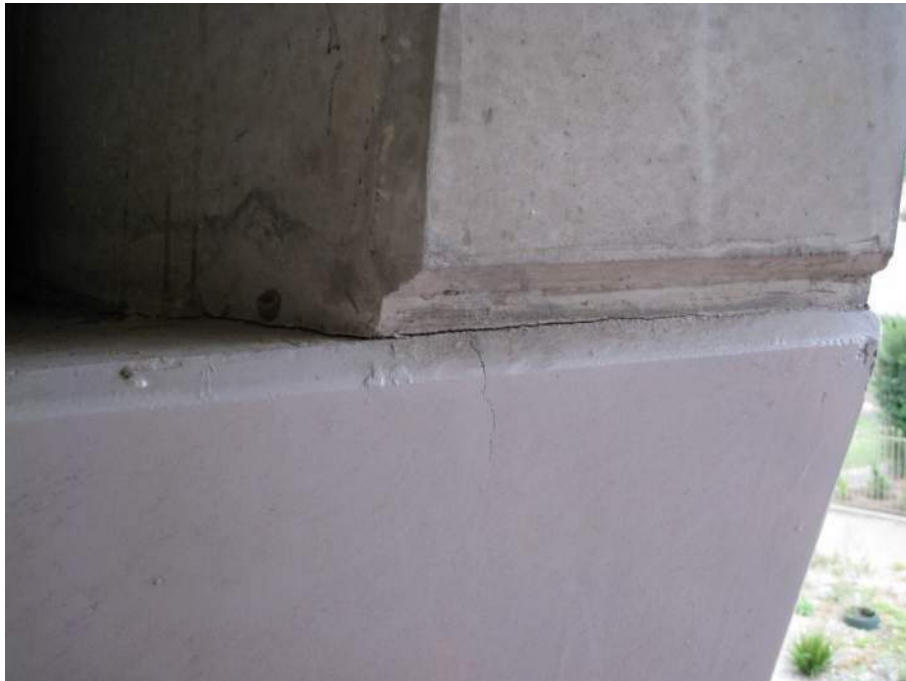
P2 East Wall Cracking

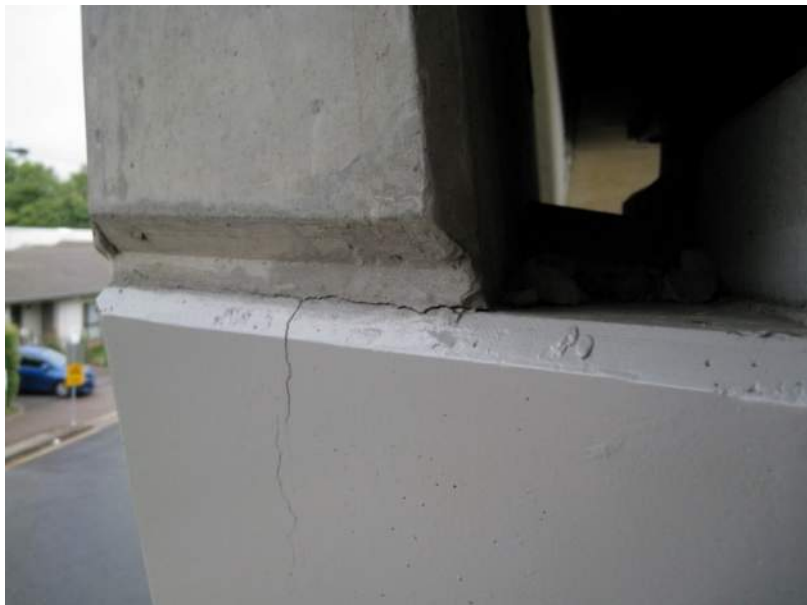
P2 West Wall Cracking

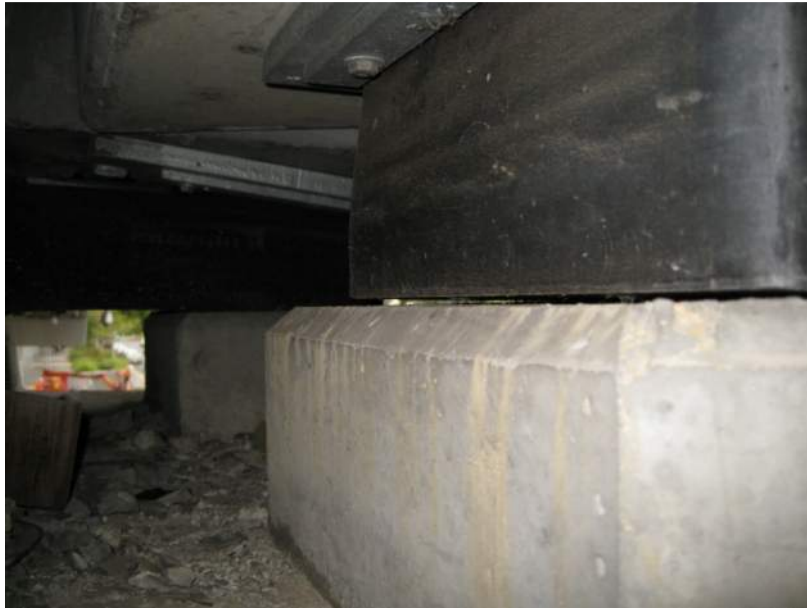
P3 East Bearing Rotation

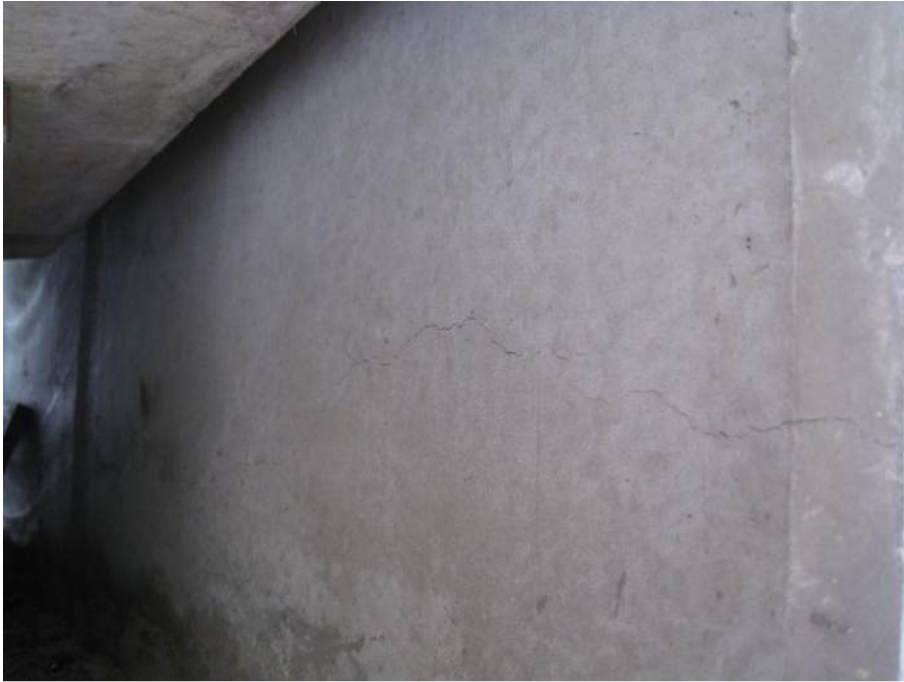
P3 East Wall Cracking

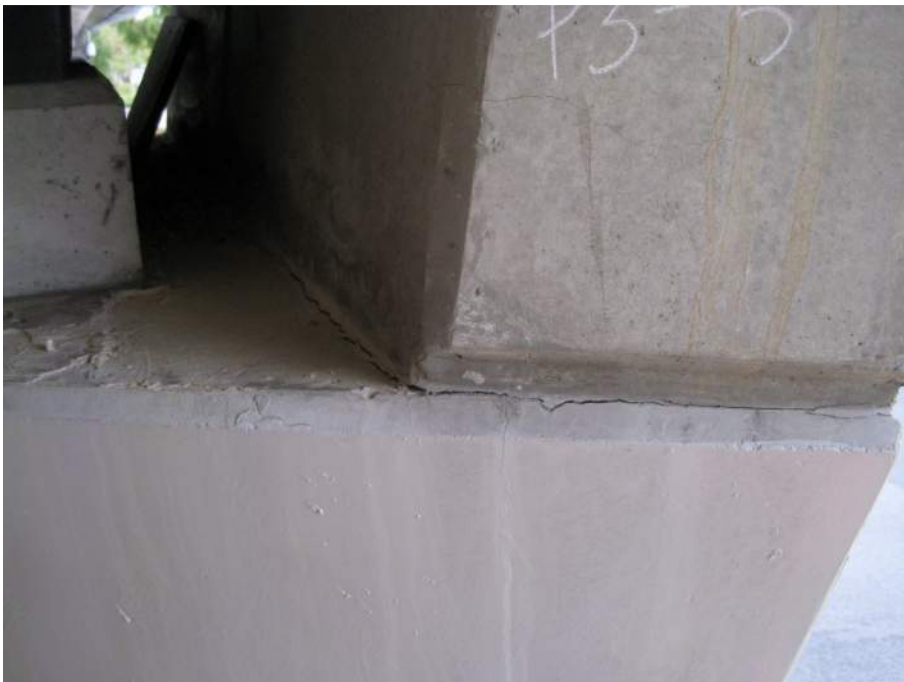
P3 East Wall Cracking

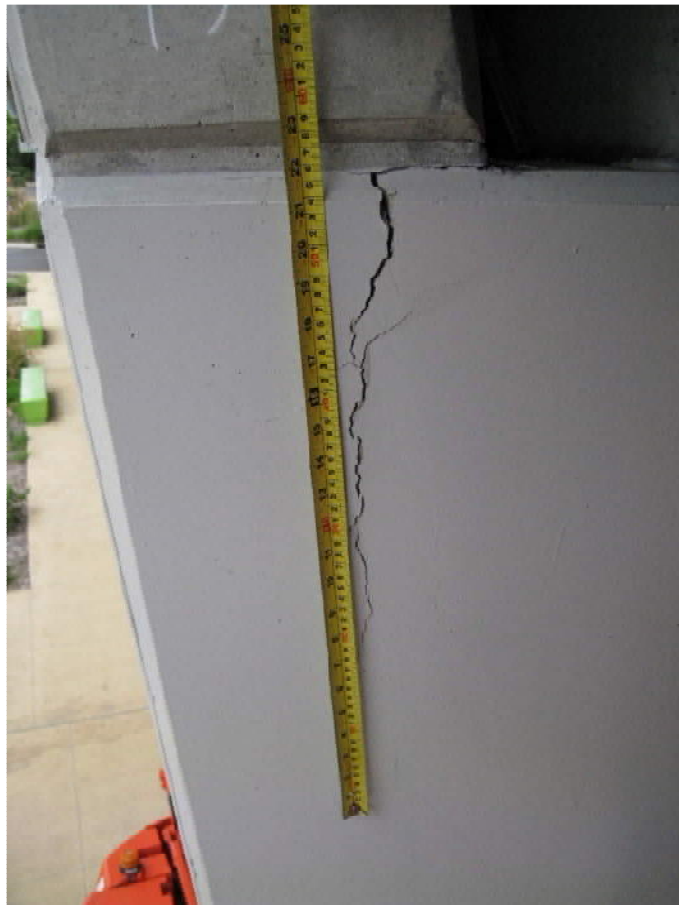
P3 West Wall Cracking

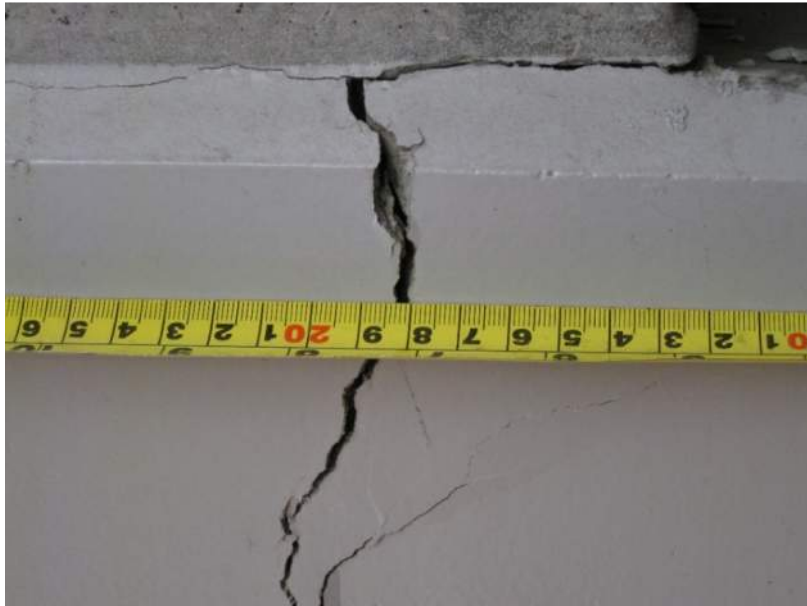
P3 West Wall Cracking

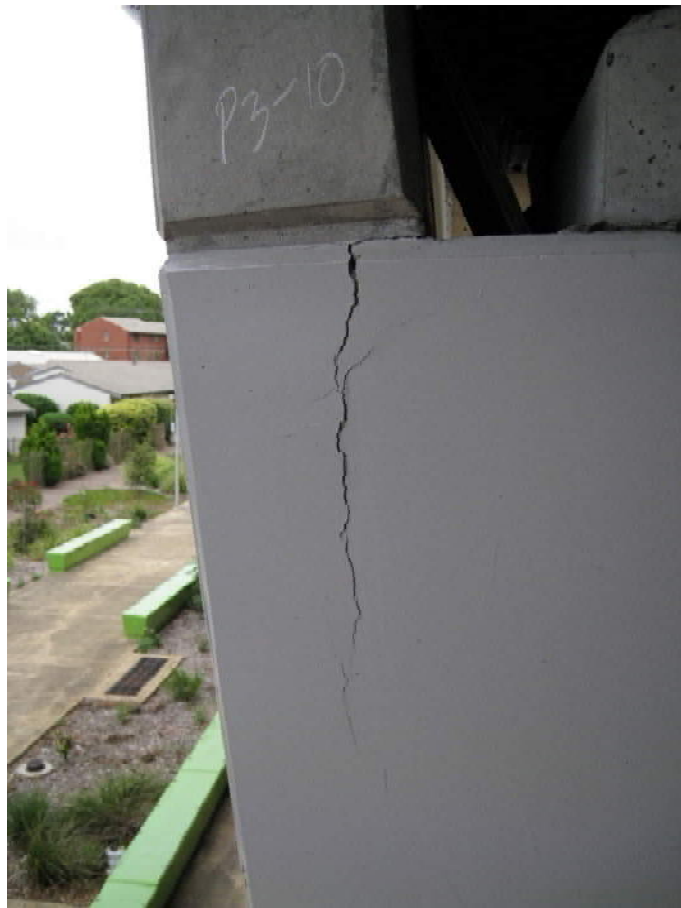
P3 West Wall Cracking

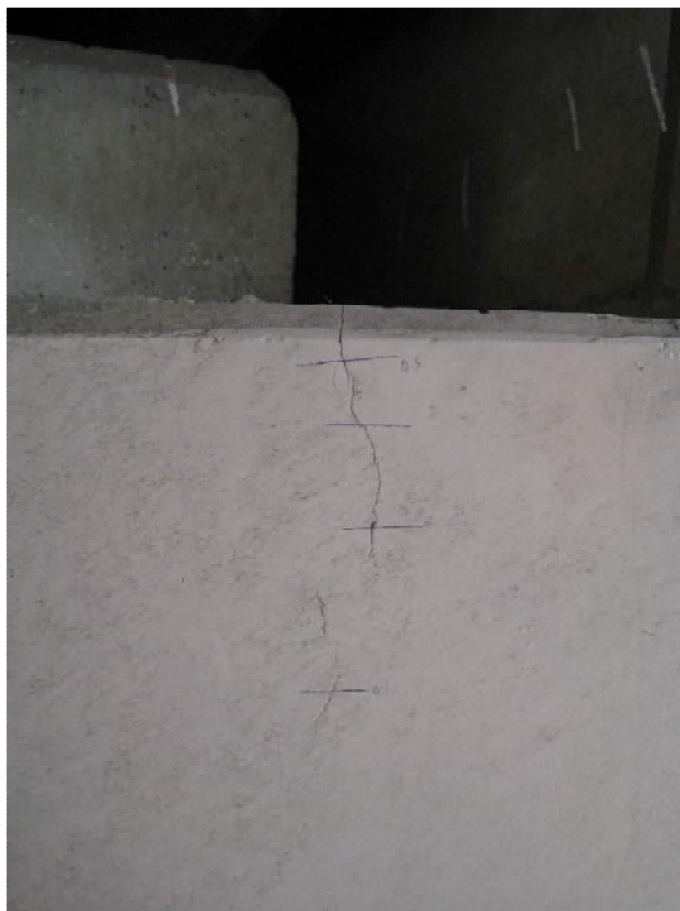
P4 East Pier Cracking

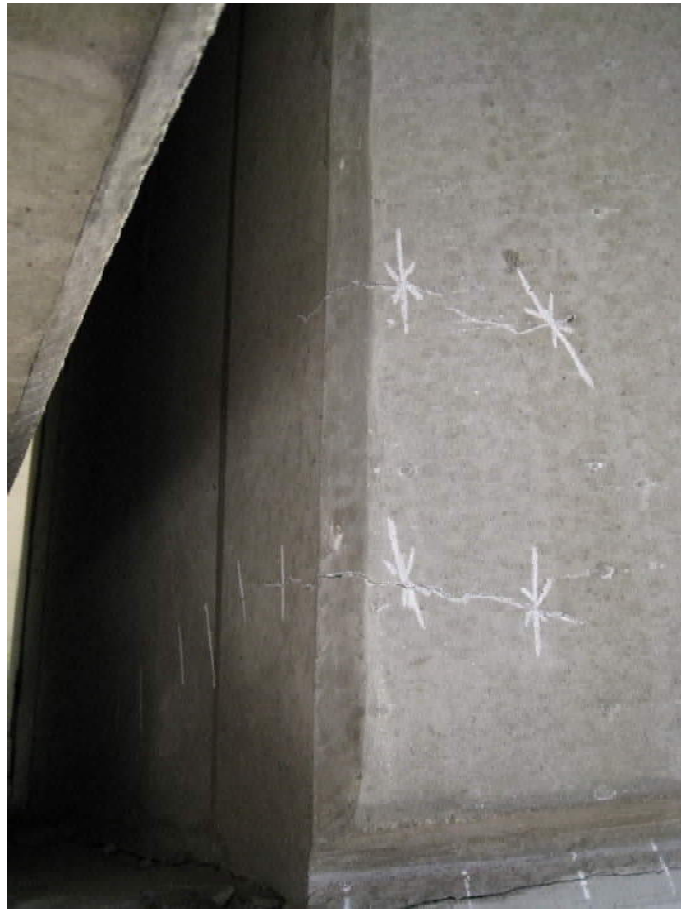
P4 East Wall Cracking

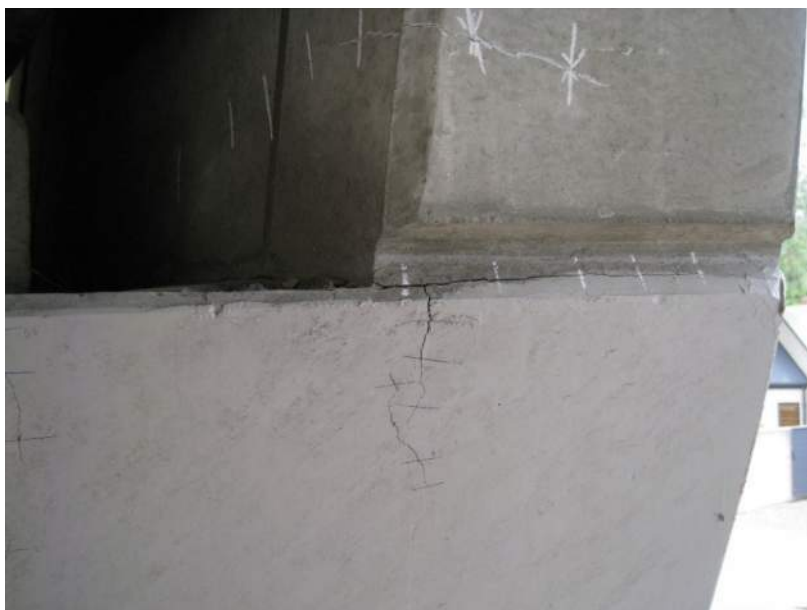
P4 East Wall Cracking

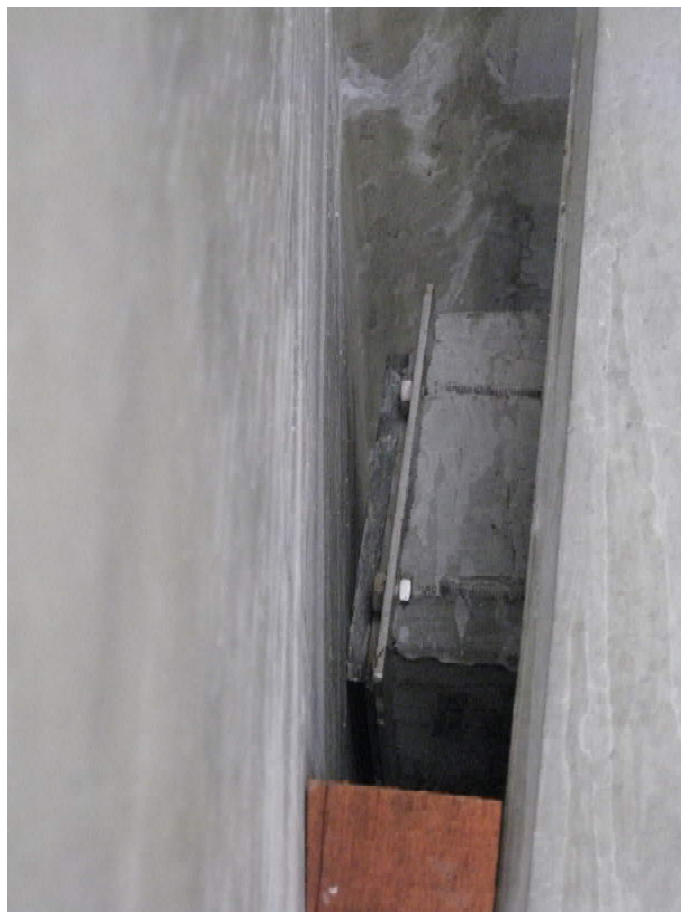
P4 West Side Bearing Separation

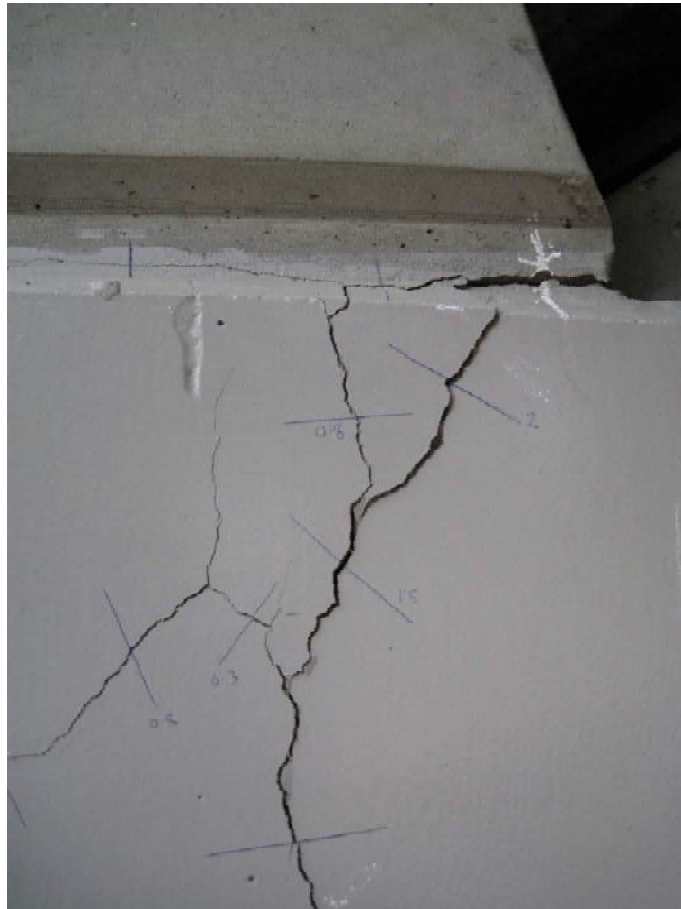
P4 West Wall Cracking

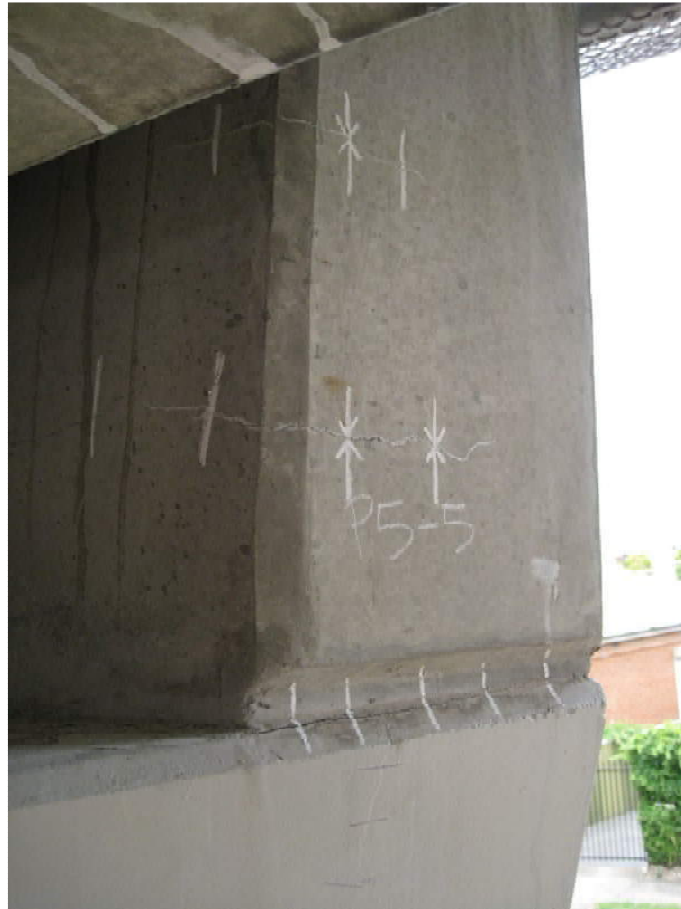
P5 East Wall Cracking

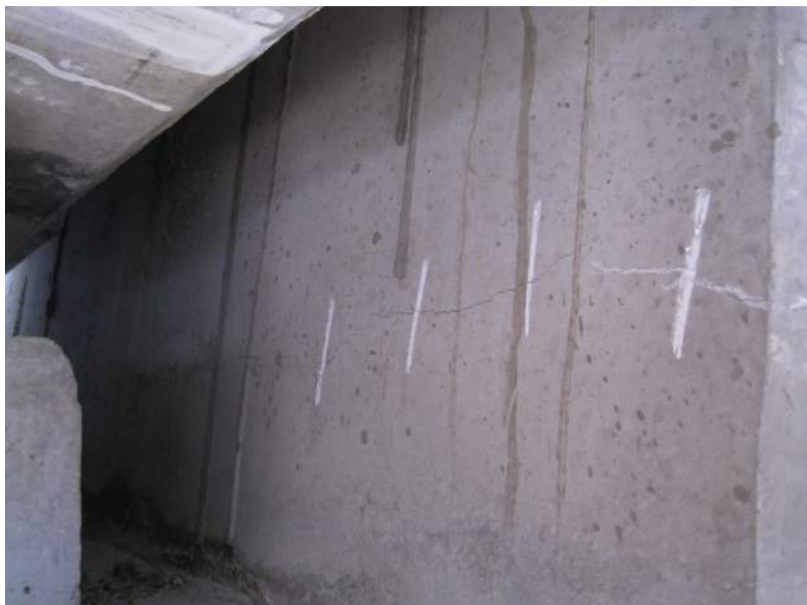
P5 East Wall Crack inside Face

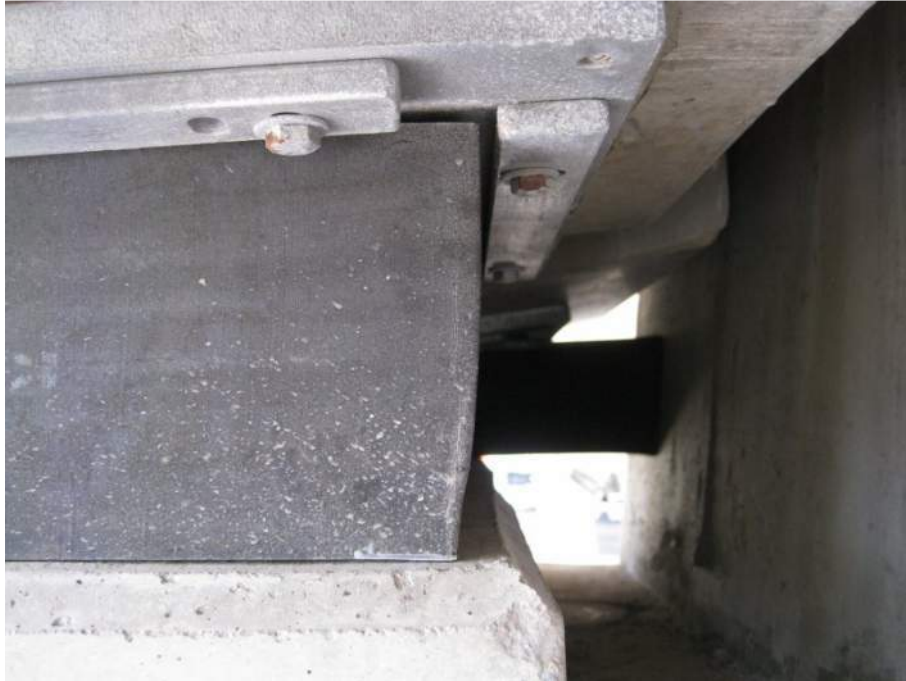
P5 West Bearing Rotation

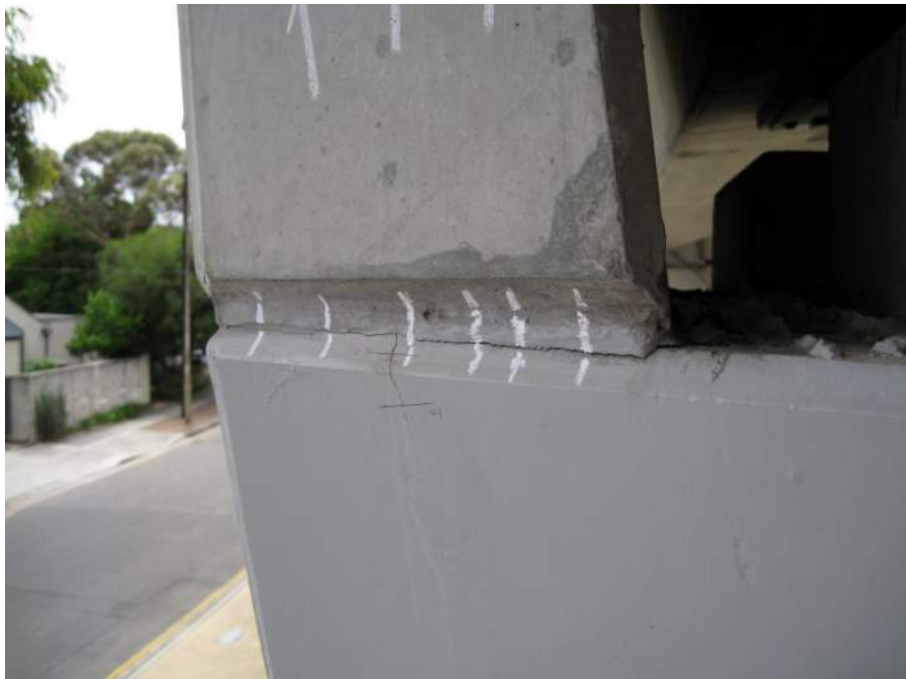
P5 West Wall Cracking

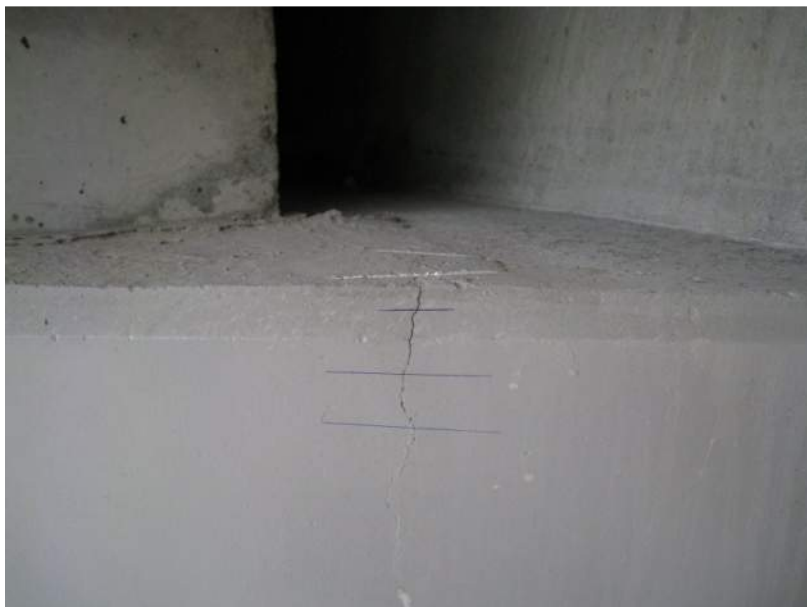
P5 West Headstock Cracks

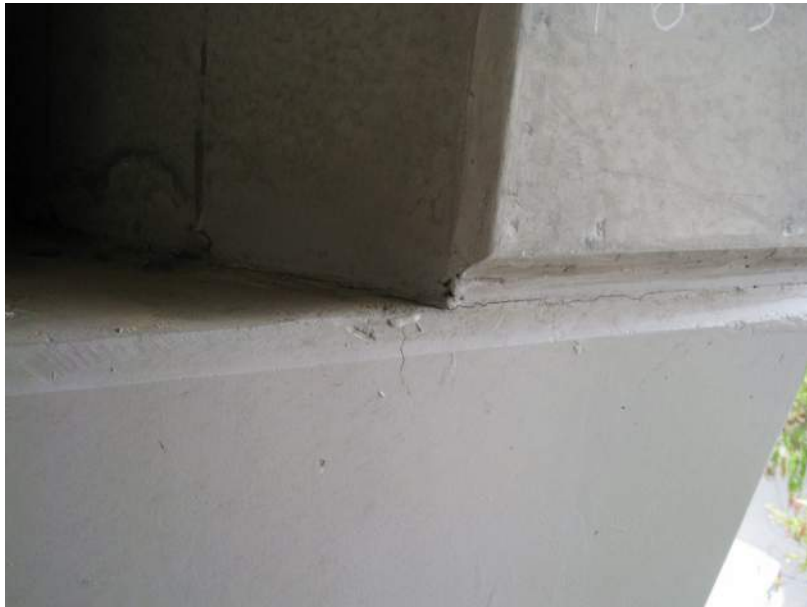
P6 East Wall Cracking

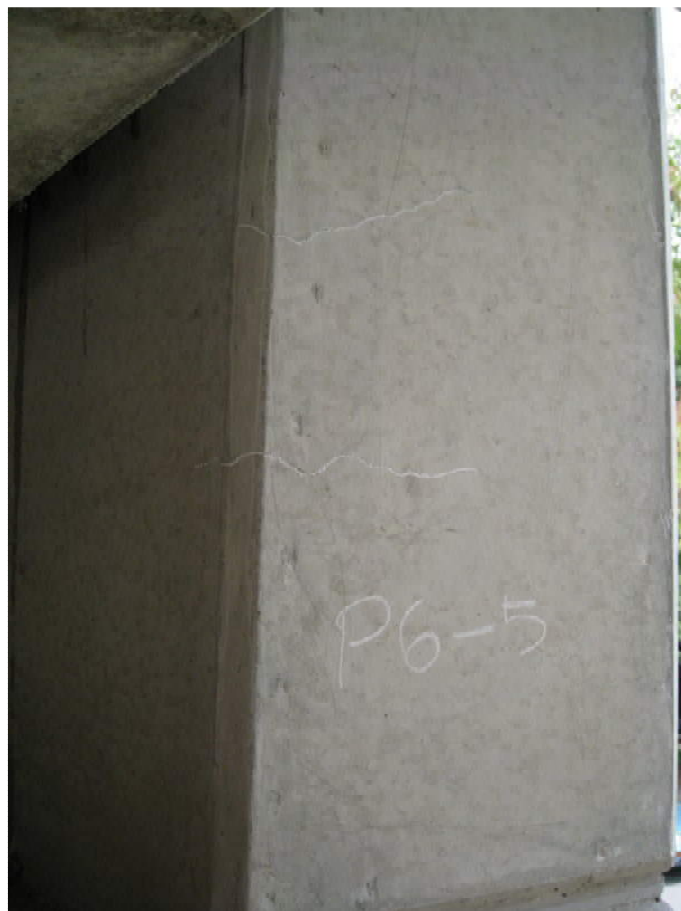
P6 East Wall Cracking

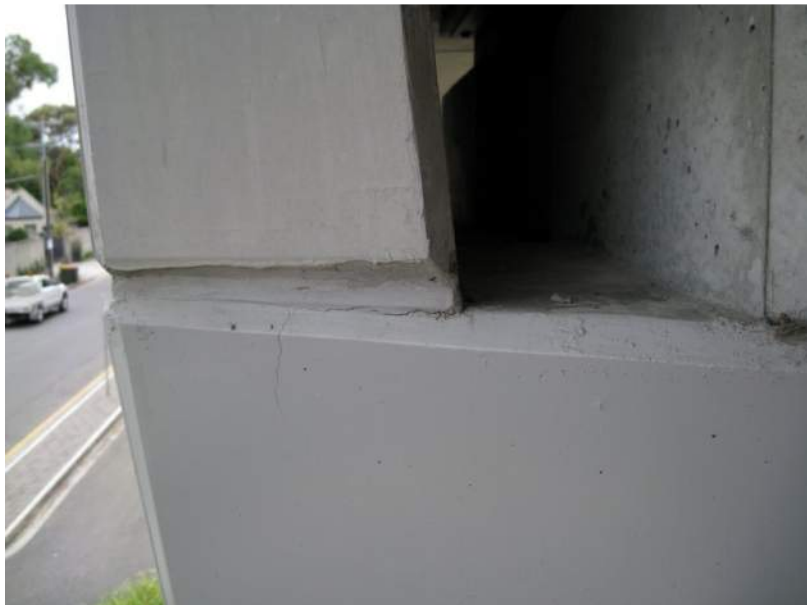
P6 West Wall Cracking

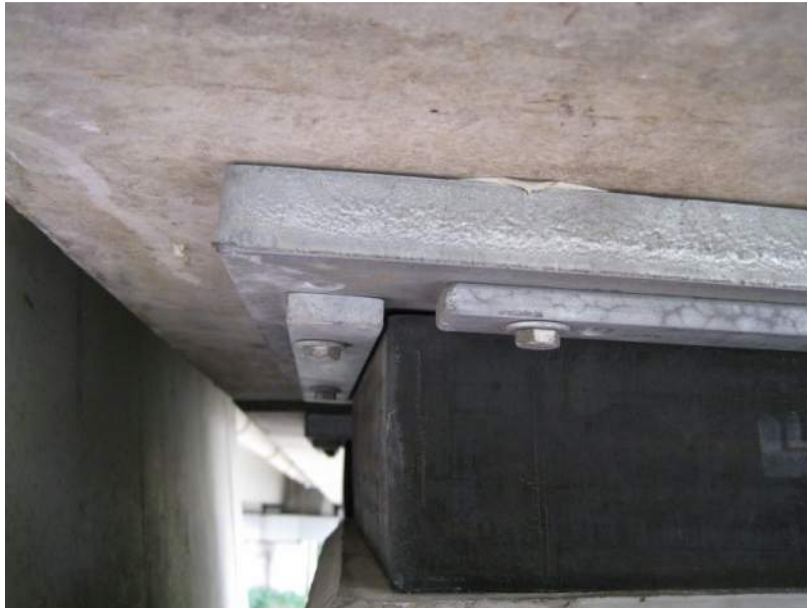
P7 East Bearing Rotation

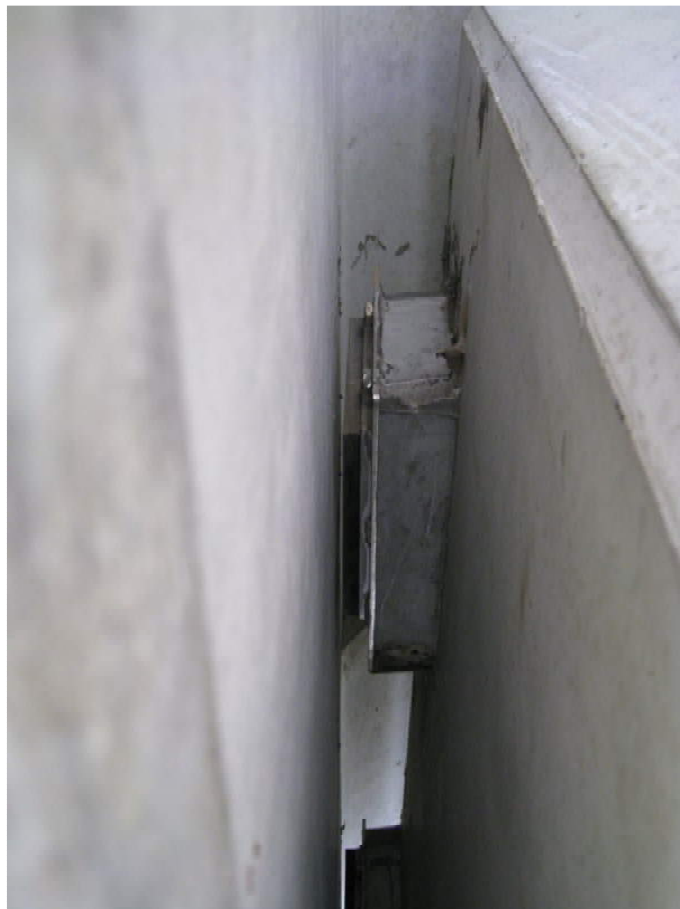
P7 West Side Bearing Separation

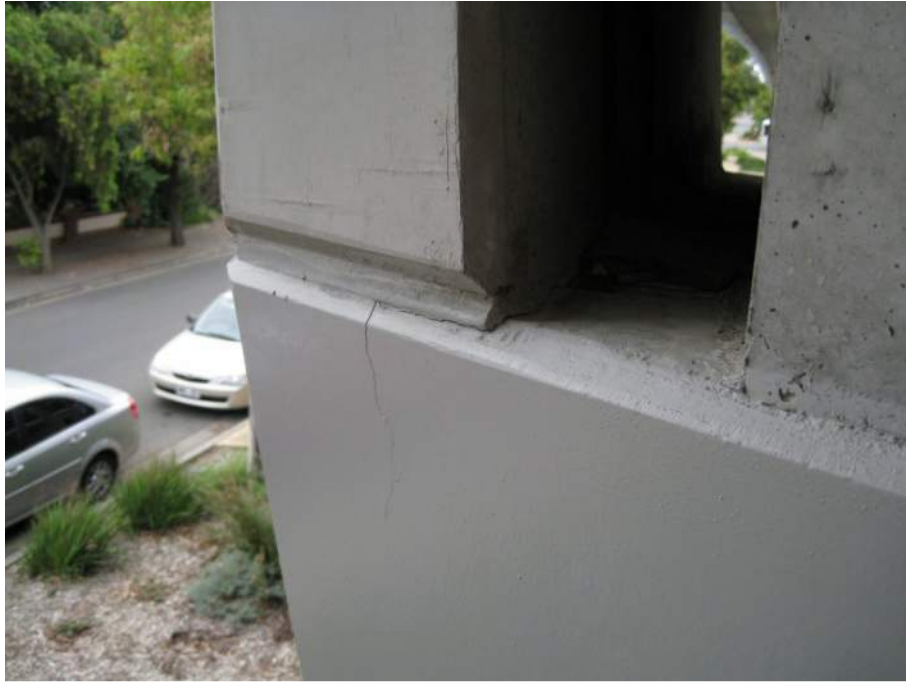
P7 West Wall Cracking

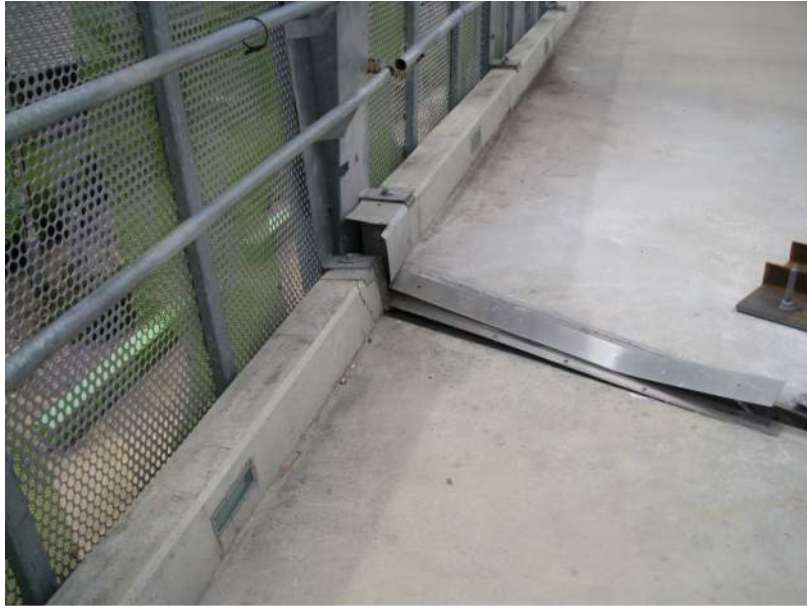
Joint Damage Typical

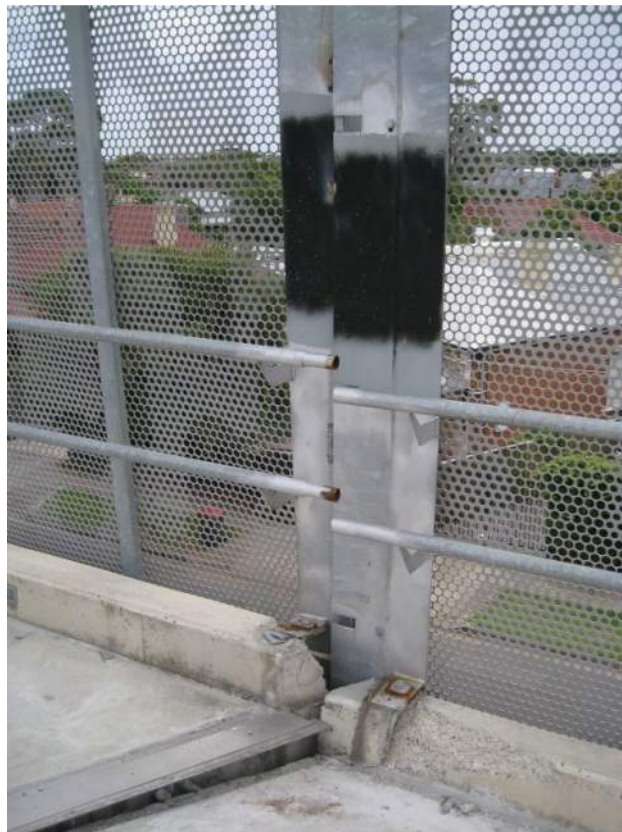
Handrail Misalignment
