BYMARO FATAL INCIDENT OVERVIEW- TANGIER MOROCCO PROJECT

06 July 2018

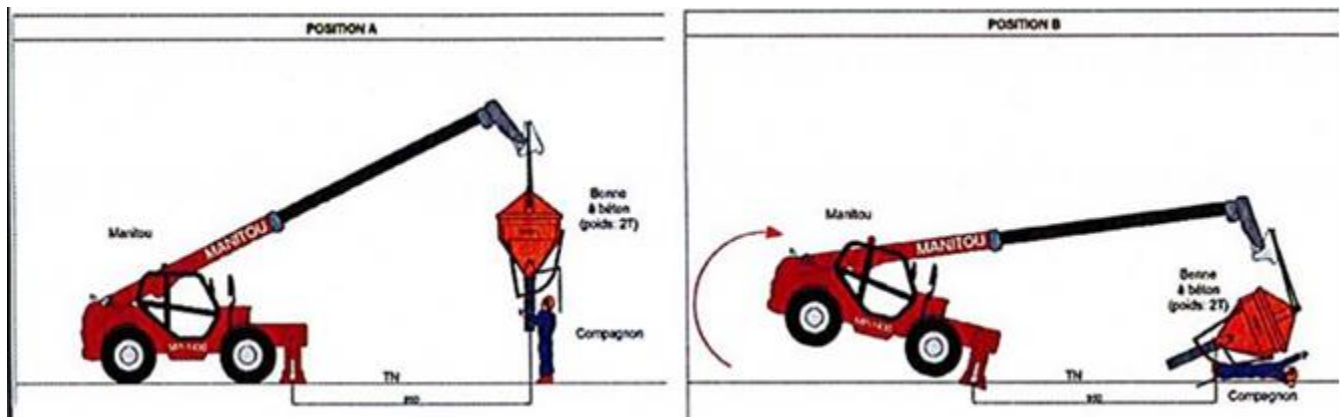
- A 1000l concrete skip (half full of concrete) was being lifted using a telescopic handler. At the location where the skip was to be emptied, the back wheels of the telehandler rose up, causing the skip to go down. The victim could not avoid being crushed by the skip.

- The concrete skip weighed 2t; and the boom had been extended until that load was 8.50 meters from the front outriggers of the telehandler. According to the manufacturer's notice, this was far beyond the maximum distance authorised for such a load.
- The telehandler is equipped with a safety device (load moment indicators), that gives warning of approaching overload. It should have stopped the extension of the boom, once the maximum distance reached with this load. It appears that this safety device has been switched off by the operator.
- The team in charge was as follows:
 - The telehandler operator (> 20 years of experience, qualified)
 - A foreman and the victim, both on the ground.

The victim was standing behind the skip, so the operator could not see him properly.

- **No preparation** had been carried out for this lifting operation:
 - The positioning of the telehandler and the checking of the maximum distance authorised in relation with the load were left up to the workers.

- This is confirmed by additional findings, not related to the accident: the load was lifted using chain slings, that were poorly suspended at the extremity of the boom.
As for telehandlers, lifting operations necessitate the use of dedicated accessories, with proper lifting point. In the case we have to transport the lifted loads from a location to another, dedicated accessories must ensure that the load won't go swinging (standard concrete skip is not suitable in this case).

- **Weak safety culture** from the operator, who breached a basic safety rule, in switching off the load limit device of the telehandler. In the morning, a near miss had occurred when the same operator had unloaded two pallets at the same time, causing the upper one to overturn. No stop work directive had been issued at that moment, which would have been necessary to understand what had happened. This reveals a **weak safety culture within the team**, beyond the operator himself.

- **No supervision** was in place: as for any lifting operation, a signaller should have been part of the team in charge.

- Lifting Plans and Lifting Organisation to be implemented:
 - **Lifting operations are to be designed (Lifting Plan)**, whether throughout method studies, or for simple cases (such as this one) throughout a preparation carried out by a site engineer. This design should take into account the lifting equipment, the manufacturer's recommendation (capacities, accessories to be used..), and clear instructions should be given to the lifting team.

- **Each site should implement a lifting organisation**, with lifting teams independent from the production teams. Trained signallers on the ground should be part of these lifting teams, to guide the operators and to prevent workers around from being in hazardous areas.

- **Access of the operators to the load limit device to be limited**, by protecting this device with a closed box whose key is given to the lifting manager.

- **Safety culture and safety leadership to be strengthened**, by the use of Stop & Go notifications by production teams themselves whenever necessary.
