Incident Alert

2018-010 Near Miss - Worker Fall Through Opening in Scaffold

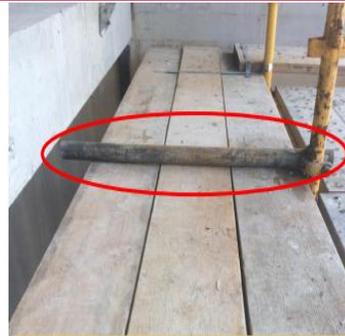
Just prior to the incident occurring, a subcontractor Scaffolder had removed the tube that was securing the boards (as seen in the photo), whom was unaware the cantilevered boards were not supported underneath.

The scaffolder presumed the tube securing the boards was a “trip hazard” and consequently removed the “hazard”, unaware of the new risk created in doing so.

Support Tube, which had been **removed** by scaffolder

- Projects to ensure that Scaffolding companies have adequate Supervision present on site to ensure High Risk Works carried out are in accordance with site and legislative requirements.
- Subcontractor Supervisors to provide adequate instruction and training to workers prior to commencing.
- Workers to be reminded, they should never “assume” a control is in place (i.e. Assuming the cantilevered boards were supported underneath when removing the tube above), especially when it comes modifying scaffolding.
- Incident to be discussed at toolboxes and displayed on the site noticeboard

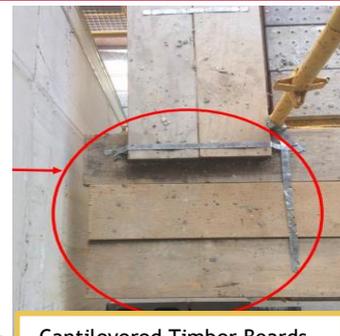
A Subcontractor was tasked to remove excess Ritek Wall braces and ply strips from level 4, near Stair Core 2. Whilst the Subcontractor stepped from the concrete slab onto the scaffold working deck, 3 LVL boards, which had previously been fixed due to them overhanging, gave way, resulting in the Subcontractor falling through the opening. The contractor was able to pull himself back up, however was exposed to a potential fall approx. 2.9m to the below working deck. No injuries sustained.

Cantilevered Timber Boards, showing location in area where contractor stepped on
