South Road Tram Overpass Shared Path 5 May 2017 Bridge Revision: 3

Remediation Options Report

Department of Planning, Transport, and Infrastructure

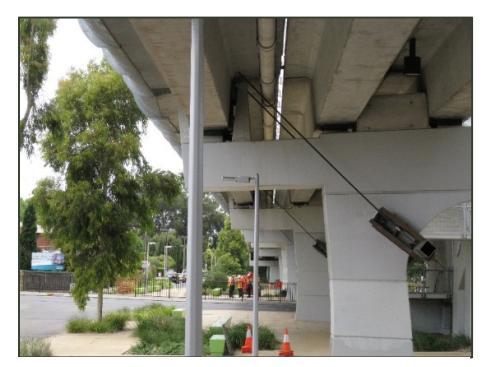
Figure 2 Temporary stabilising tiebacks

On 18 January 2017 DPTI became aware of girder dislodgement to two spans of the South Road Tram Overpass shared pedestrian and cycle path bridge (Shared Use Path Bridge). The girder dislodgement occurred in Spans 4 and 5, between Piers 3 and 5 and resulted from a loss of support caused by a gross transverse movement of the elastomeric bearings beneath the girder soffit. The two girders of Spans 4 and 5 subsequently became unstable and have tilted about their longitudinal axis. Reinforced concrete keeper walls have acted to restrain the girders and prevented them from falling off the piers.

As a result of the incident, South Road was temporarily closed to traffic whilst stabilisation of the structure was installed. The girders have been stabilised using temporary tiebacks to the piers, as shown in Figure 1. This stabilisation is a short term measure only.

Following the installation of this temporary stabilisation, South Road was reopened to traffic, however the shared use path bridge remains closed to pedestrians and cyclists due to the gross misalignment of the footpath sections and the hazards presented by the temporary support anchors installed in the pathway.
