Port Spencer Grain Export Facility
Amendment to Public Environmental Report

VOLUME 5 OF 5

IW219900-0-RPT-0003 | 1

Appendix D. Causeway Construction Methodology

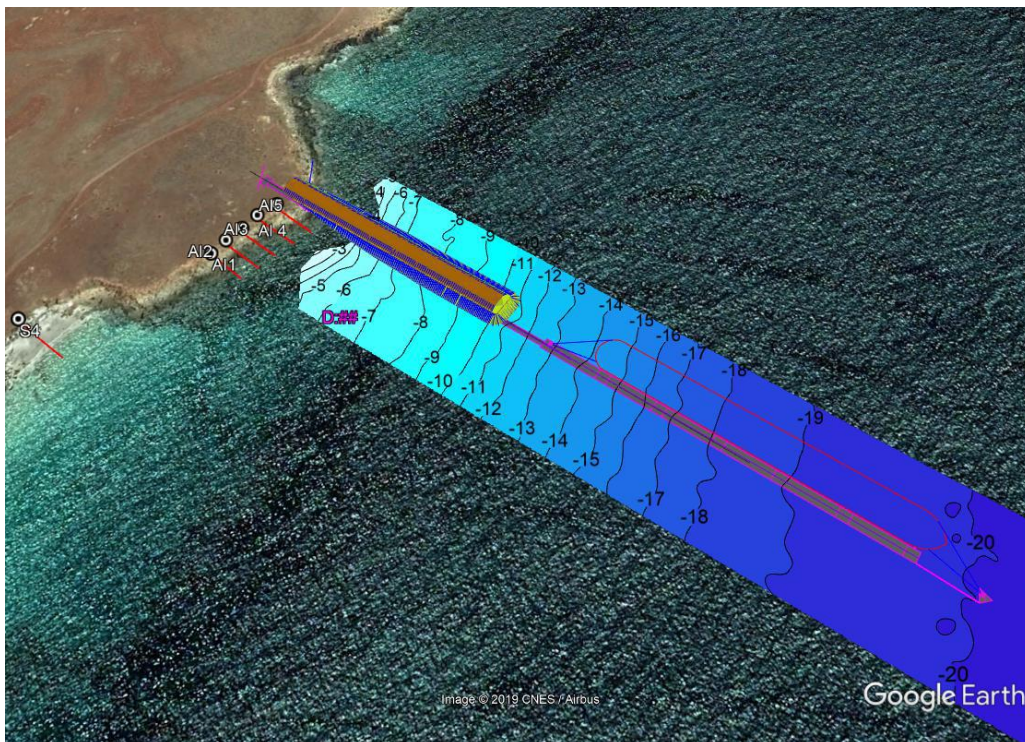
Figure 1. The inner section of the proposed Port Spencer is an approximately 220 m long causeway/reclamation out to 10-11 m depth.

The following provides a description of the proposed beach monitoring and management for Port Spencer. The proposed docking facility will have a ~220 m long solid section/causeway from the land/beach out to where the pile wharf begins in 10-11 m of water (Figure 1).

In the present case, erosion of the coast immediately north of the wharf causeway is alleviated because the rock substrate that forms the foreshore and nearshore subtidal zone (Figure 1). However, there is potential to have chronic erosion impacts on Rogers Beach approximately 500 m to the north because the sediment that would have previously moved northward along the toe of the nearshore reef will be blocked by the wharf causeway leading to a deficit of sand into the southern end of Rogers Beach. While it is expected that accumulation of sediment on the southern side of the wharf causeway will be relatively slow at this reasonably benign site, with consequently slow loss of sand at Rogers Beach, this can effectively be managed and mitigated through the application of beach monitoring and management in the form of sand transfer; similar strategies are these days applied worldwide, with a local example being part of the Adelaide 'Living Beach' strategy in the form of back-passing.

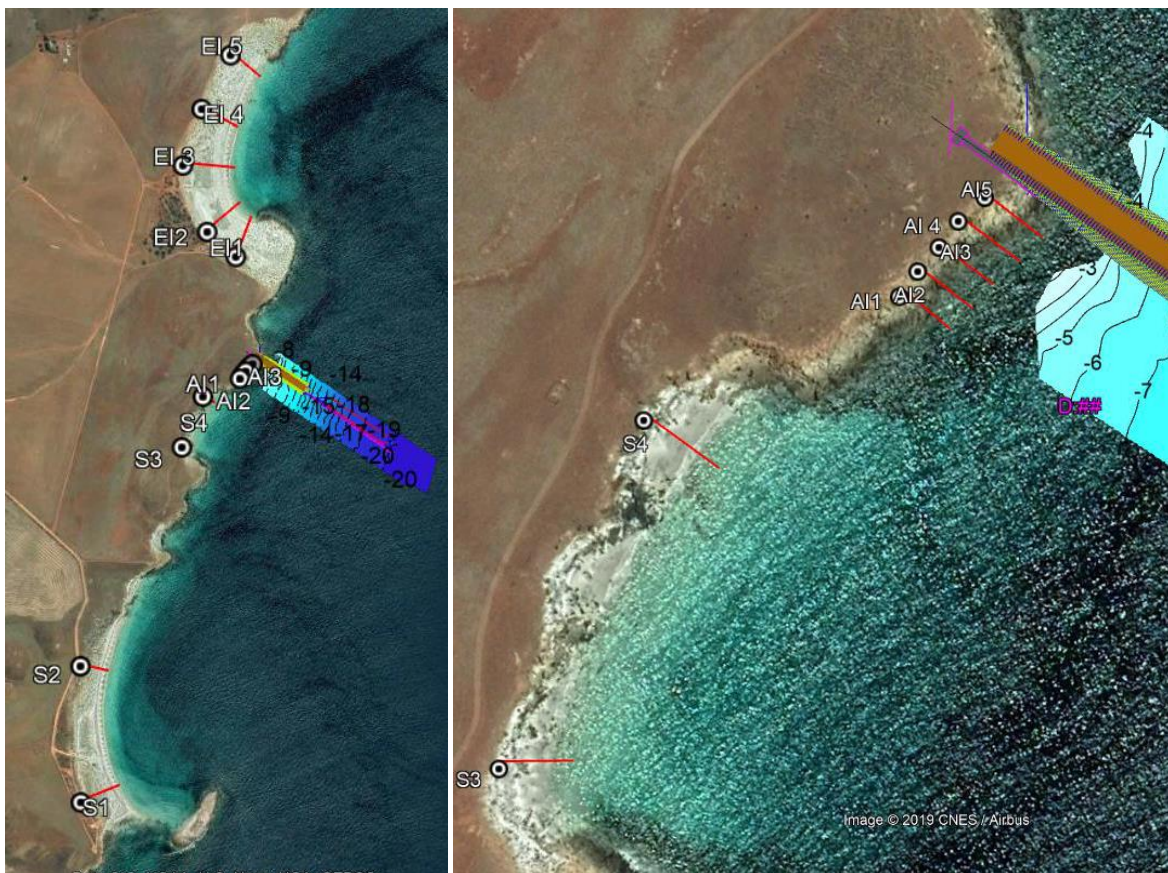
Figure 2. Approximate locations of monitoring BM's (Table 1).

The approximate locations of 14 BM's for the beach profiles are presented in Table 1 and Figure 2. These locations can be modified in order to establish them in locations where they are unlikely to move. The 4 southern profiles are 'control' sites, which are considered outside of the proposed Port's influence; by monitoring these sites, natural variation not attributable to the project can be identified (e.g. significant loss of sand may be due an intense local storm that would impact all beaches along the coast similarly). The 5 profiles on the southern side of the wharf causeway are to monitor/measure the volume of sand accreting against the structure. The 5 profiles on Rogers Beach are to monitor any changes in the beach width to determine the impact of the structure and the need to transport sand from the southern side of the wharf causeway to mitigate this effect.

Table 1. Approximate locations of monitoring BM's (see Figure 2).

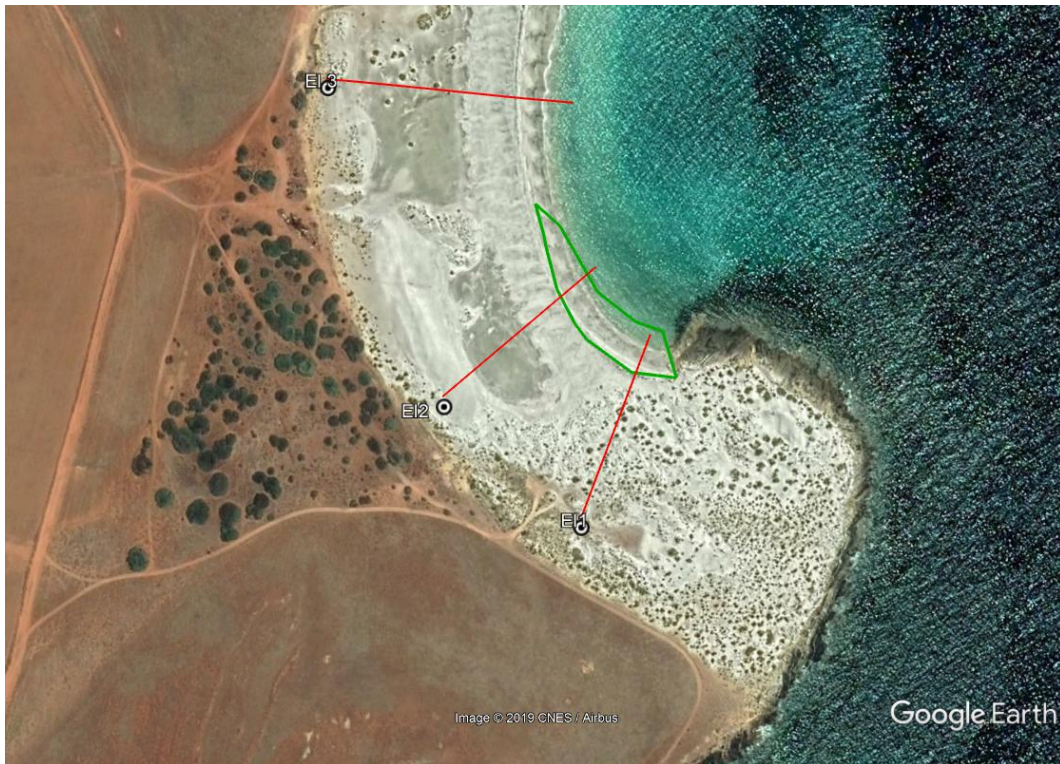
Figure 3. The recommended location for deposition of bypassed sand is shown in the green area – a small road provides access to the this part of the beach.

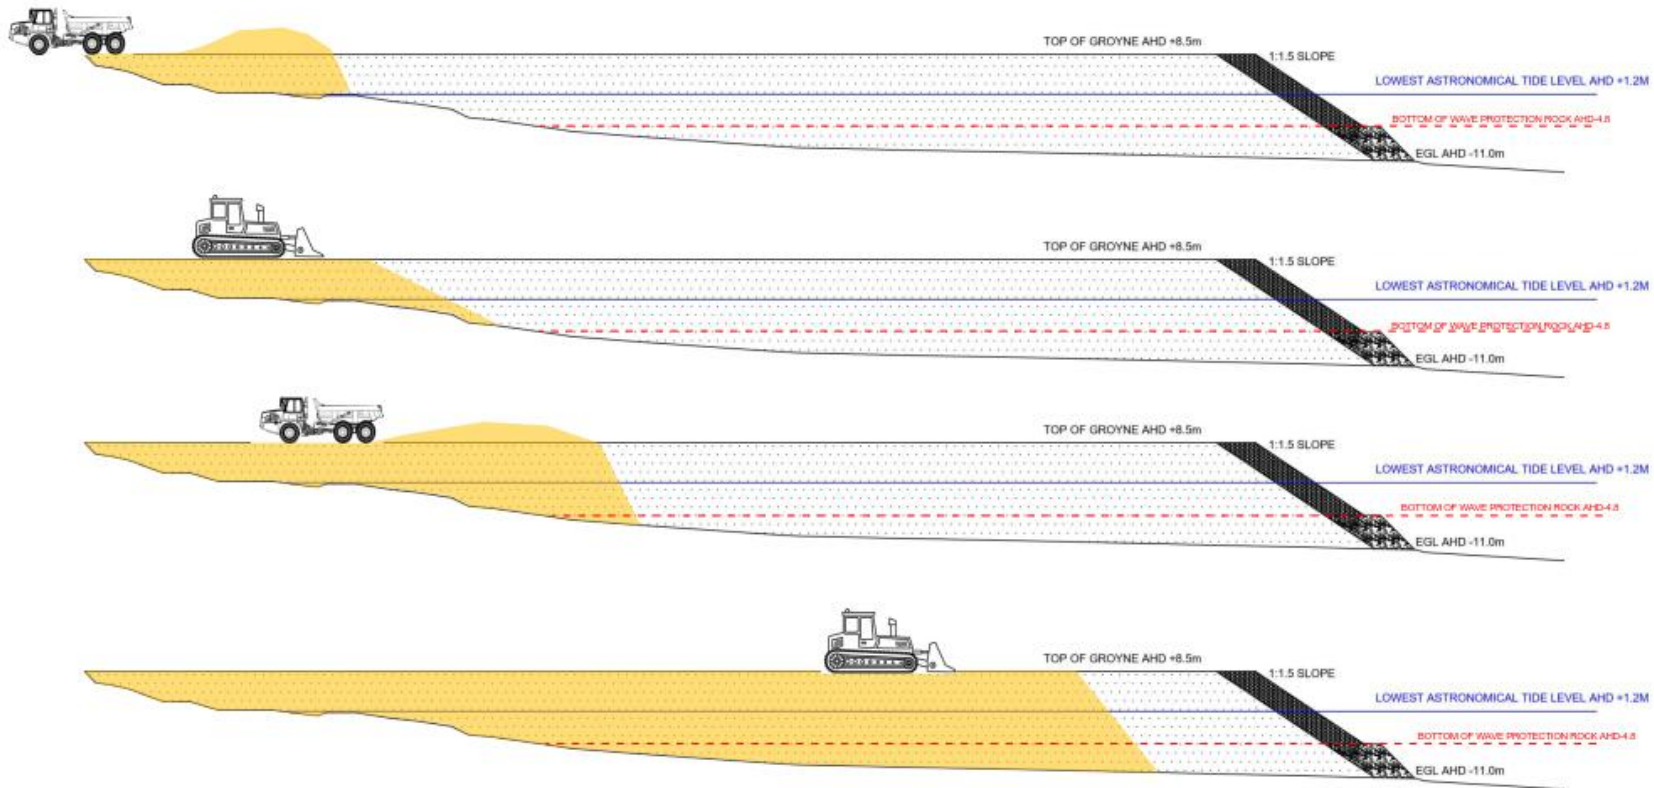
A combination of trucks and a dozer to create a platform out into the water over footprint of causeway.

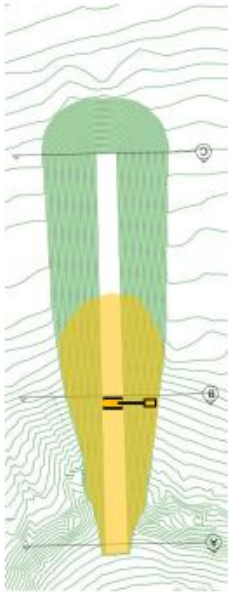
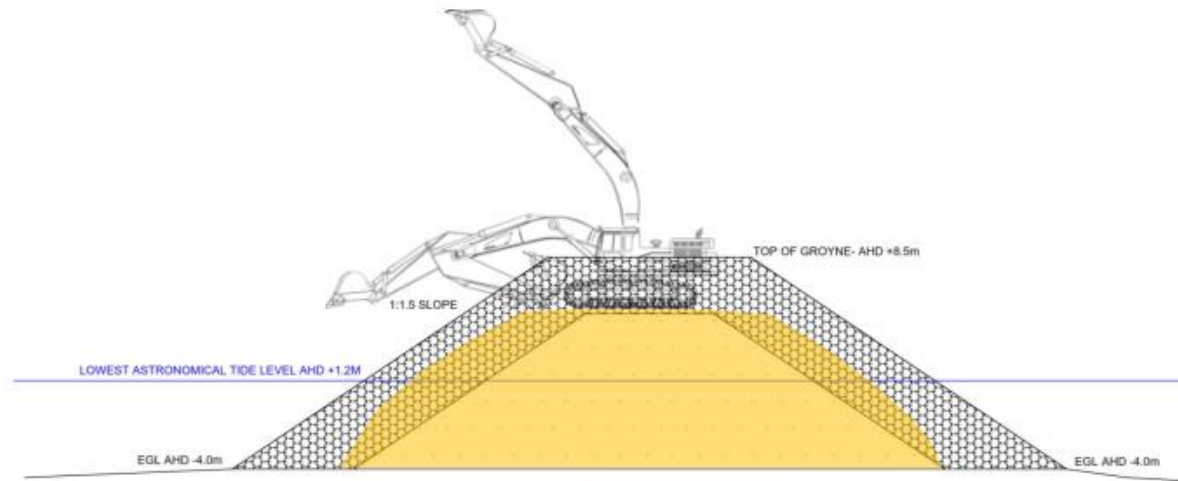
A long reach excavator is to trim the batters from the platform created by the trucks and dozer.

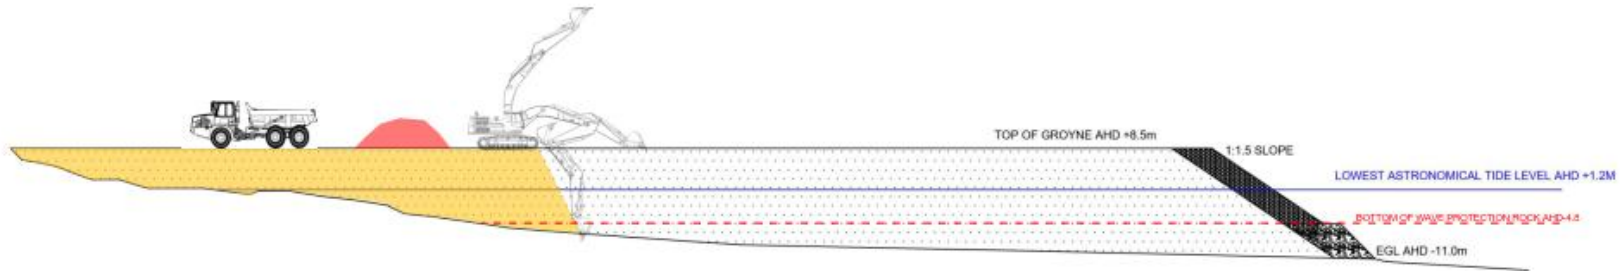
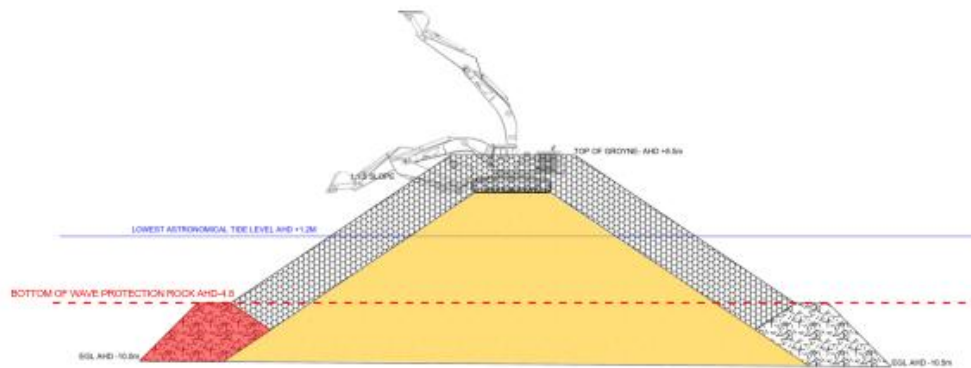
A truck is to end tip the 1-2 tonne armour rock onto the trimmed core and an excavator is to place the rock on/roll the rock down the causeway batters to create a bench for the 8 tonne rock to sit on.

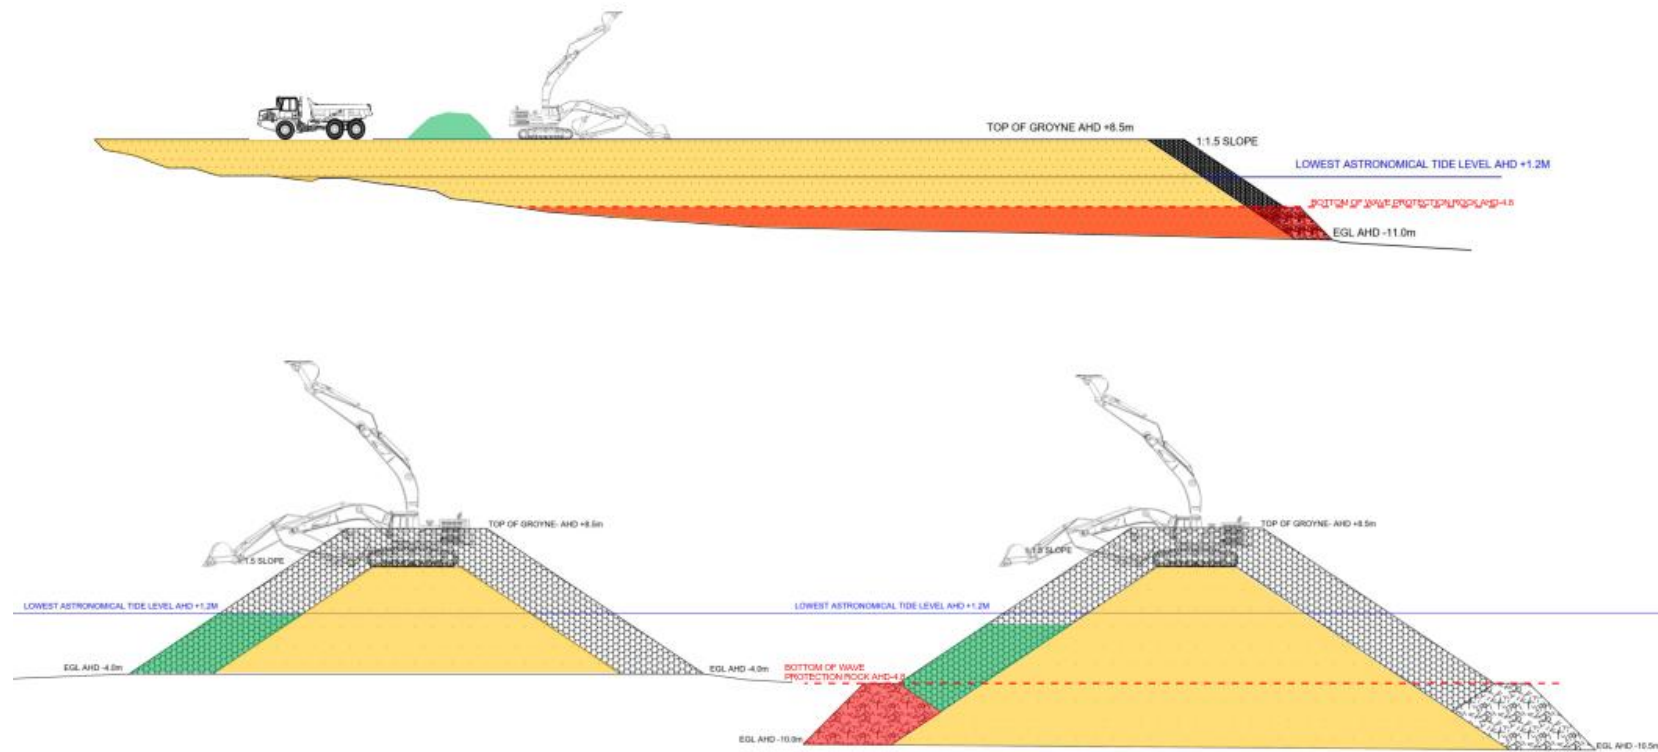
A truck is to end tip the 8 tonne armour rock onto the trimmed core and an excavator is to place the rock on the causeway batters.

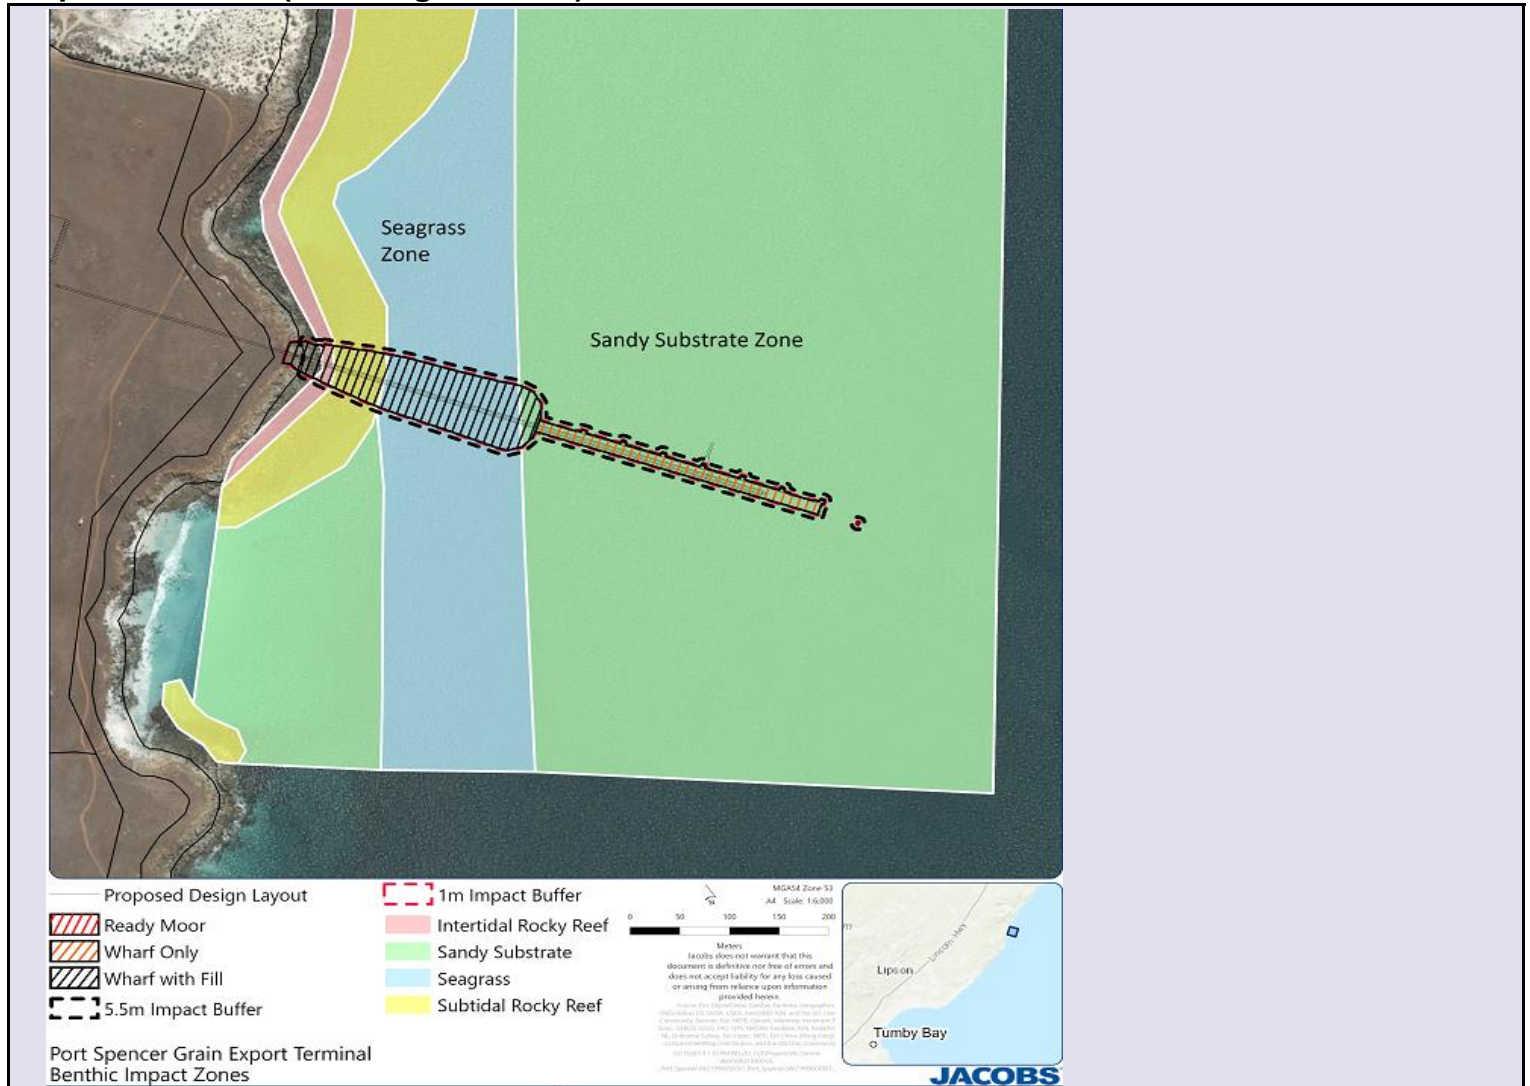
Map of the Block (Including the Sites)

Block	Port Spencer Benthic Impact
Size of Block (Ha)	2.057616
NRM Region	Eyre Peninsula

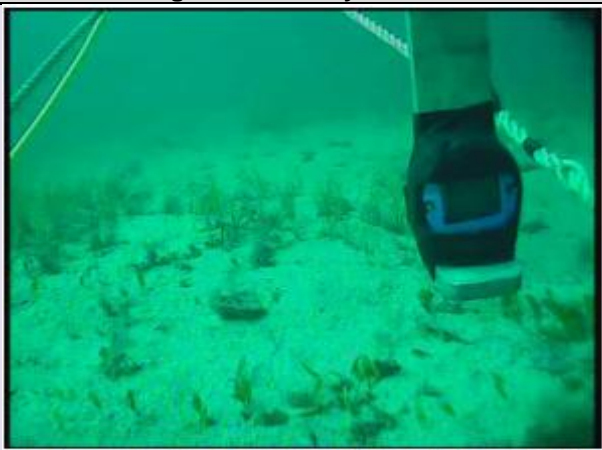
<p>a) A patch of <i>H. nigricaulis</i> and <i>H. australis</i> (14.9 m deep).</p>		
	GPS Reference	
	Datum	
	Zone (52, 53 or 54)	
	Easting (6 digits)	Not known
	Northing (7 digits)	Not known
	Description	Photo copied from Golder Associates (2011) Port Spencer Marine Baseline Quantitative Surveys. Submitted to Centrex Metals Ltd.
