Safety Share

Incident Title: A SCAFFOLDER DIED AFTER FALLING INTO A PROCESS VESSEL AT A REFINERY	Date: December 2015
What happened? On the day of the incident, a five-man scaffolding team had established a ladder at the bottom entry of a digester that still contained scaffold. The scaffolder had gone up a series of stairways over three levels, with another team member, to the top level of the digester bank to enter through the top manway of the digester being worked on. However, he inadvertently entered a manway into an adjacent digester, from which the scaffold had already been removed, and fell about 12 metres.

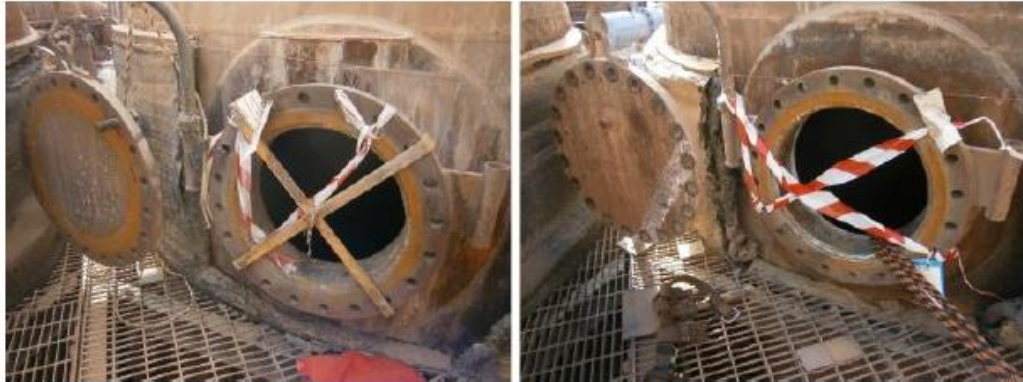
<p>Left: Manway into a digester with mechanical guard fitted. Right: Manway entry for the digester without scaffolding (tape placed by emergency response team).</p>
High risk activities involved <ul style="list-style-type: none">• Confined space Entry	
Contributing Factors (Organisational, Task, Team, Individual) <ul style="list-style-type: none">• A digester has two manways. The company procedure required a mechanical guard to be fitted on each manway when the doors were opened for maintenance to proceed but did not address how guards were to be removed and replaced during and after the work.• On the day of the incident, not all guards were in place.• The company procedure for scaffolding did not address how scaffolds were to be constructed in process vessels and how to access them. There was confusing terminology in the company procedures regarding confined spaces.• There was a lack of appropriate signage, and digester entry points were not identified or differentiated with a number or name.

Key Learnings <ul style="list-style-type: none">• There was no device or guard on the open manway to prevent inadvertent access to the digester from which scaffolding had been removed.
