Safety Alert

Ride on Rollers

20 January 2021

Ride on Roller Incident

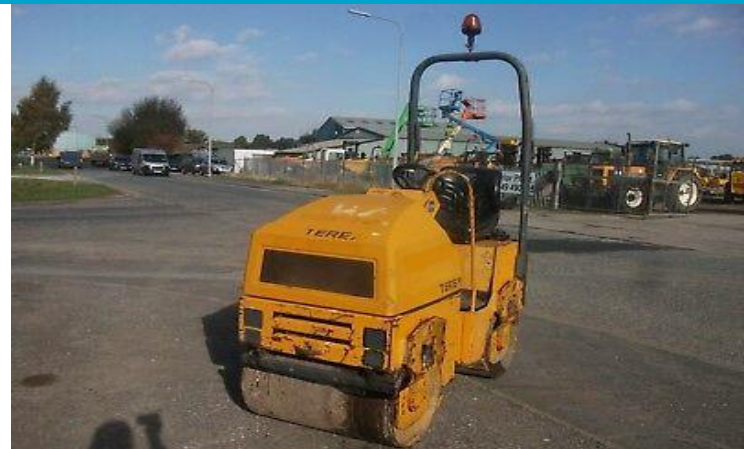
- Rollers must travel with the seat locked in the forward position. The seat must only be adjusted when stationary.

- Seat belts must be worn.
- Do not operate close to an embankment.
- Banksmen and other personnel to be kept at a suitable distance from the plant.
- Reversing of any plant must be kept to a minimum
- Ensure that adequate rest breaks specifically for plant operators are provided.

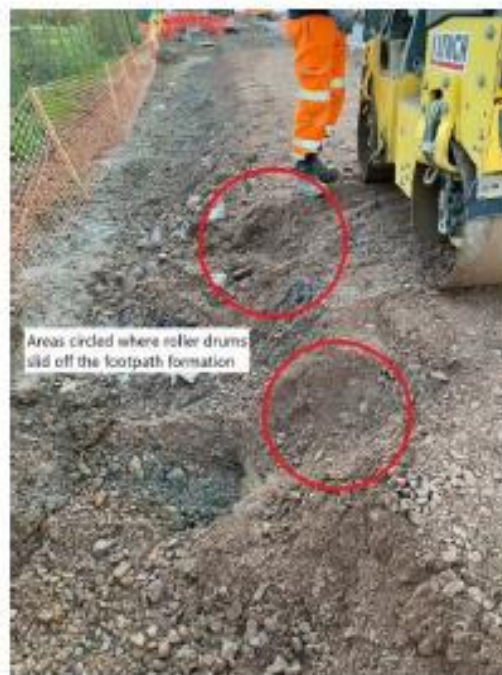
On the 26th October, an incident occurred which resulted in a ride on roller tipping onto its side as it was being operated too close to the edge of the footpath formation. As the operator of the roller was wearing his seatbelt, he was not injured.

The investigation identified that:

- the narrow width of the roller reduced stability;
- the roller was being operated too close to the edge of the footpath;
- the supervisor had not briefed the operator additional site-specific controls that should have been implemented during this activity.

To prevent any recurrence of this incident a thorough review of the safe systems of work have been undertaken which has resulted in the production of 'RA 120 – Ride on Rollers', the controls detailed within this new generic risk assessment include:

- **A minimum permitted ride on roller width of 1200mm**
- **A minimum 500mm exclusion zone between a ride on roller and any leading edge**

A site-specific risk assessment **must** be undertaken for each shift. The findings must be recorded and briefed to the relevant operatives to ensure any additional relevant controls are identified and implemented – compliance must be monitored throughout the shift by the Supervisor.
