South Road Tram Overpass Shared Path 5 May 2017 Bridge Revision: 3

Remediation Options Report

Department of Planning, Transport, and Infrastructure

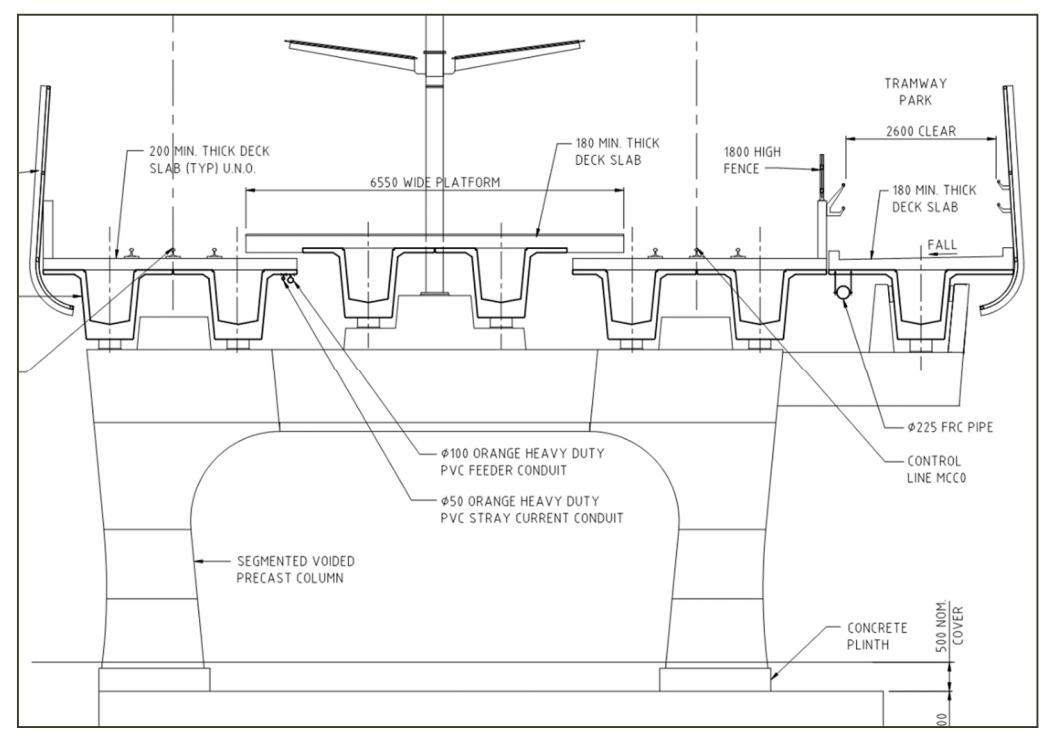
Figure 1 Typical Bridge Cross Section at Station Platform

At span 4, which is located over South Road, a section of deck is located between the up and down track decks, forming the station platform. This section of deck again consists of a pair of pre-stressed Super T girders connected by a topping slab. Figure 1 below shows a typical section of the structure at span 4.

The northern most part of structure consists of a shared use path deck (denoted "tramway park" in Figure 1 below), which extends for all eight spans. This is a single Super-T girder with a topping slab. Keeper walls are located either side of the girder at piers and abutments. The outer keeper walls at piers have less capacity than the inner keeper walls. Protection screens are mounted to the northern edge of this deck for spans 2 to 7.
