ROAD MANAGEMENT PLAN

RN6452 - Main Road (Belair – Blackwood)
RN6467 - Shepherds Hill Road (Blackwood - Seymour St)

Department for Transport,
Energy and Infrastructure

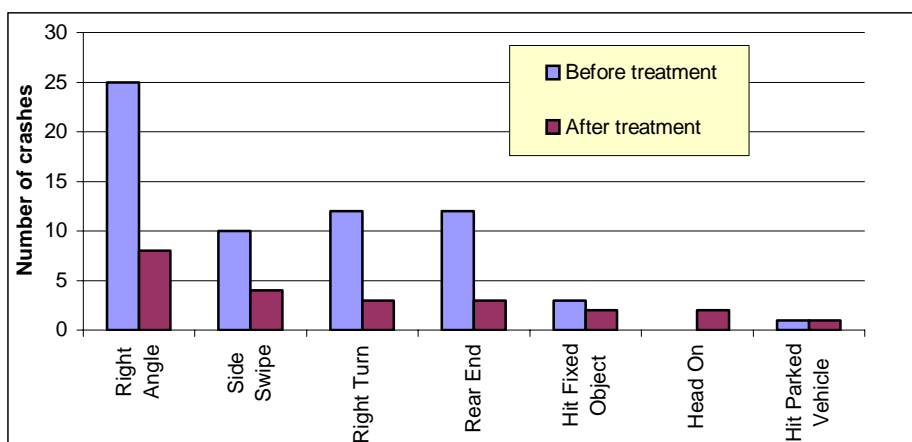
It should be noted that a similar scheme was installed at the intersection of The Parade and Sydenham Road at Norwood in February 1999. Crash statistics for the four-year periods before and after implementation of the scheme show a significant reduction in both the number and severity of crashes – refer the chart below.

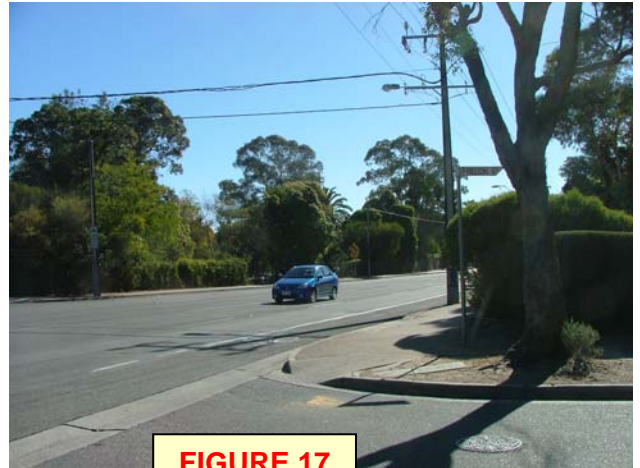
FIGURE 17

- Install painted median to reduce rear ends and right angle crashes
- Investigate clearing of vegetation to improve sight distance for traffic in Melton Street.
- Refer concept sketch below.

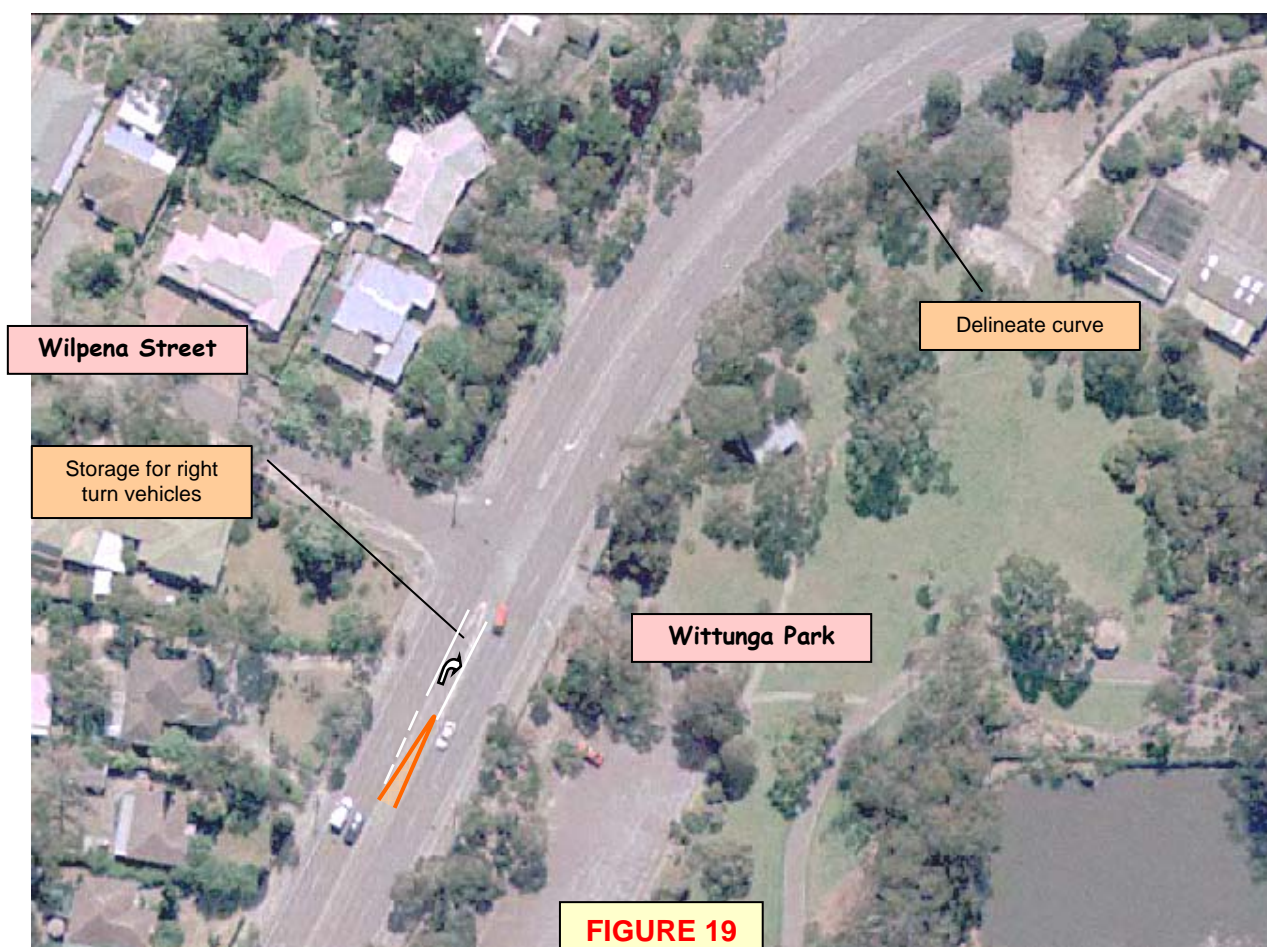
- Improve delineation of curve on Shepherds Hill Road east of Wilpena Street (Raised pavement markers, sighter posts etc)
- Consider installation of painted median with storage lane for vehicles turning right into Wittunga Park.
- Refer concept sketch below

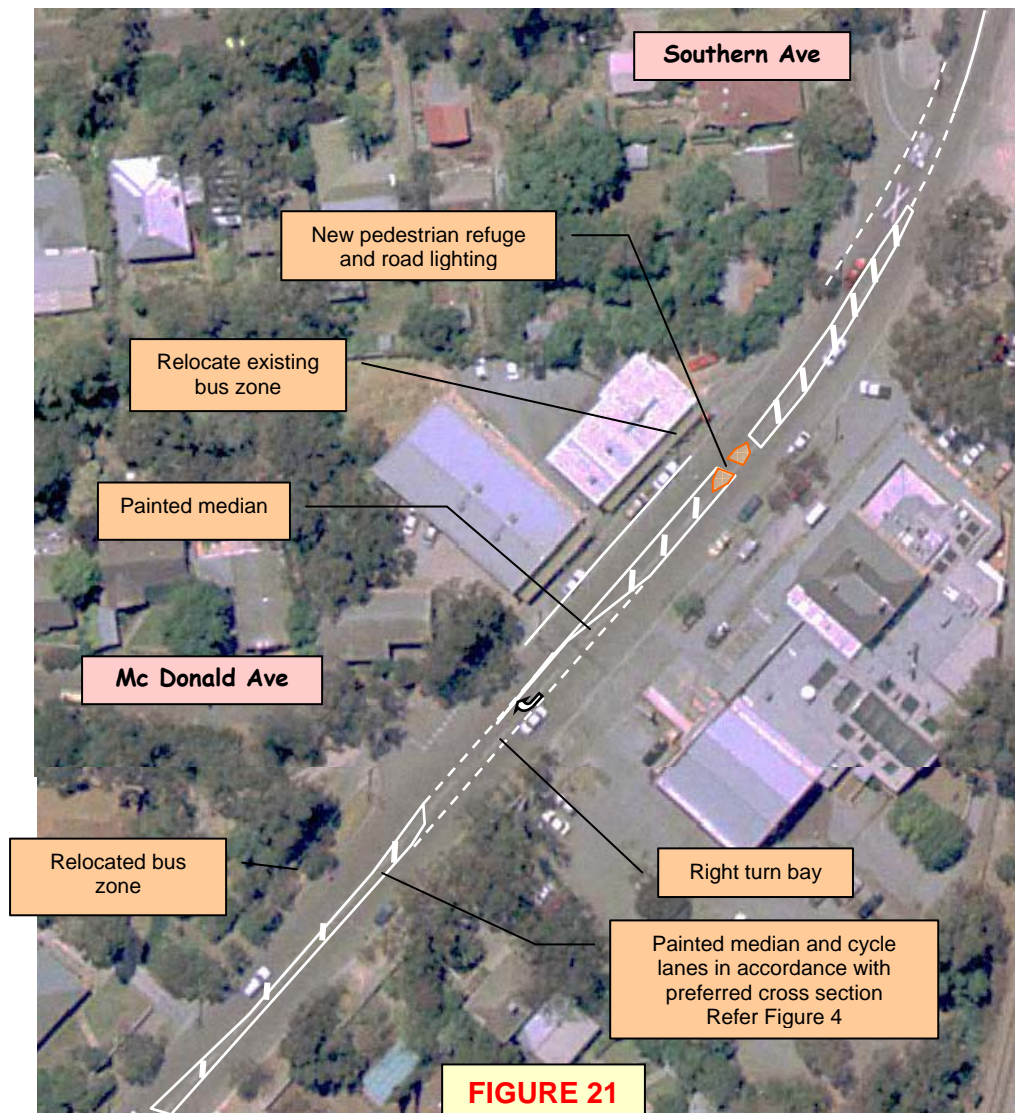
- Install painted median and raised pedestrian walk through
- Relocated bus stop on western side in front of the Blackwood Curtains, Blinds and Furniture to south of McDonald Ave.

Refer concept sketch below
