ROAD MANAGEMENT PLAN

RN4763 MAIN SOUTH ROAD

(Tatachilla Road to Sellicks Beach Road)

Department of Planning,
Transport and Infrastructure

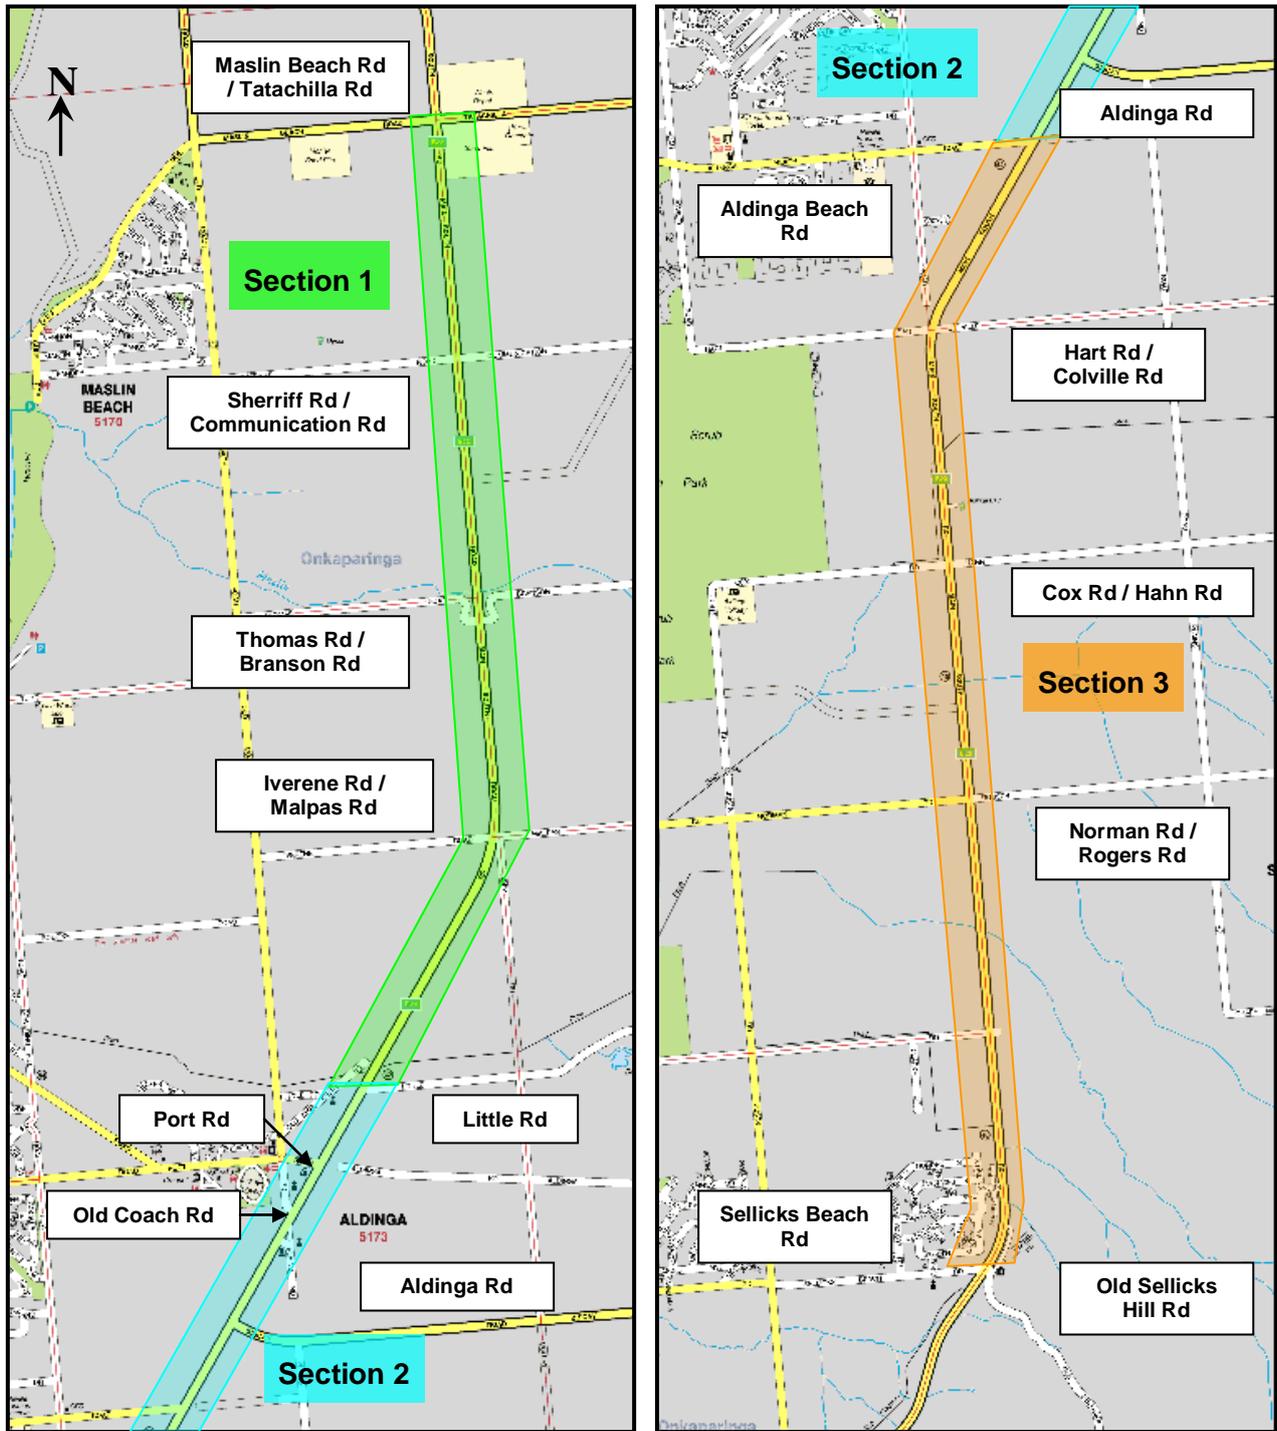
Figure 2-1 – Sections of Main South Road covered in the RMP

For the purposes of the report, the road has been divided into three sections of similar cross section and road conditions (refer to Figure 2-1).

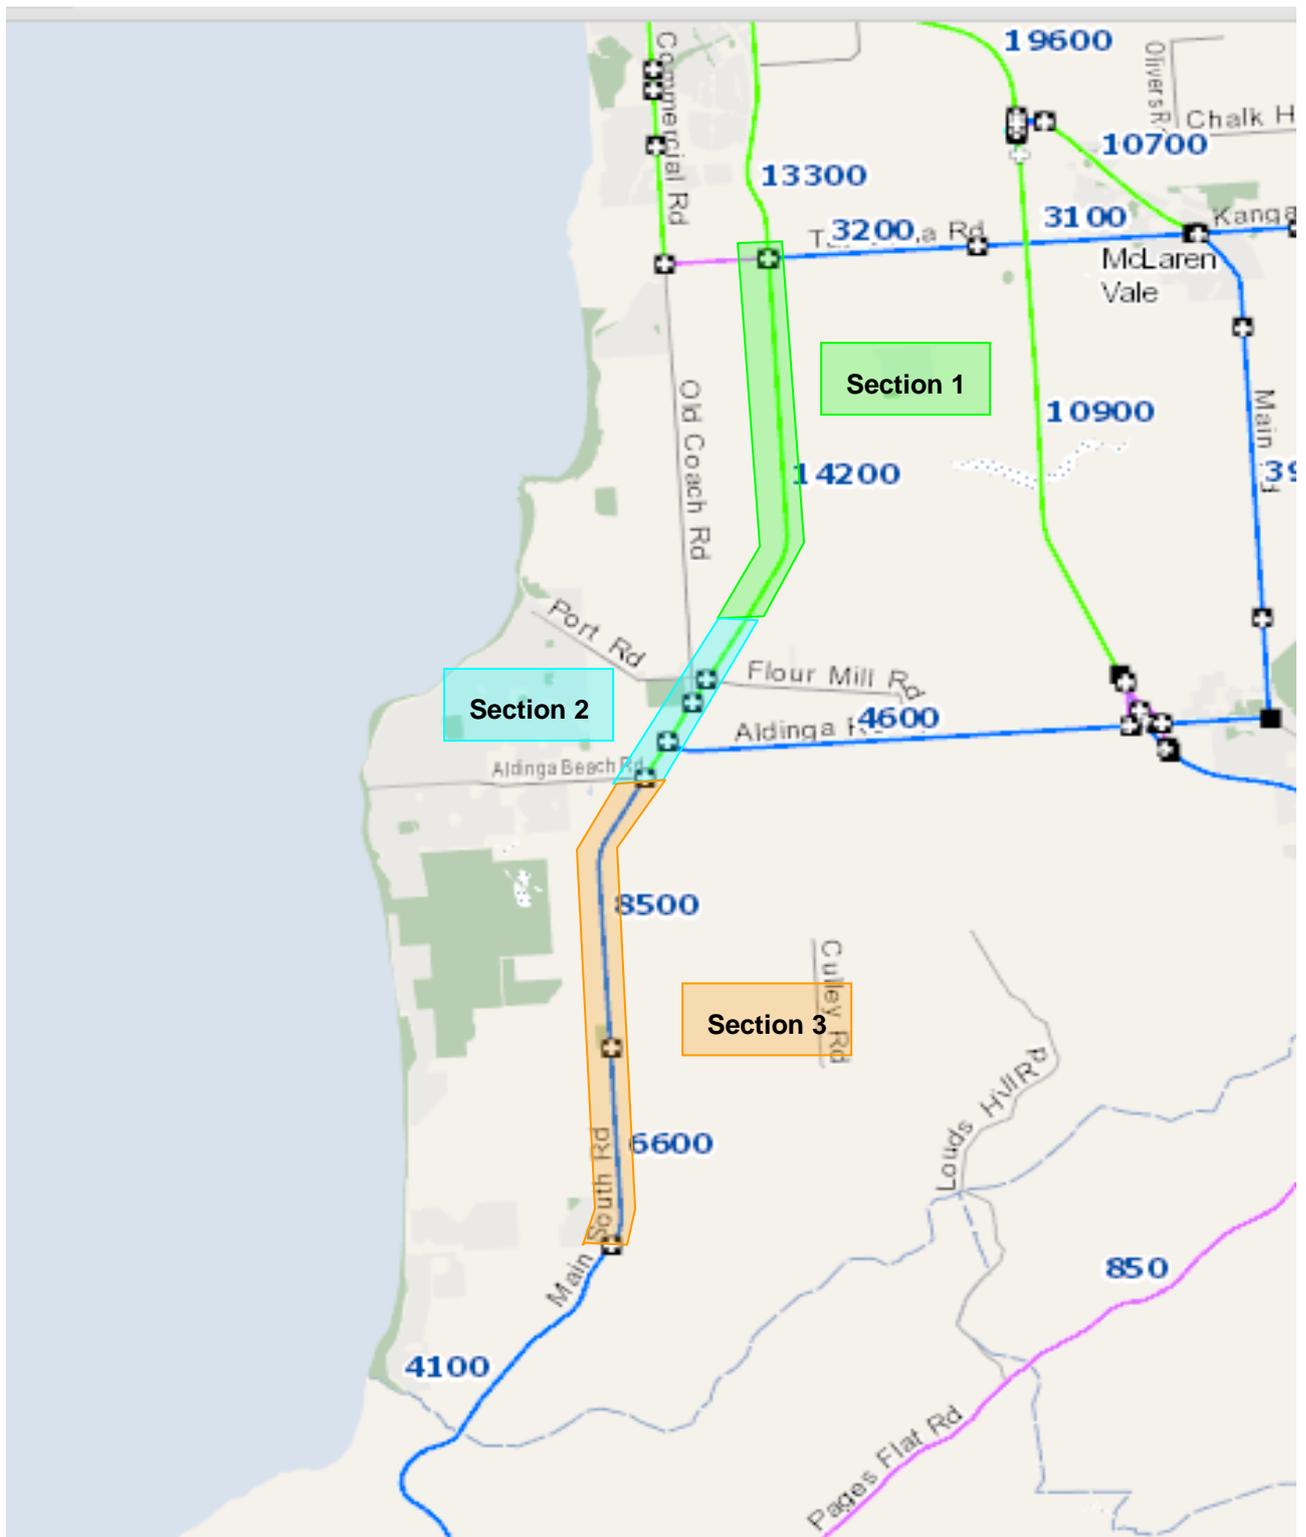
Figure 2-2—Average Annual Daily Traffic (AADT) (2015)

Traffic volumes vary greatly along the length of road under investigation. Two-way Average Annual Daily Traffic (AADT) volumes for different road sections range from 6600 – 15500 vehicles as shown in Figure 2-2. For the extents of this study Main South Road runs for approximately 12.5 km through the Onkaparinga region and the abutting land use varies along the length of the road (refer Figure 2-3).

Section 2 between Little Road and Aldinga Beach Road has AADT ranging from 10700 to 15500 vehicles and is an important connection which provides access to Aldinga, Port Willunga and Aldinga Beach townships. This is not only for north-south travel but also provides links to east-west routes in the region, particularly to Willunga for access to services. Traffic is also generated locally by the nearby community areas, schools and places of worship.

Section 3 between Aldinga Beach Road and Sellicks Beach Road has AADT volumes ranging from 6600 to 8500 vehicles and carries freight and tourist traffic accessing Sellicks Beach or the Fleurieu Peninsula and Kangaroo Island. Other traffic generators in the area are the Aldinga Aerodrome and the Victory Hotel at Sellicks Beach.

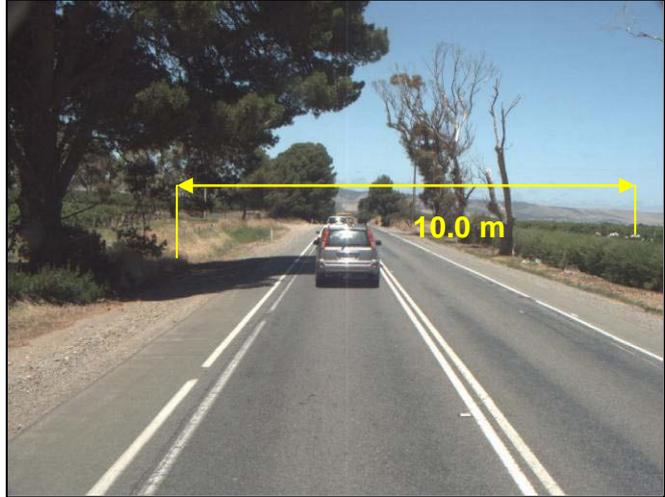
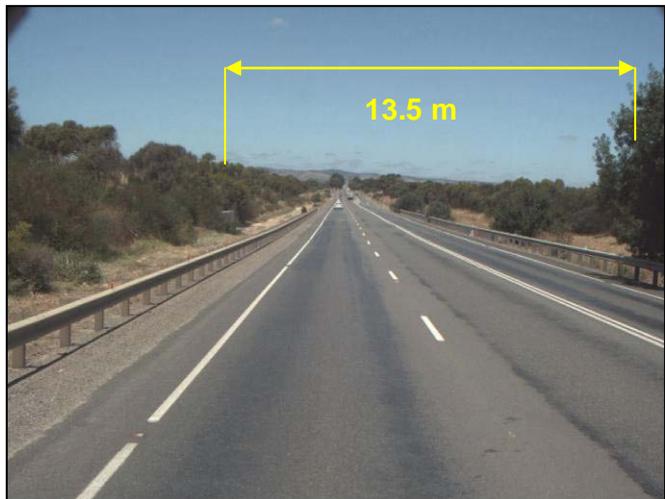
Section 1 - Tatachilla Road to Little Road

- Single lane in each direction
- 10 m wide pavement: 3.5 m wide lanes with 1.5 m wide sealed shoulder on both sides (no kerbing)
- No bicycle lanes
- No formalised parking but wide shoulders enable vehicles to pull off the road
- No median and no pedestrian facilities
- Typically no road lighting
- Road reserve width approximately 18 metres
- 100 km/h speed limit
- Overtaking typically banned outside of overtaking lanes by installation of double white lines
- Two portions of Section 1 have overtaking lanes installed.
 - Southbound overtaking lane between Tatachilla Road and Branson Road
 - Northbound overtaking lane between Malpas Road and Little Road.
 - These sections have 1.5 m sealed shoulders and 3.5 m wide lanes.

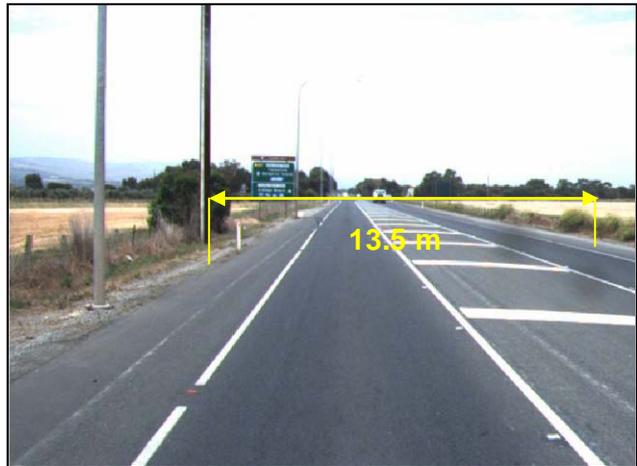
Section 2 - Little Road to Aldinga Beach Road

- Single lane in each direction
- 13.5 m wide pavement: 3.5 m lanes, 3.5 m median, 1.5 m sealed shoulders on both sides
- Some kerbing provided at Old Coach Road and Stonehouse Lane intersections
- Typically wide painted median to separate opposing through lanes and right turn vehicles from through lane vehicles
- No pedestrian facilities
- No formalised parking
- No bicycle lanes
- Road lighting of appropriate standard (V3) provided for most of this section, with the exception of the 250 m section immediately south of Little Road
- Road reserve width approximately 23 metres
- 80 km/h speed limit

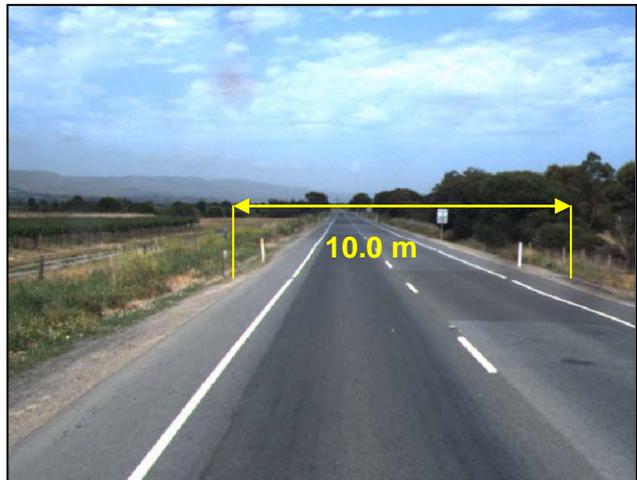
Section 3 - Aldinga Beach Road to Sellicks Beach Road

- Single lane in each direction
- 10 m wide pavement: 3.5 m lanes with 1.5 m wide sealed shoulders on both sides (no kerbing)
- No bicycle lanes
- No formalised parking but shoulders enable vehicles to pull off the road
- No median and no pedestrian facilities
- Typically no road lighting
- Road reserve width approximately 18 metres
- 100km/h speed limit
- Overtaking typically allowed
- Southbound overtaking lane located between Rogers Road and Perth Street with 1.5 m sealed shoulders and 3.5 m wide lanes.
- Section 3 is generally similar in cross section and conditions to Section 1 but currently caters for a much lower volume of traffic and traverses through flatter terrain.

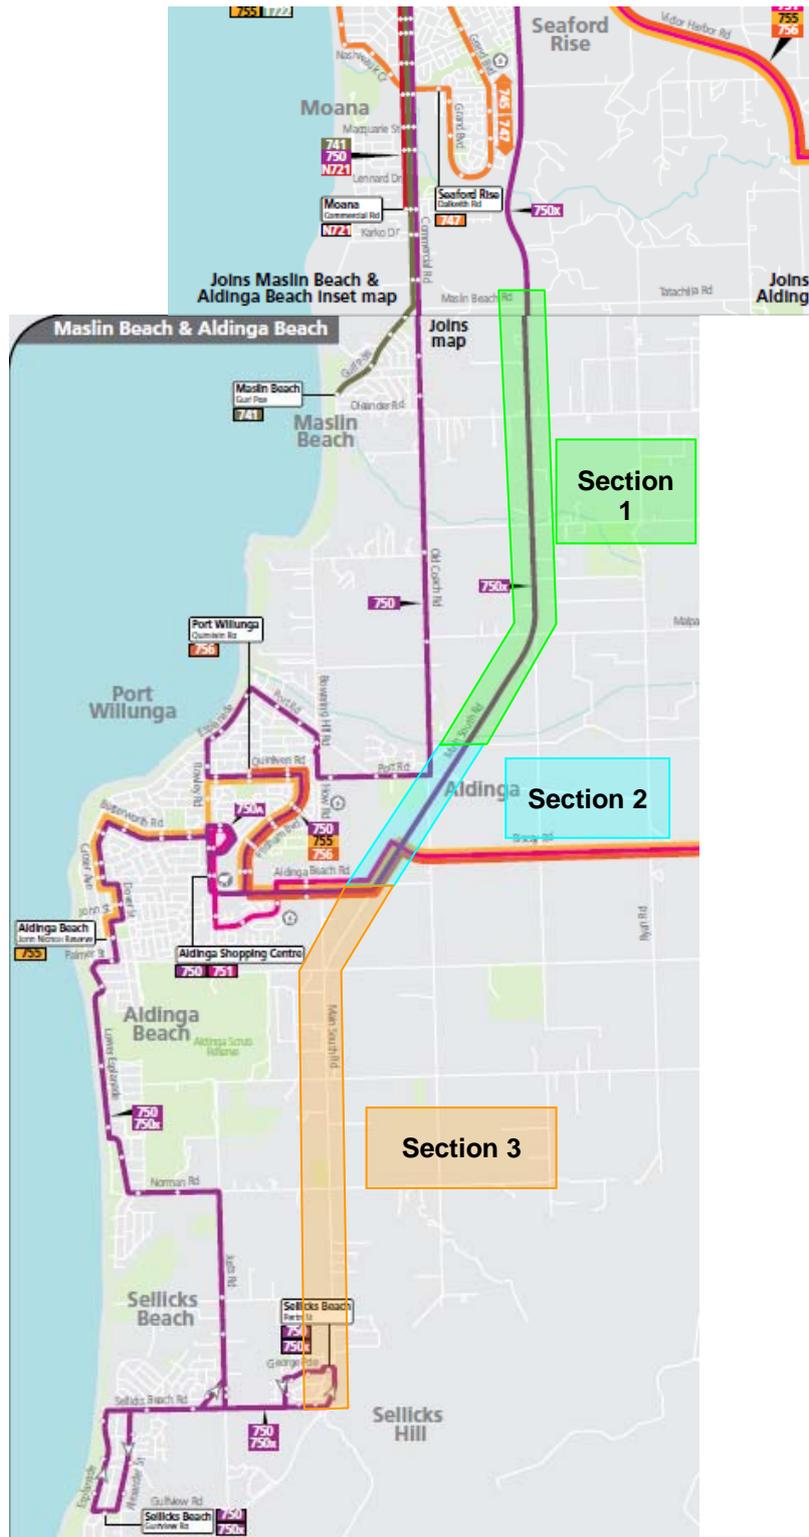
Figure 24— Bus Routes on Main South Road in the Study Corridor (as of July 2014)

Buses experience some delays turning left onto Main South Road from Aldinga Beach Road and Aldinga (Biscay) Road due to the Main South Road traffic volumes and the speed environment. Furthermore, the frequency of buses travelling on these routes is likely to increase in the future as the region grows.

Given the relatively low use of this section of Main South Road for public transport services, improvements for public transport are not considered a high priority at this time. However, any possible upgrades to improve access for buses along current and potential future bus routes on Main South Road have been considered as part of any intersection improvement recommendations made in this RMP.

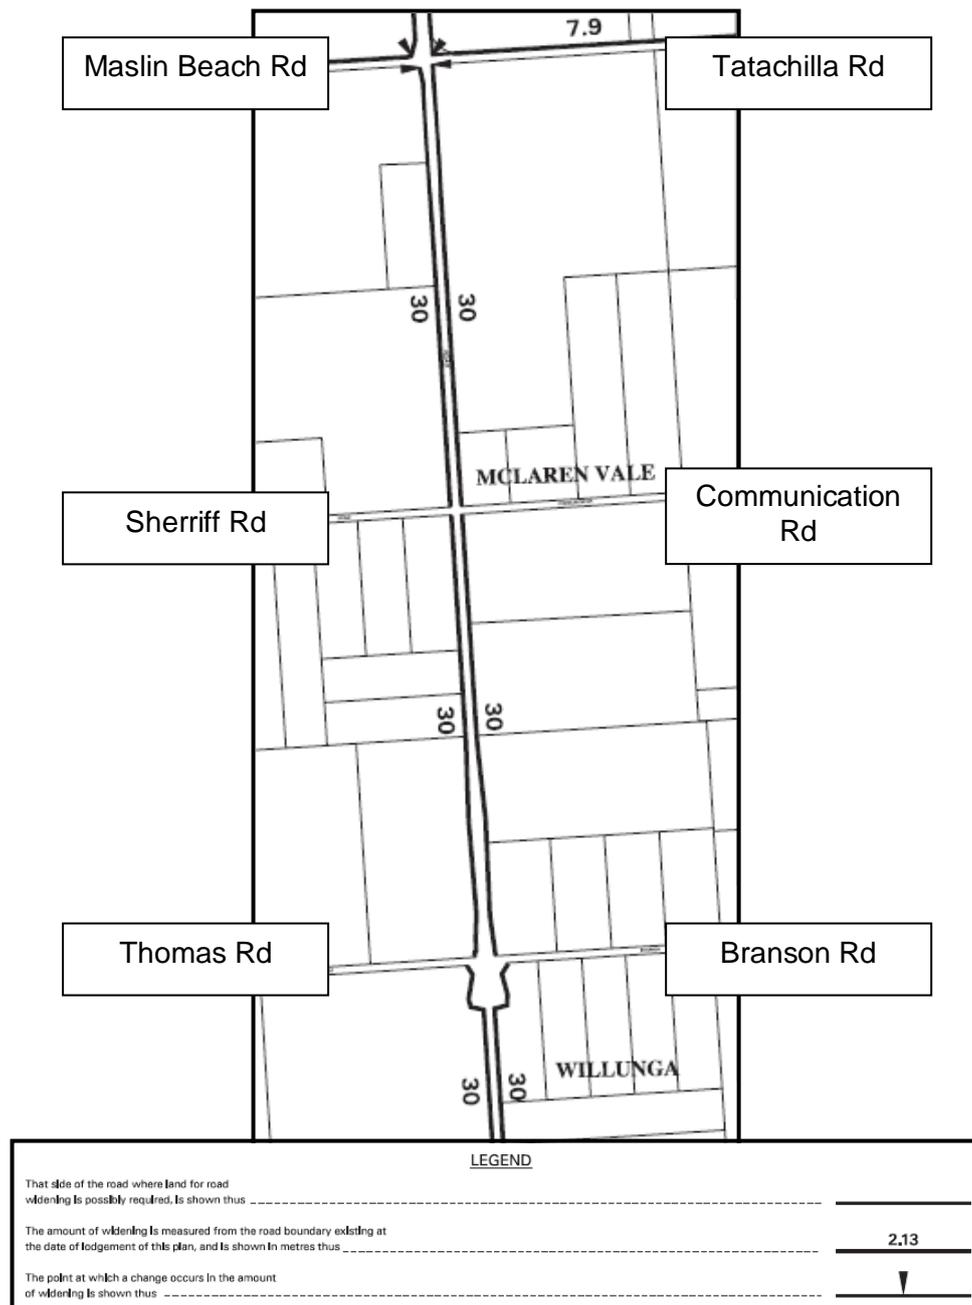
Figure 2-5(a): Metropolitan Adelaide Road Widening Plan (MARWP) Requirements on Main South Road

Sections 1, 2, and 3 of Main South Road have a 30 m wide corridor of land reserved on both sides of the road (Refer Figure 2-5). The 30 m setback is in recognition that the road currently plays an important strategic function and that in some time in the long term future (date unknown) there will be a need to expand the capacity of the road (i.e. add lanes) to accommodate future travel demands.

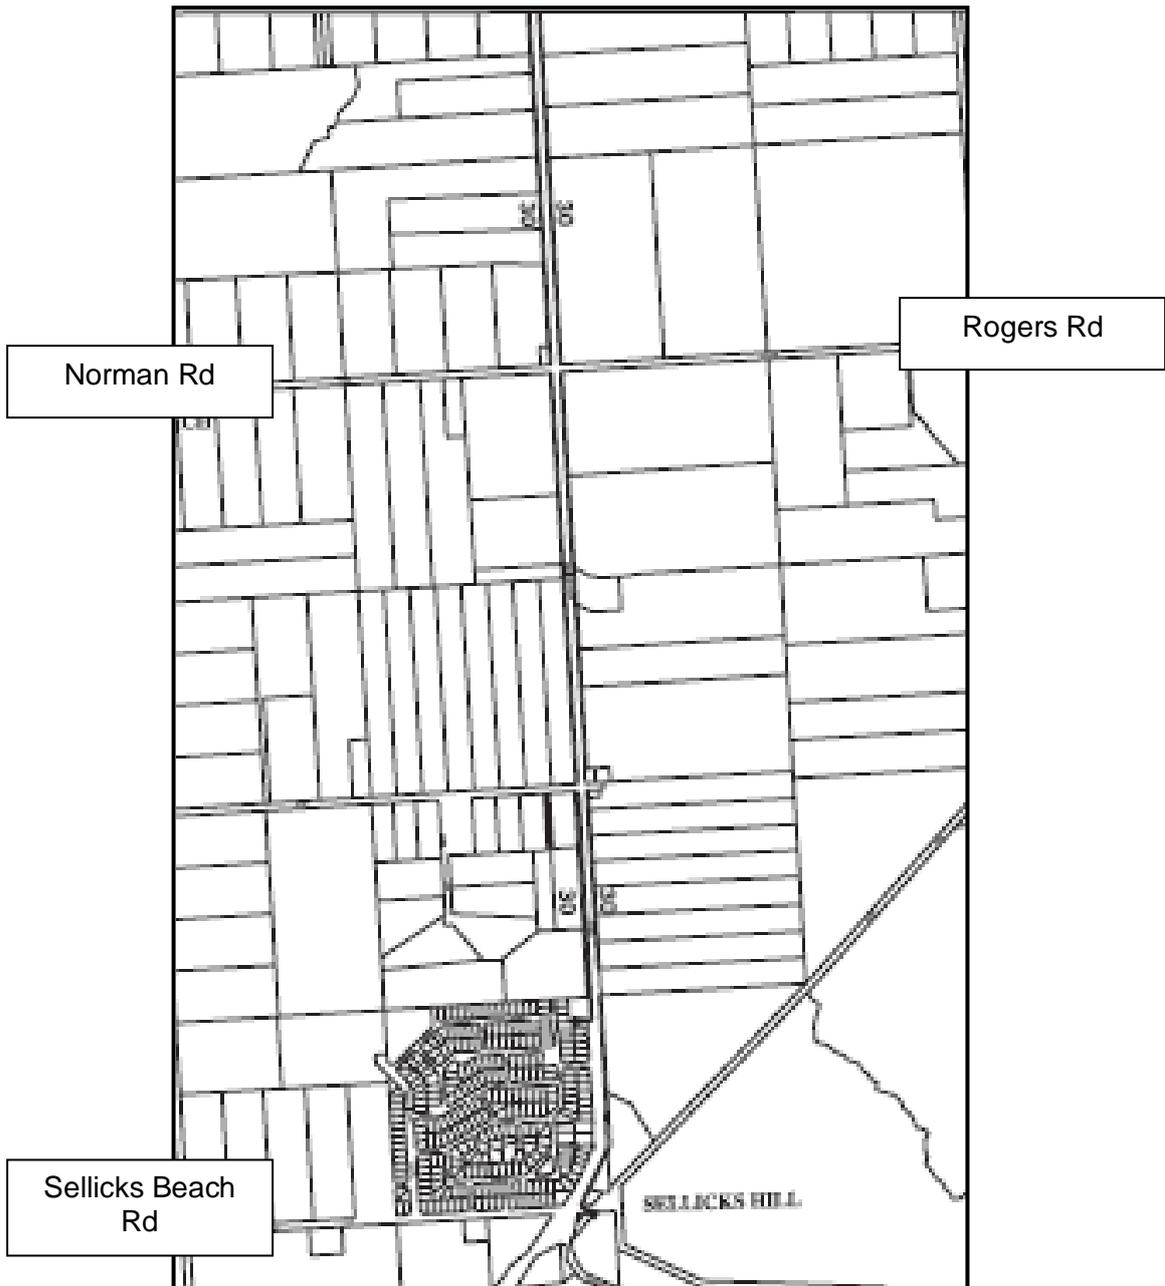
Figure 25(c): Metropolitan Adelaide Road Widening Plan (MARWP) Requirements on Main South Road

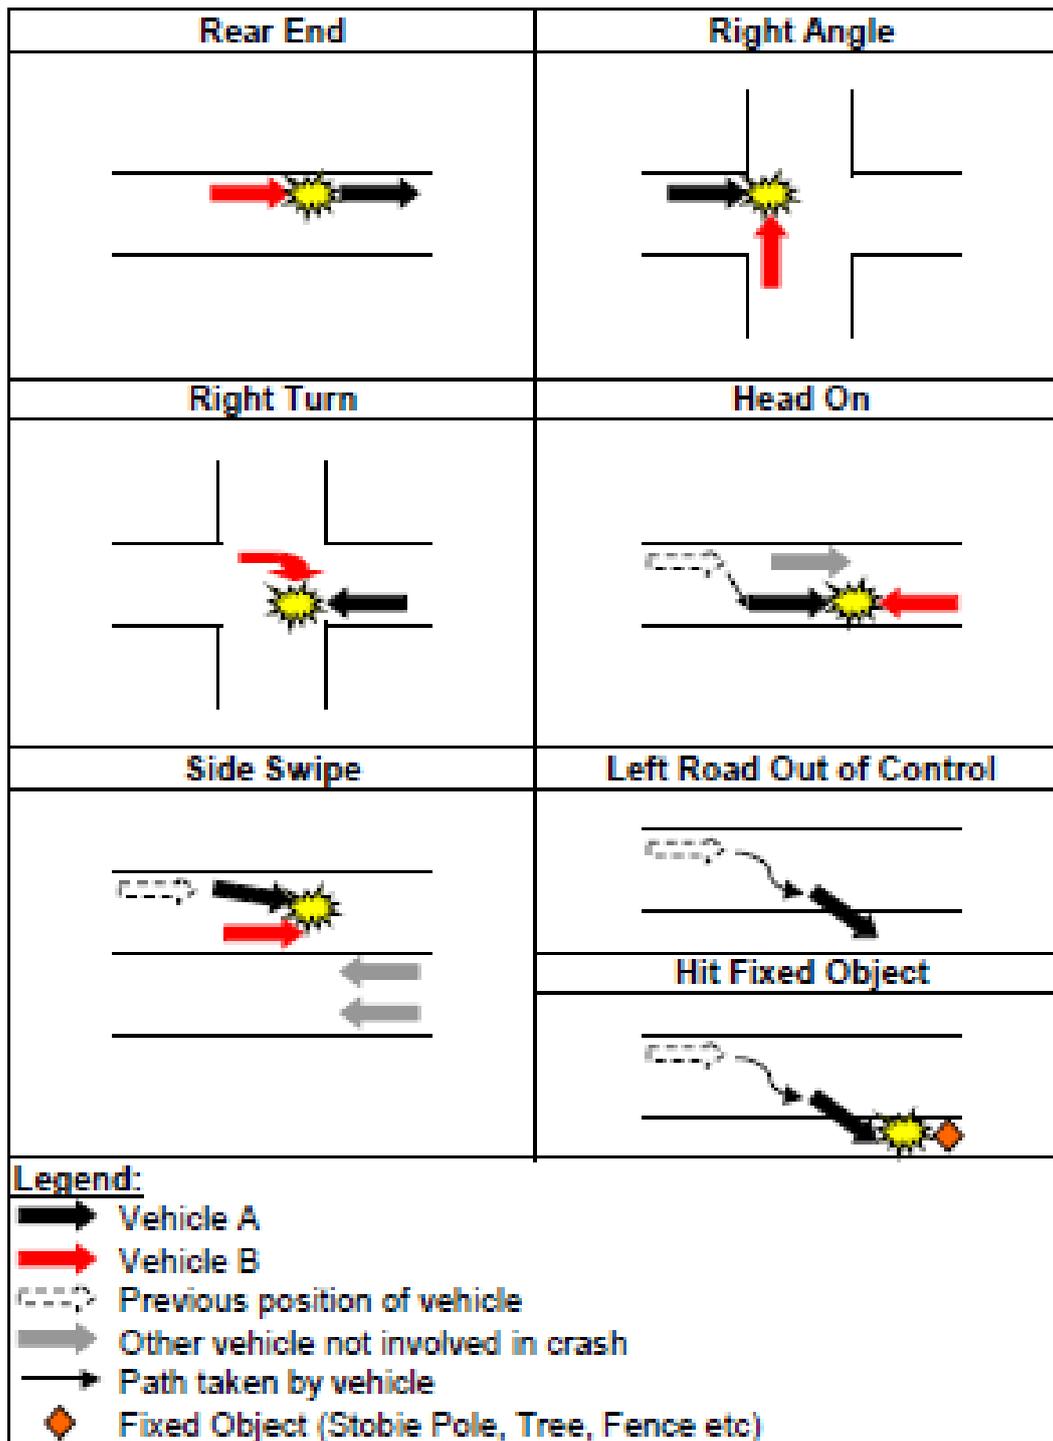
Figure 4-1 – Typical Crash Types

Right turn crashes also occur at intersections and junctions but involve vehicles from opposing directions. Typically, this type of crash involves a vehicle intending to turn right failing to select an appropriate gap in the oncoming traffic stream and getting hit as a result.

Rear end crashes are the most common type of crashes and involve vehicles crashing into the vehicle immediately in front of them. This type of crash is typically caused by a trailing vehicle failing to keep a safe distance from the vehicle in front.

Hit fixed object crashes occur when a vehicle leaves the carriageway in an uncontrolled way and collides with a fixed object.

The various crash types are illustrated in Figure 4-1.

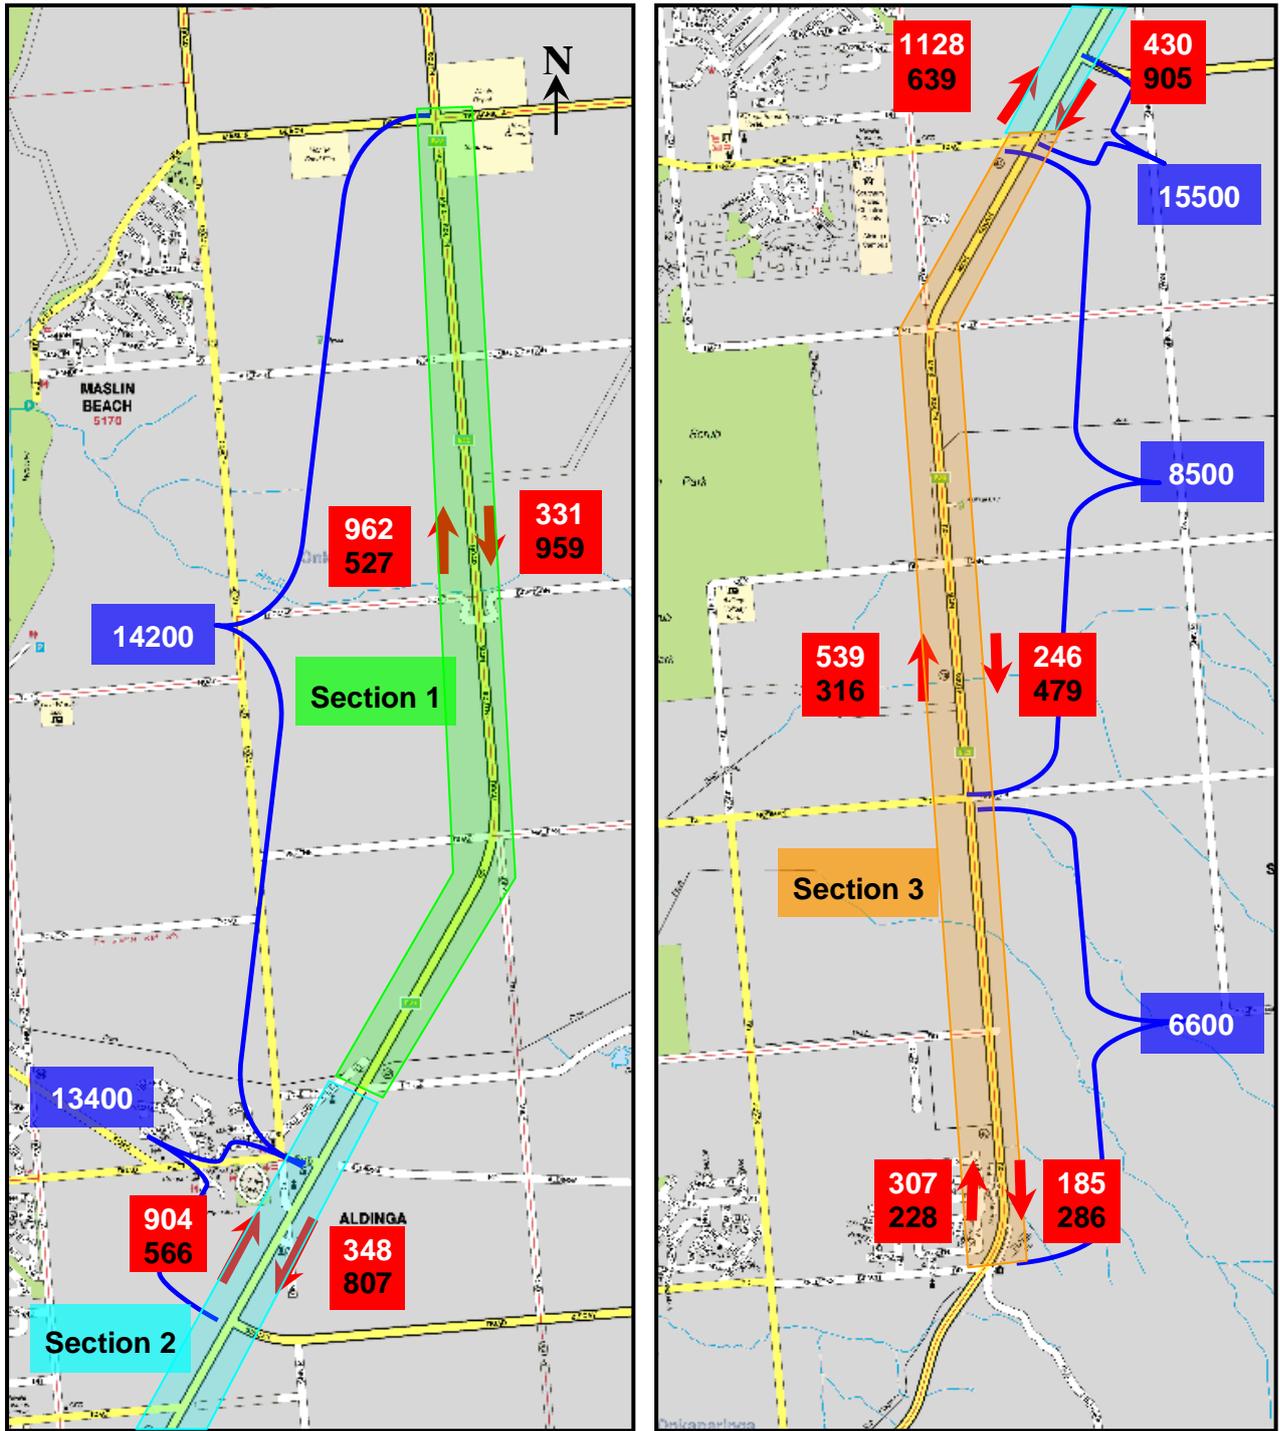
Figure 5-1 – Two-Way Average Annual Daily Traffic (AADT) (2015) and one way peak hour flows (2012-2013)

The two-way Annual Average Daily Traffic (AADT) volumes for the road sections in this report vary from 6600 in the Sellicks Beach area to 15500 vehicles in the Aldinga Beach area. Figure 5-1 shows the distribution of AADT volumes.

Figure 5-1 demonstrates the variance in the daily traffic flow numbers across the length of the road, which indicates a high number of vehicles turning on and off the road, particularly in the northern section and in the short section between Aldinga (Biscay) Road and Aldinga Beach Road. The change in traffic volumes and turning movements necessitates a review of the existing intersections to ensure that they are able to adequately manage the current traffic volumes and movements.

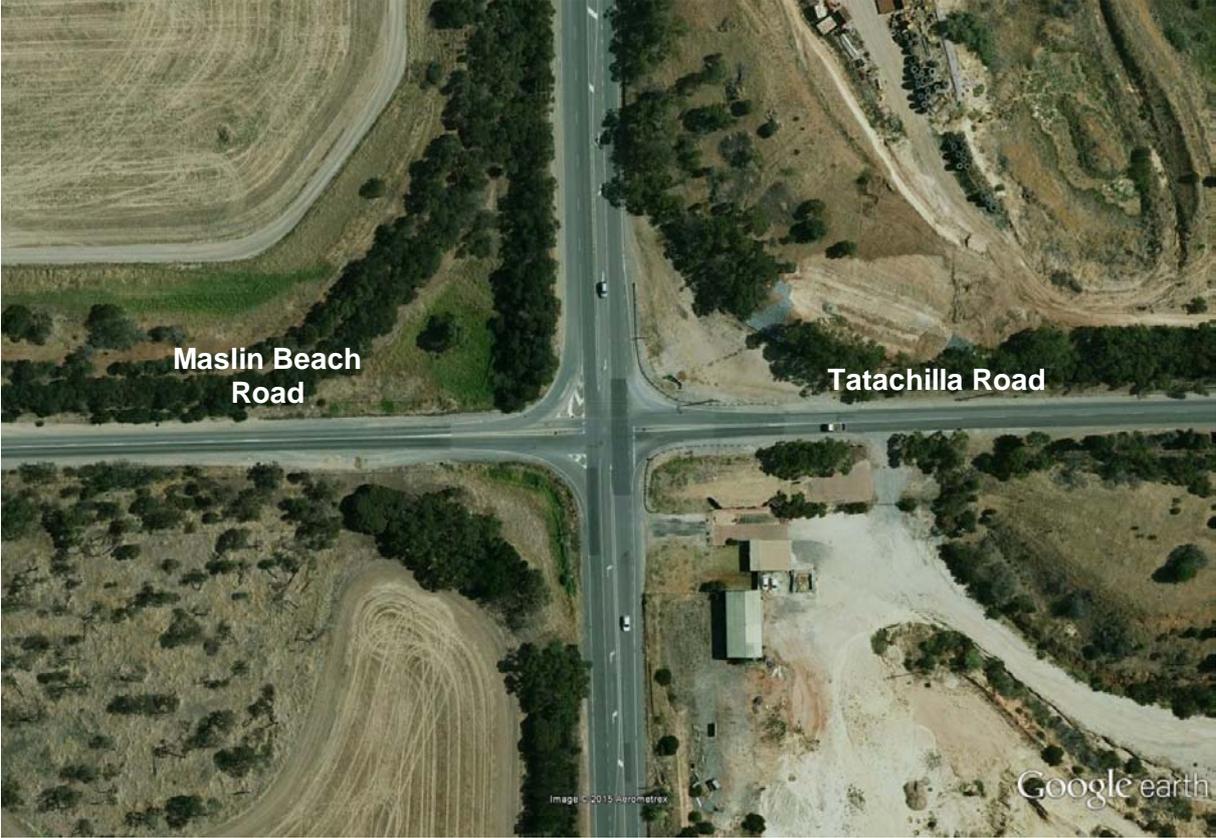
Figure 6-1 Existing Layout of Main South Road/Tatachilla Road/Maslin Beach Road Intersection

Roadside hazards around this intersection include stobie poles on the north western and south eastern corners and an unprotected culvert on the south western corner.

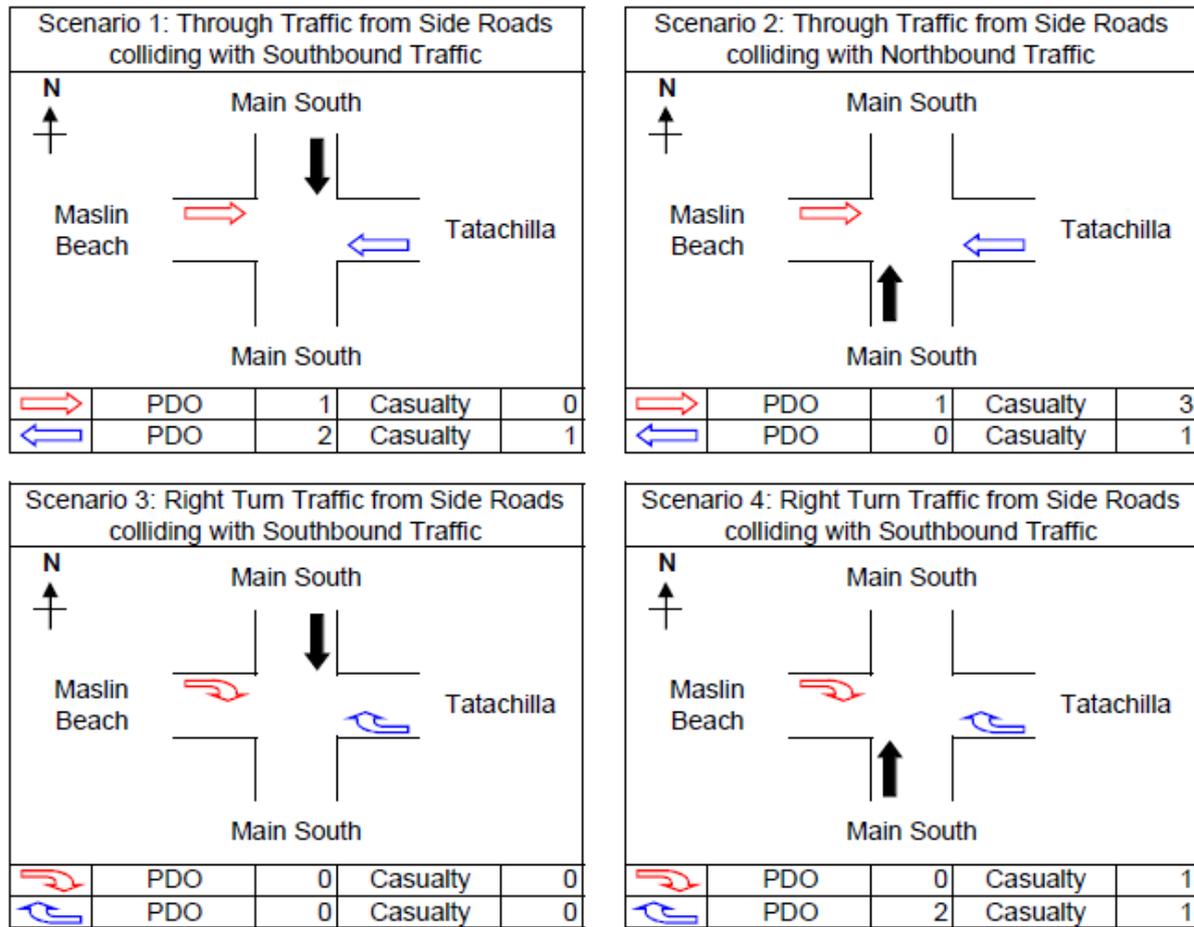
Figure 6-2 Right Angle Crashes at Main South Road/Tatachilla Road/Maslin Beach Road Intersection (2009-2013)

Some of the factors contributing to crashes include the high speed environment, the number of vehicles accessing this intersection and the number of vehicular conflict points. Analysis of incident reports indicate that the high number of right angle crashes were caused by vehicles attempting to turn right out from Tatachilla Road and Maslin Beach Road and those attempting to cross from Tatachilla Road to Maslin Beach Road or vice versa. One factor that may be contributing to these crashes is the crest located to the south of the intersection which reduces sight distance for vehicles waiting in the side roads. Another factor in these crashes may be drivers selecting inappropriate gaps in the oncoming traffic after experiencing frustration at having to wait at the intersection for a considerable amount of time. A graphical representation of the right angle crashes is shown in Figure 6-2.

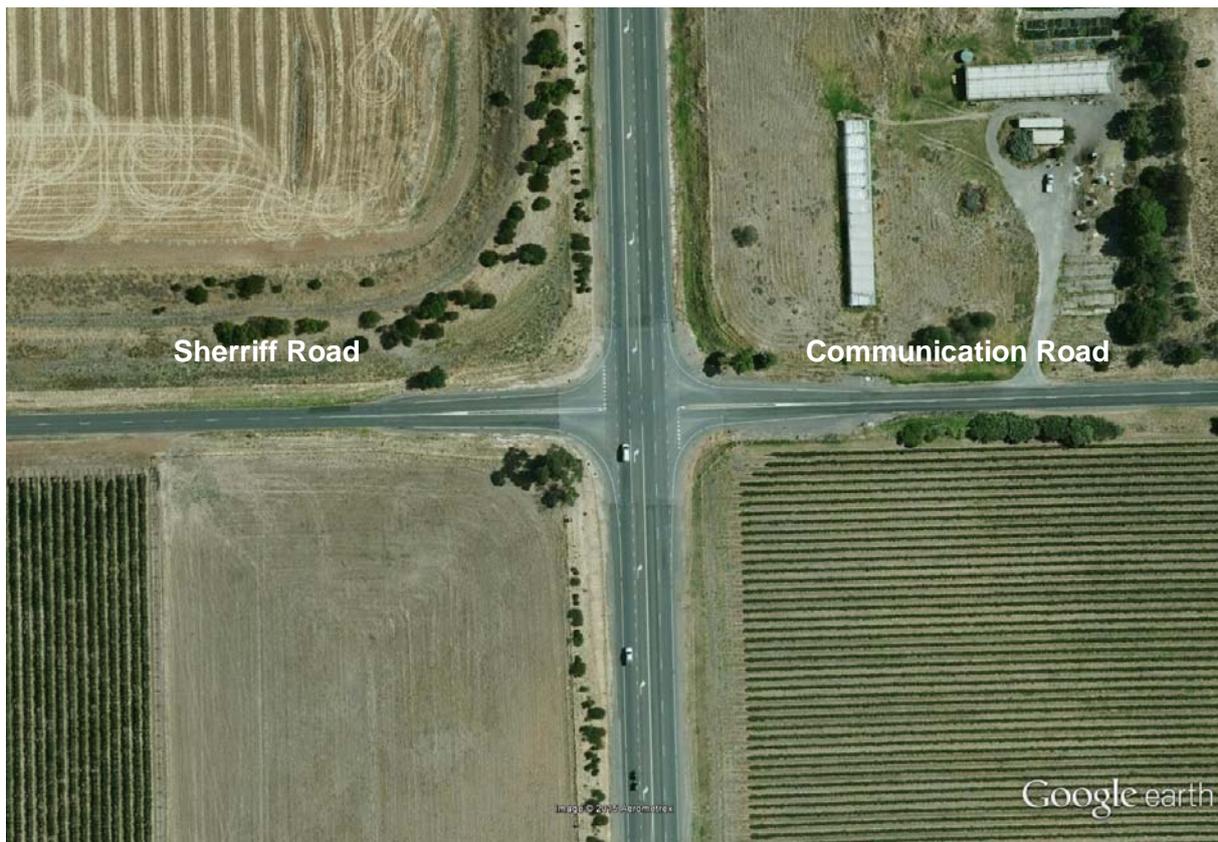
Figure 6-4 Existing Layout of Main South Road / Sherriff Road / Communication Road Intersection

There is an unprotected culvert on the north eastern corner which may present a roadside hazard.

The existing configuration of the intersection requires vehicles from the side roads to negotiate a wide section of road to perform through and right turn out movements. Observations revealed vehicles were storing side by side to cross the intersection and to turn right out of Communication & Sherriff Roads.

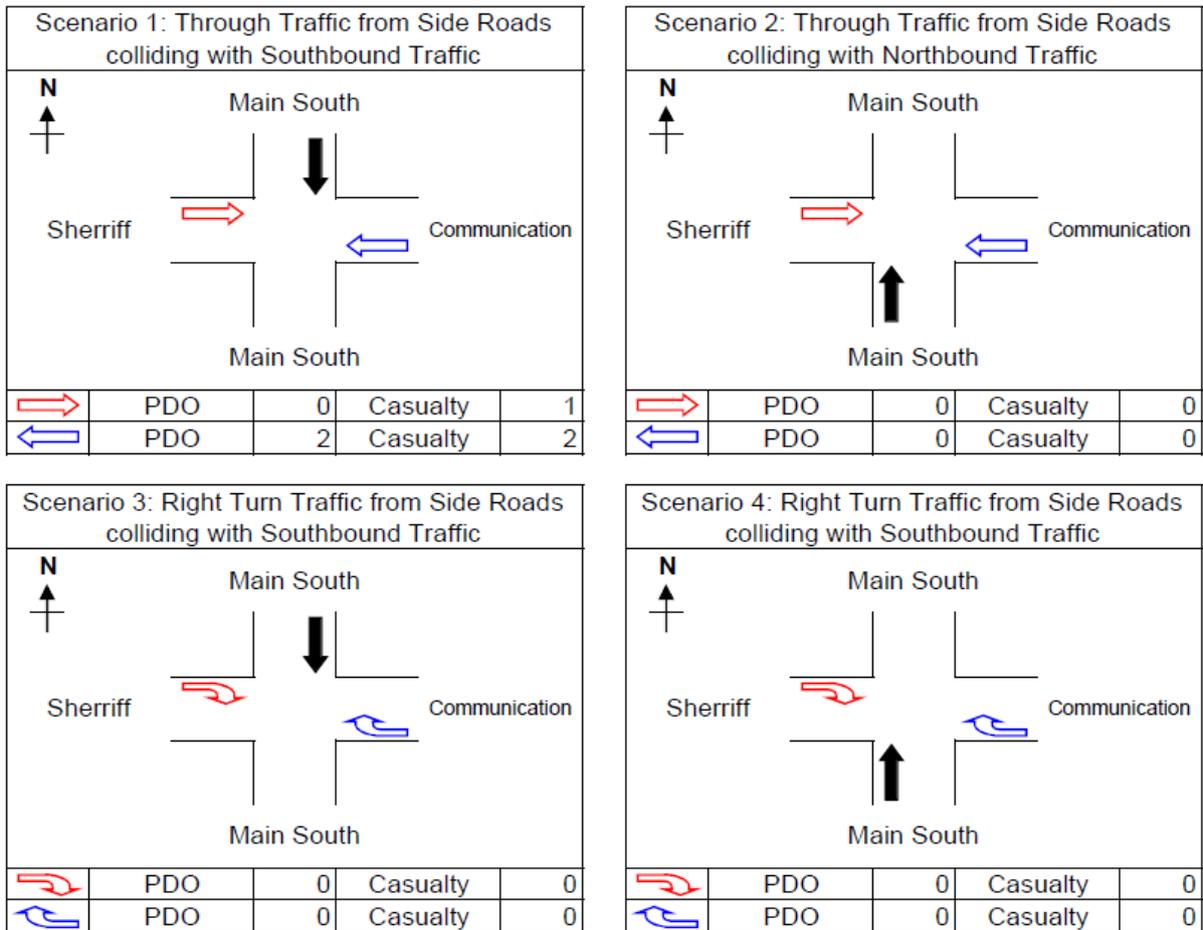
Figure 6-5 Right Angle Crashes at Main South Road/ Sherriff Road/ Communication Road Intersection (2009-2013)

Detailed assessment of the crash data indicates that factors contributing to crashes include the high speed environment, the number of vehicles and number of vehicular conflict points. Sight distance at the intersection is considered adequate. All five of the right angle crashes were caused by vehicles from Communication Road attempting to cross over to Sherriff Road and vice versa. The two other crashes were caused by driver inattention whilst travelling on Main South Road resulting in crashes into a fence. A possible factor in these crashes is that left turning vehicles into the side roads may be obscuring vehicles behind them that are continuing along Main South Road. In addition, four of the seven crashes at this intersection occurred at night, suggesting that night time visibility at the intersection may have been a contributing factor and another crash occurred when there were wet conditions. Figure 6-5 shows the types of right angle crashes that have occurred at the intersection.

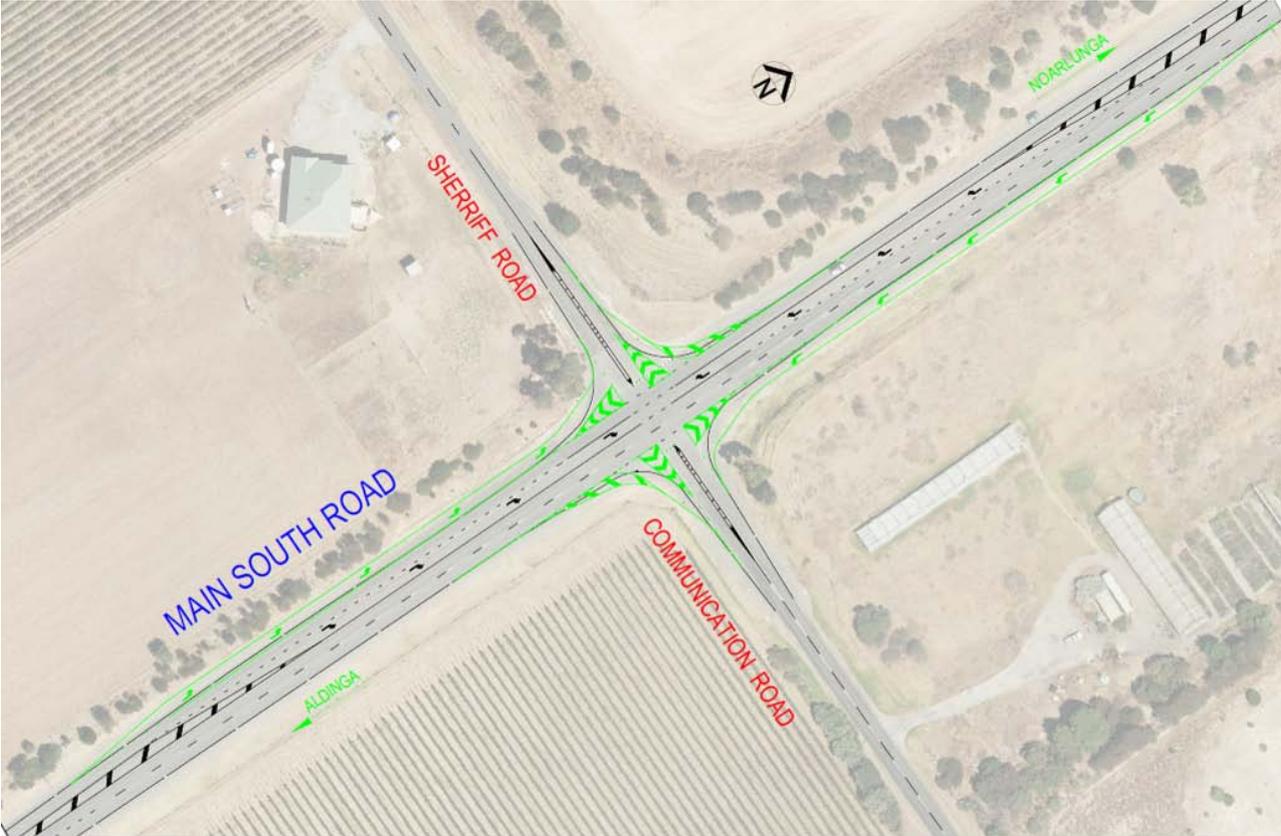
Figure 6-6 Proposed Upgrades for Main South Road/ Sheriff Road/ Communication Road Intersection

A further option considered at this intersection is the installation of deceleration lanes on Main South Road for vehicles turning left into the side roads (refer Figure 6-6). The advantages of this option are that it provides left turning traffic from Main South Road with a separate lane to safely decelerate and it will also address the possibility of left turn vehicles obscuring the through vehicles behind them. Additionally, this treatment allows the overtaking lane to be retained as well as maintaining access into both side roads. This is the recommended option for this intersection.

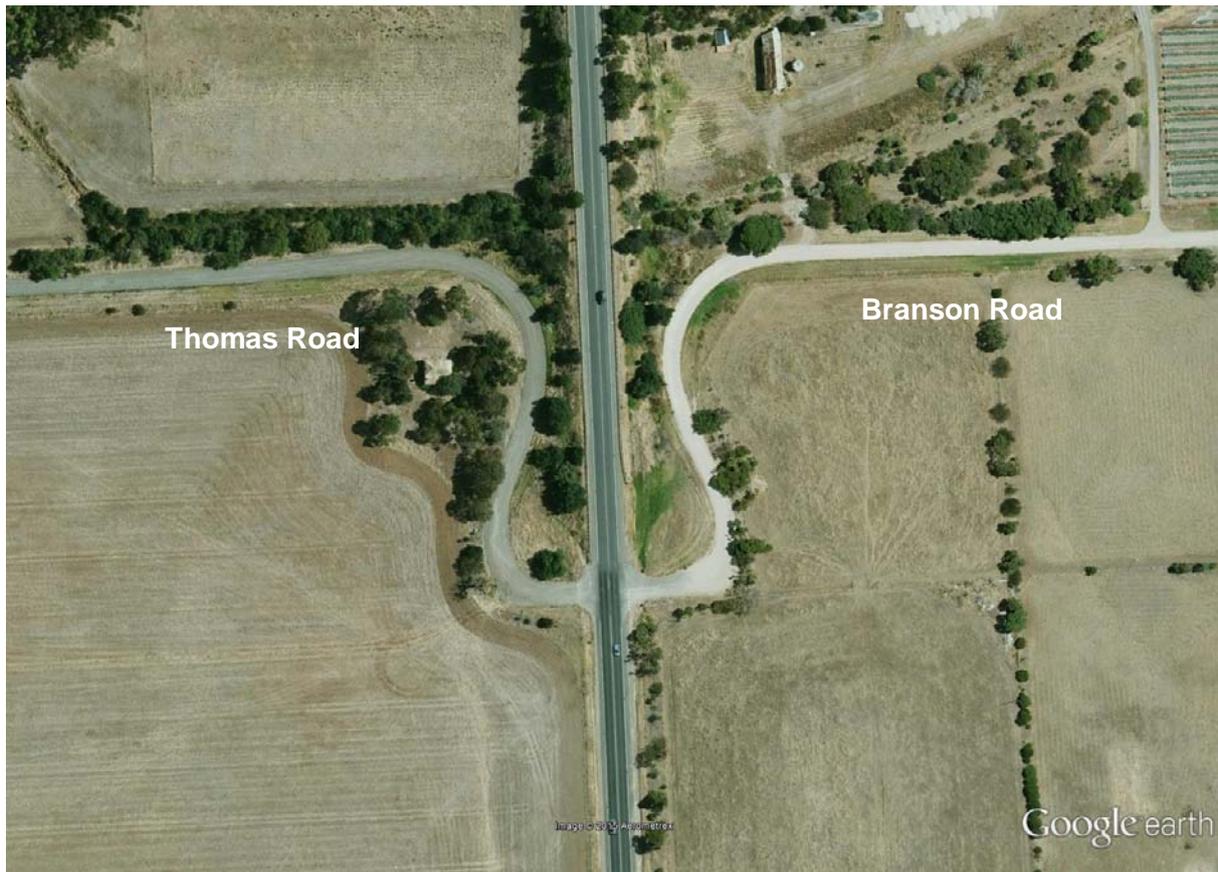
Figure 6-7 Existing Layout of Main South Road/Thomas Road/Branson Road Intersection

There are unprotected culvert headwalls on both sides of Branson Road and Thomas Road which present roadside hazards close to the intersection.

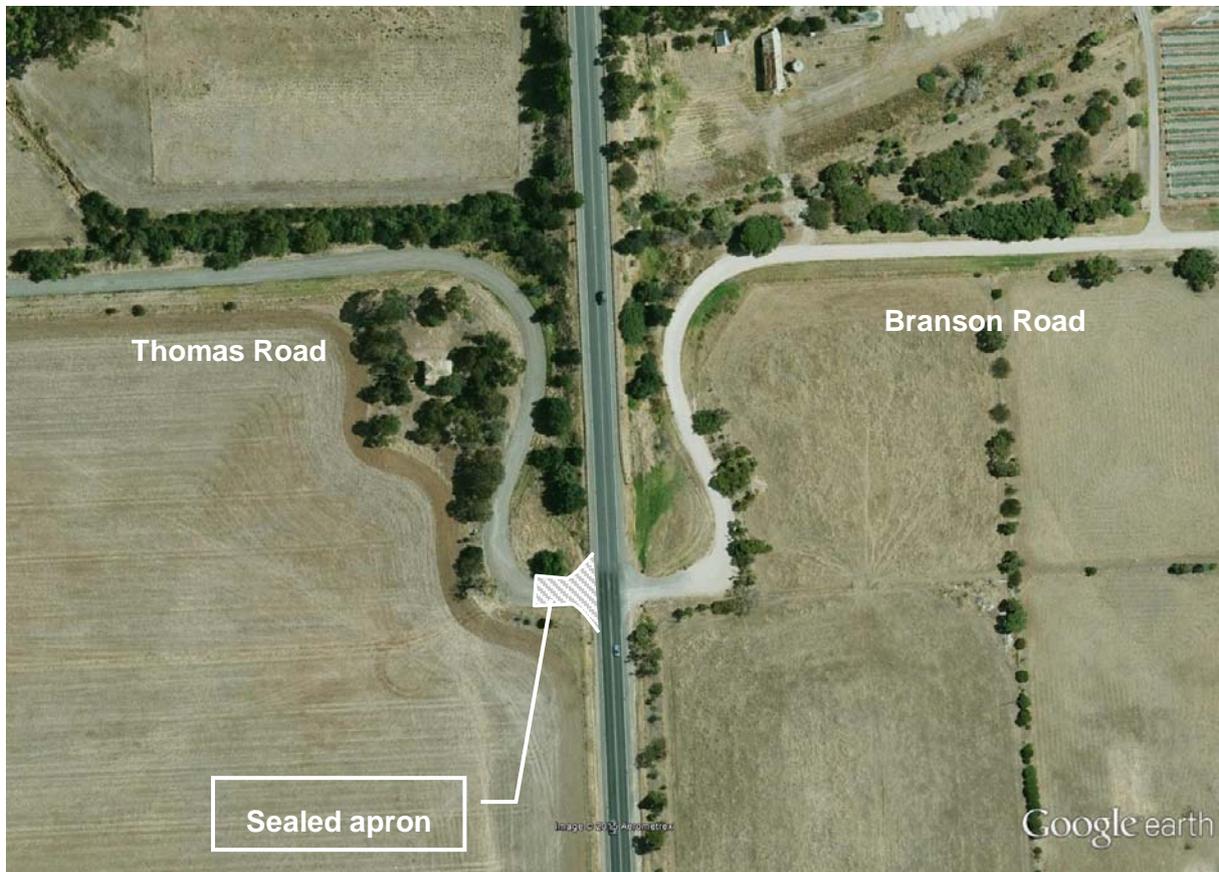
Figure 6-8 Proposed Upgrades for Thomas Road / Branson Road Intersection

Safety at the intersection could be improved by providing channelised right turn lanes into the side roads and installing road lighting. However, given the low crash statistics at this location as well as the low traffic volumes on Thomas Road and Branson Road it is considered that any upgrade to the intersection would be a low priority.

Instead, it is recommended that interim treatments such as sealing the apron of Thomas Road, re-painting the “Give Way” lines on the side road approaches and installing Reflective Raised Pavement Markers (RRPMs) to improve the visibility of the intersection are implemented instead.
