ROAD MANAGEMENT PLAN

RN4763 MAIN SOUTH ROAD

(Tatachilla Road to Sellicks Beach Road)

Department of Planning,
Transport and Infrastructure

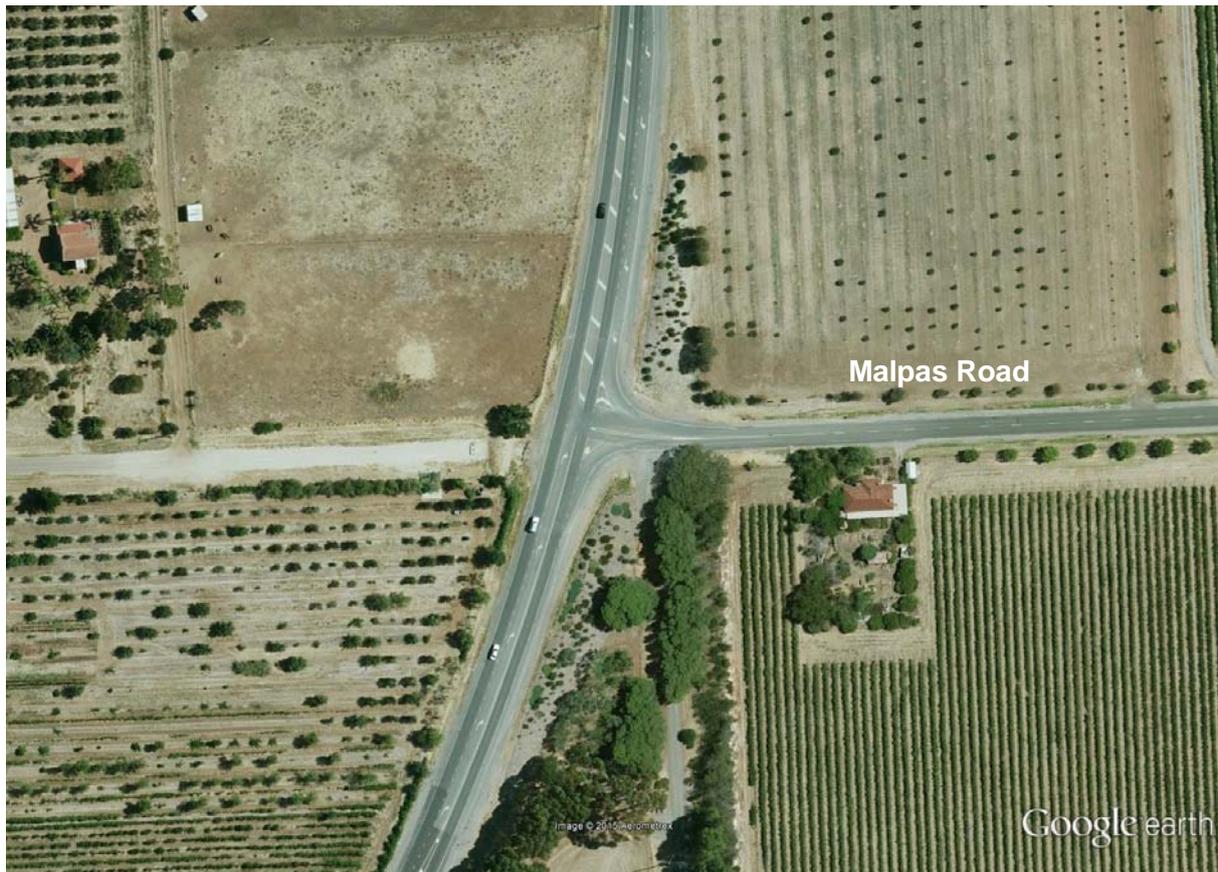
Figure 6-9 Existing Layout of Main South Road / Malpas Road Intersection

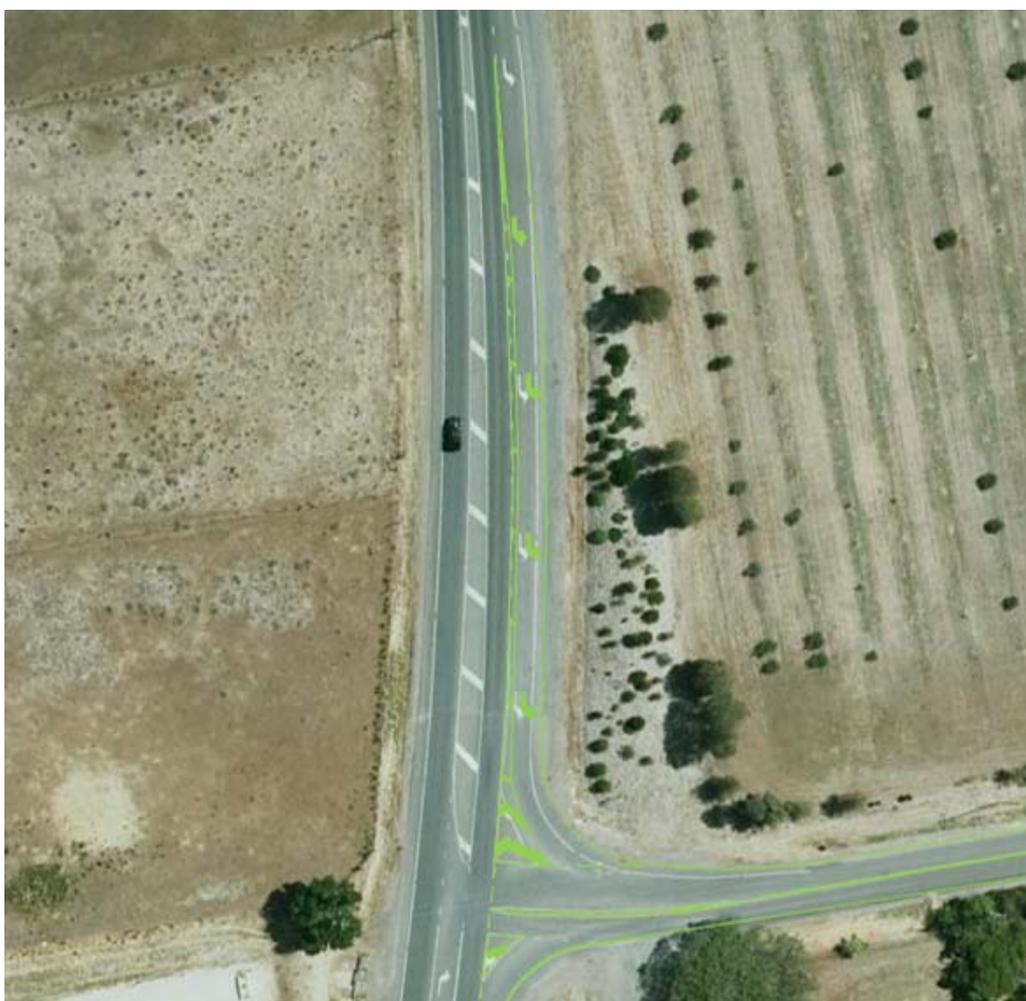
Figure 6-10 Proposed Upgrades for Main South Road / Malpas Road Intersection

The geometry of the intersection could be upgraded by providing a further separated left turn lane into the side roads to enhance sight distance. This is shown in Figure 6.10.

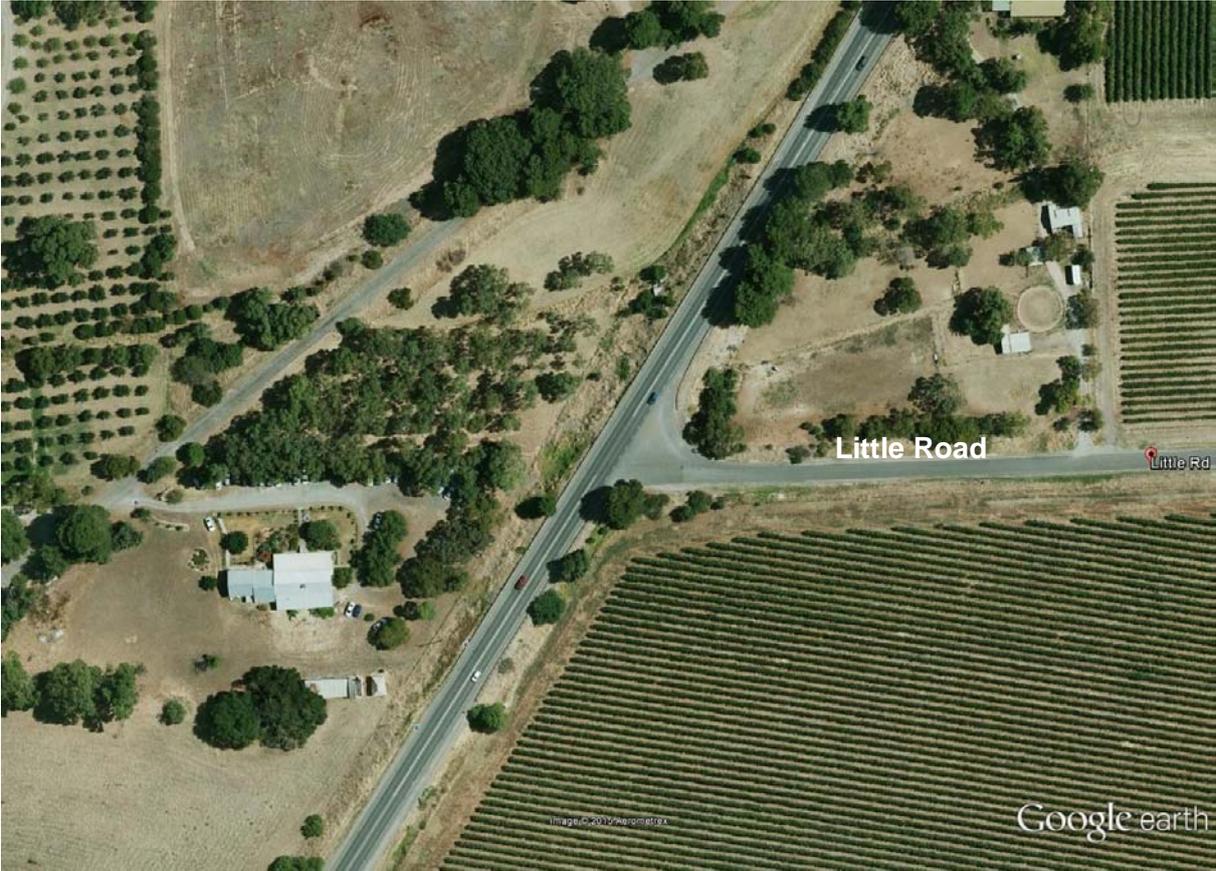
Figure 6-11 Existing Layout of Main South Road / Little Road Intersection

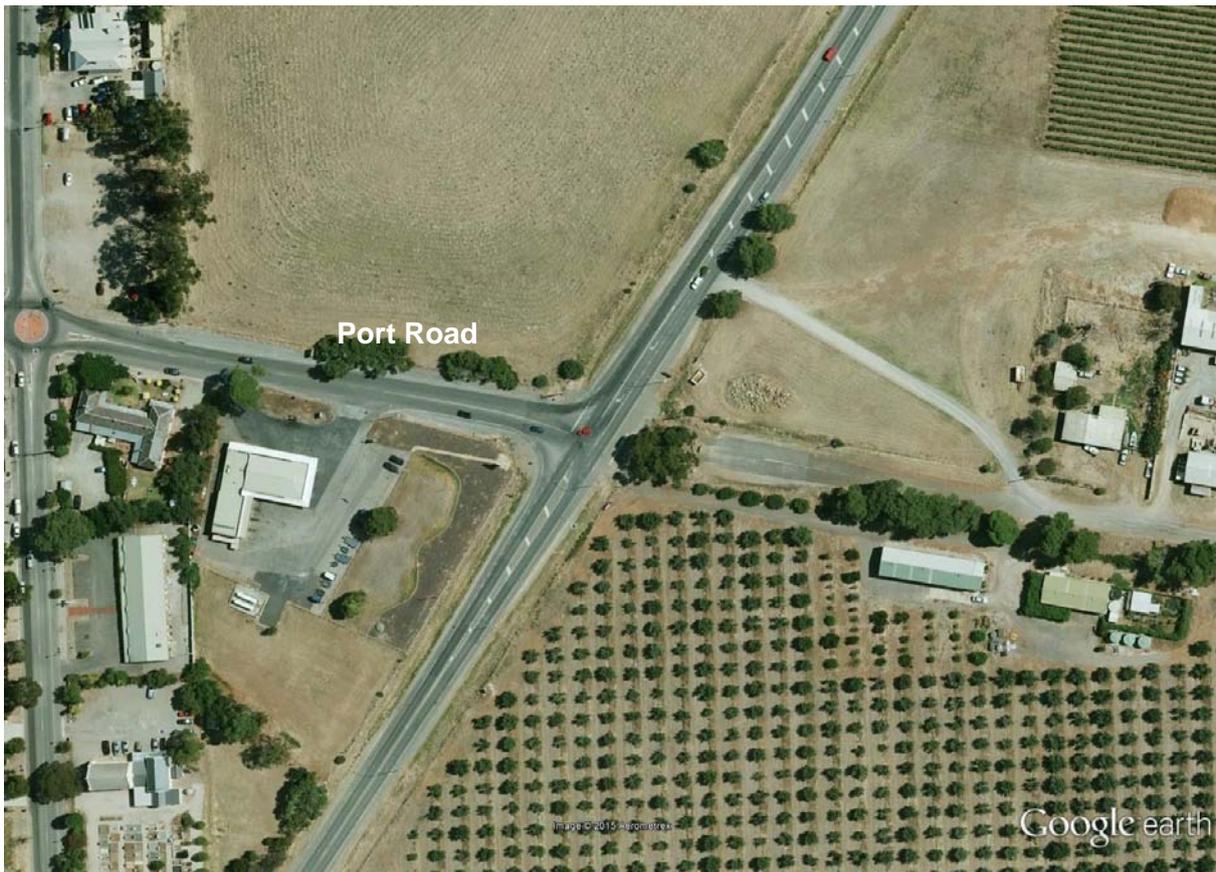
Figure 6-12 Existing Layout of Main South Road / Port Road Intersection

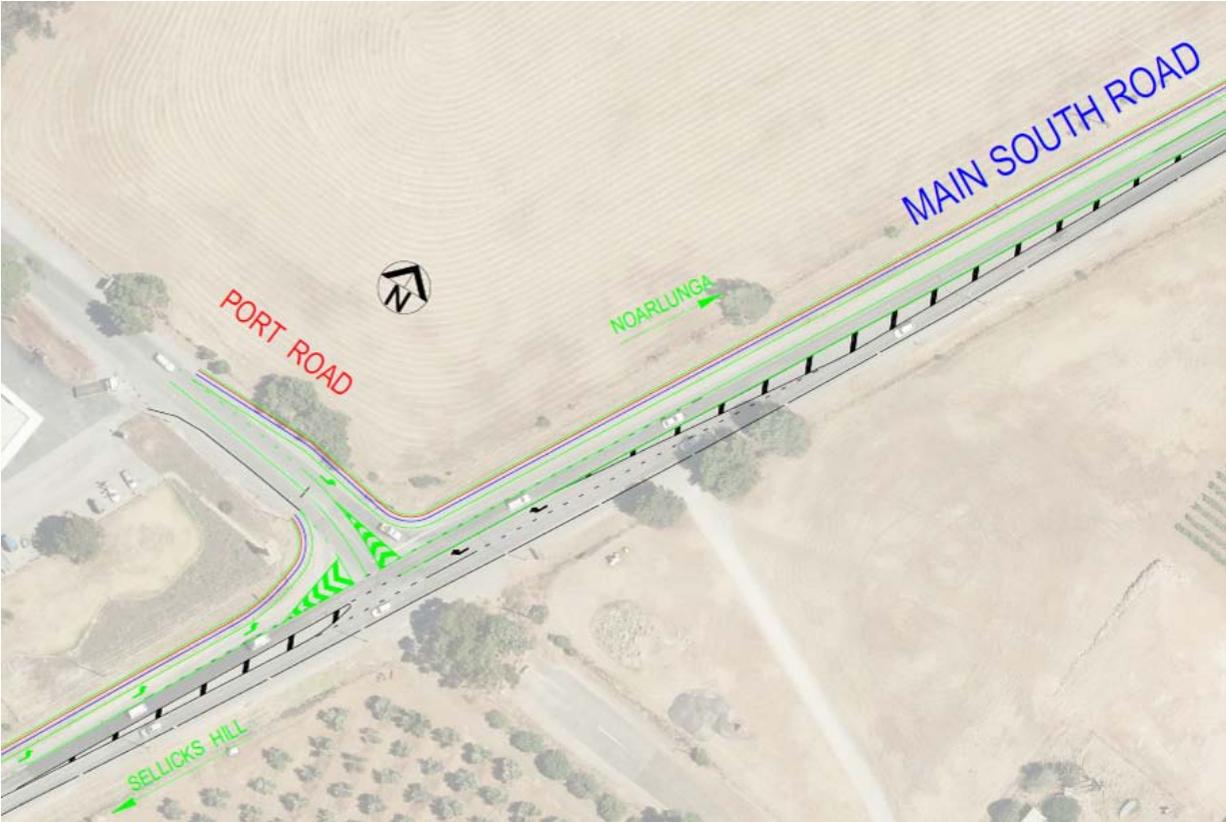
Figure 6-13 Proposed Upgrades for Port Road Intersection: Option 1 - Realignment & Improved Left Turn Facilities

A deceleration lane for left turning traffic into Port Road, which will separate the left turn traffic from the through traffic on Main South Road to prevent left turners obscuring trailing northbound through traffic which causes stop-start manoeuvres (causing rear ends) on the side road as motorists are unaware of the trailing vehicle.

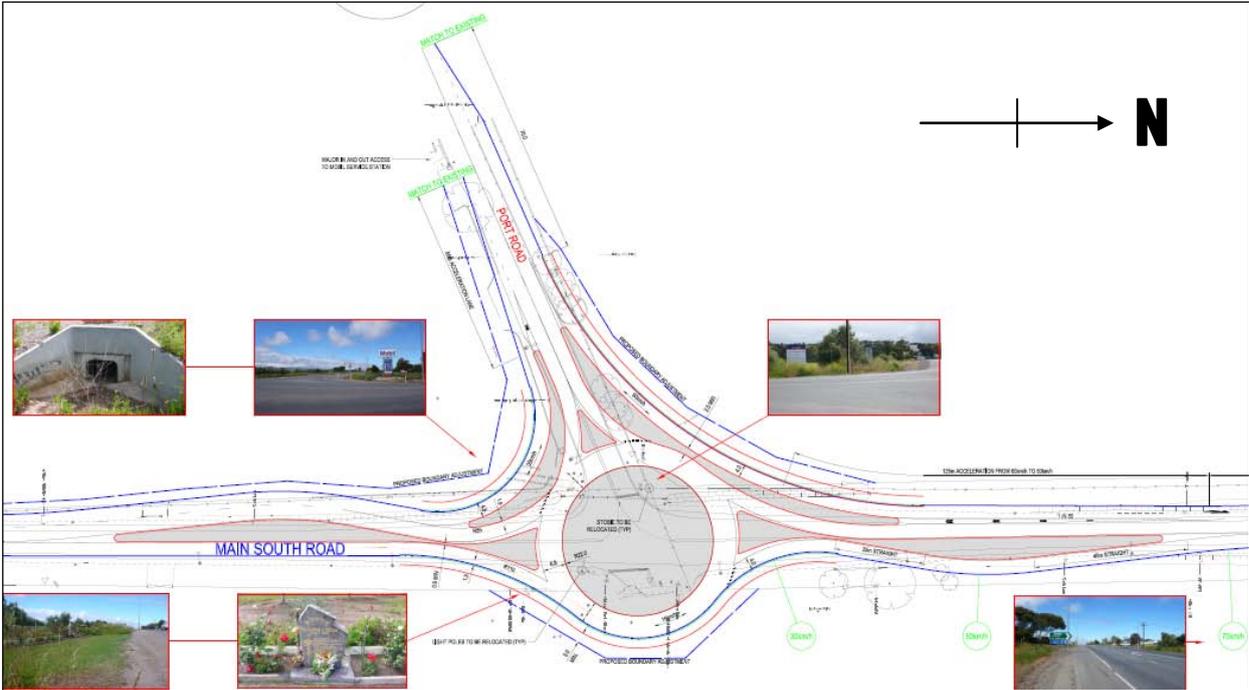
Figure 6-14 Proposed Upgrades for Port Road Intersection: Option 2 - Roundabout

The second medium term treatment considered (Option 2) for this location is to install a roundabout at the intersection of these roads. This treatment would cater for future development in the area and provides safety benefits of preventing right angle type crashes and reducing the severity of any crashes that may occur by forcing vehicles to slow down on approach to the intersection. This will also enable left and right turners from Port Road to exit the intersection with less hesitancy. The disadvantages of the roundabout are that it would incur high construction and land acquisition costs. A concept design of the roundabout is shown in Figure 6-14.

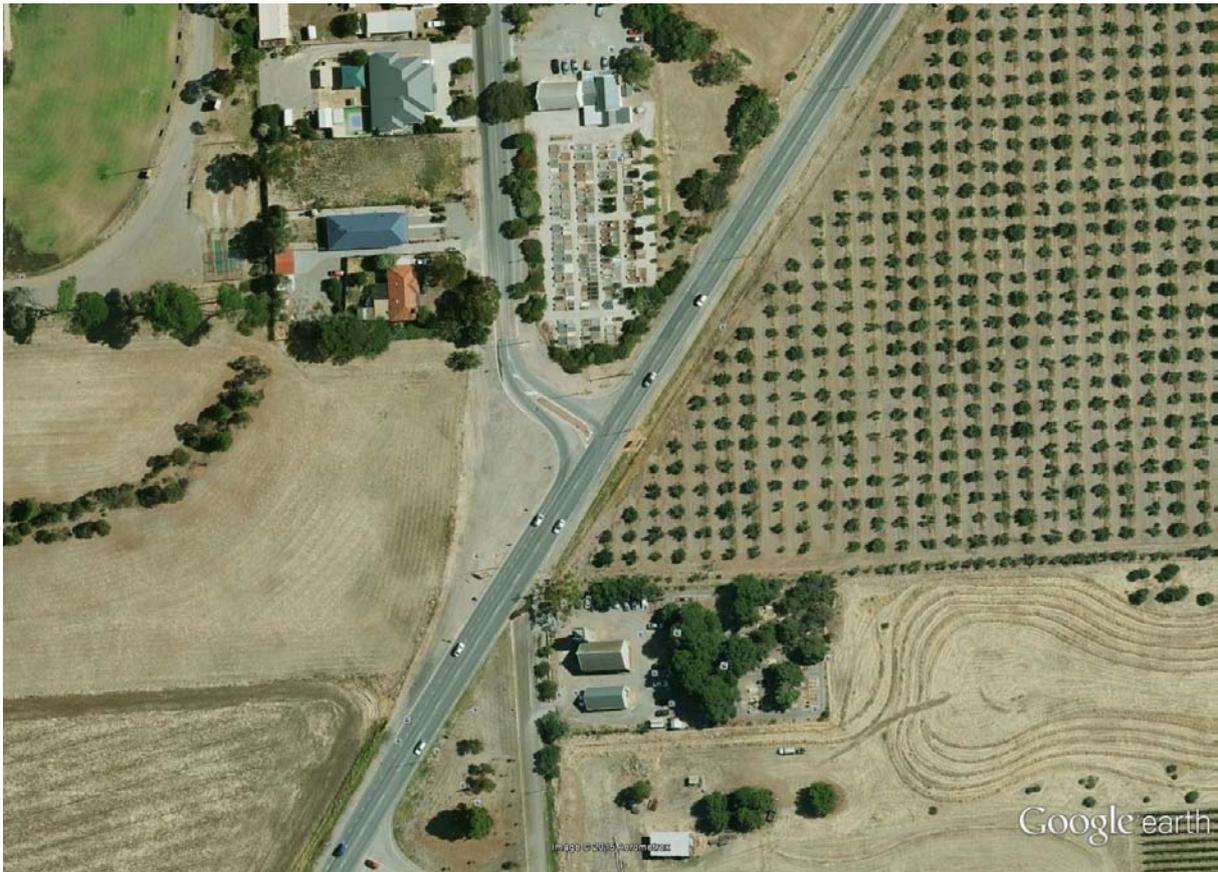
Figure 6-15 Layout of Main South Road/Old Coach Road Intersection Prior to 2012 Upgrade

There are stobie poles on the north western corner and on the eastern side of the road just south of the intersection. These present hazards for any vehicles that might make a mistake and leave the road.

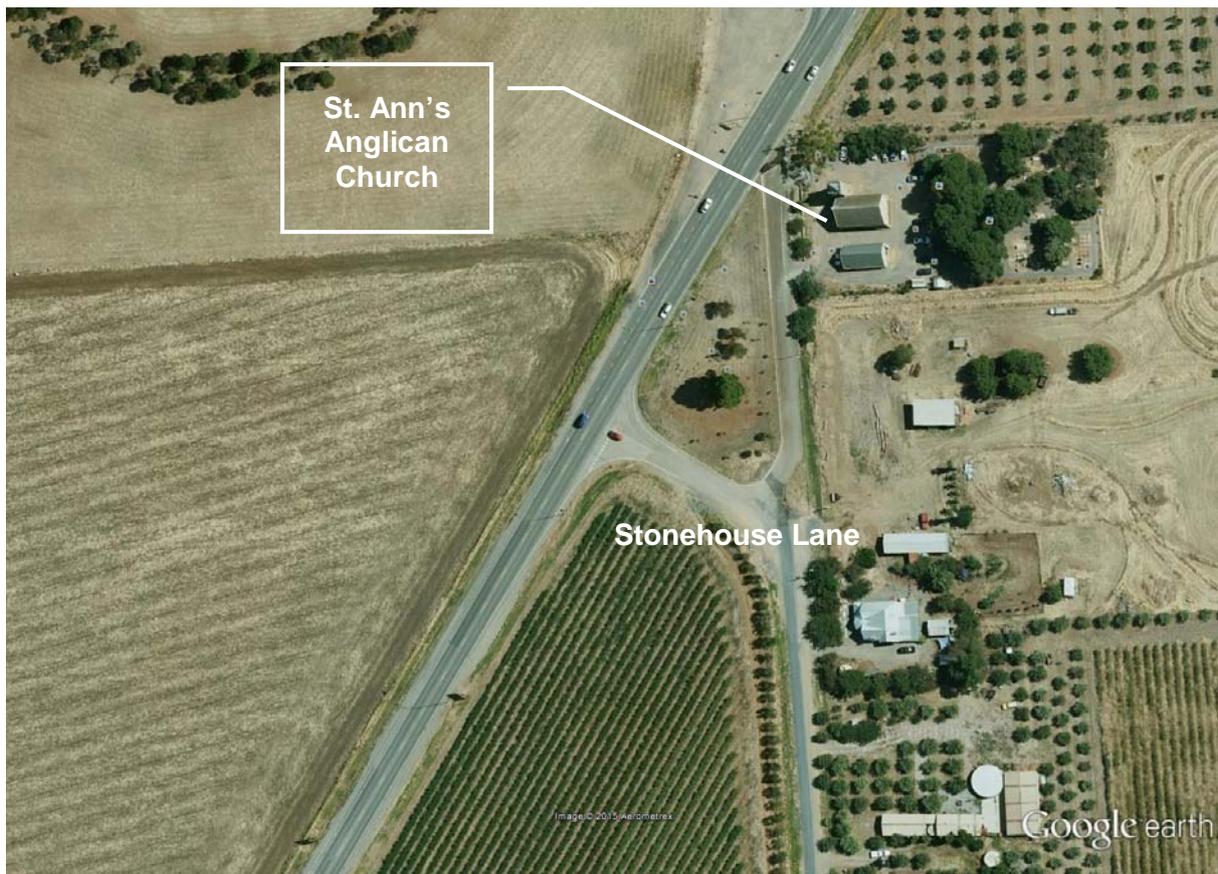
Figure 6-17: Existing Layout of Main South Road/Stonehouse Lane (formerly Plains Road) intersection

A vehicle turning movement survey was undertaken on Tuesday 12 October 2010 and estimated that the annual average daily traffic on Stonehouse Lane was 70 vehicles per day. Only 12 vehicles were observed to turn right into Stonehouse Lane from Main South Road during the survey period. Whilst it is acknowledged that there may be additional right turning traffic when services are being conducted at the church, traffic flows are insufficient to justify the installation of a sheltered right turn lane. Only eight vehicles were recorded undertaking the left turn into Plains Road during the 11 hour survey period.

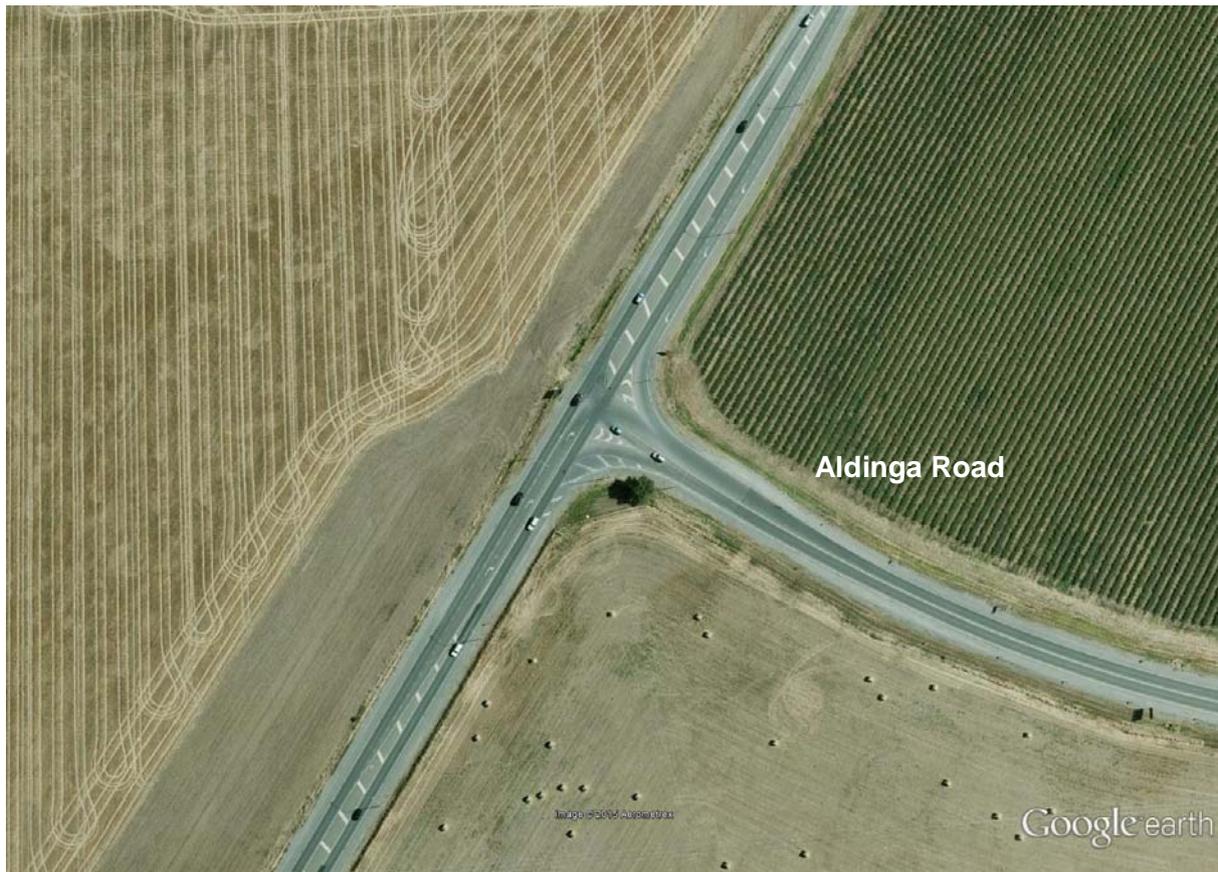
Figure 6-18: Existing Layout of Main South Road/Aldinga Road (formerly Biscay Road) intersection

The intersection was upgraded in 2004 as a part of the State Black Spot Program which involved enhancing the line marking of the intersection, reducing the radius of the left turn slip lane on Aldinga Road to reduce entry speeds, improving sight distance and shortening the right turn lane on Main South Road. The shortening of the right turn lane was carried out to prevent unsafe manoeuvres by drivers from Aldinga Beach Road intending to continue east along Aldinga Road. It was previously observed that drivers would attempt unsafe movements across Main South Road directly into the Aldinga Road right turn lane. There are no raised islands or Stop or Give Way signs on the Aldinga Road approach.

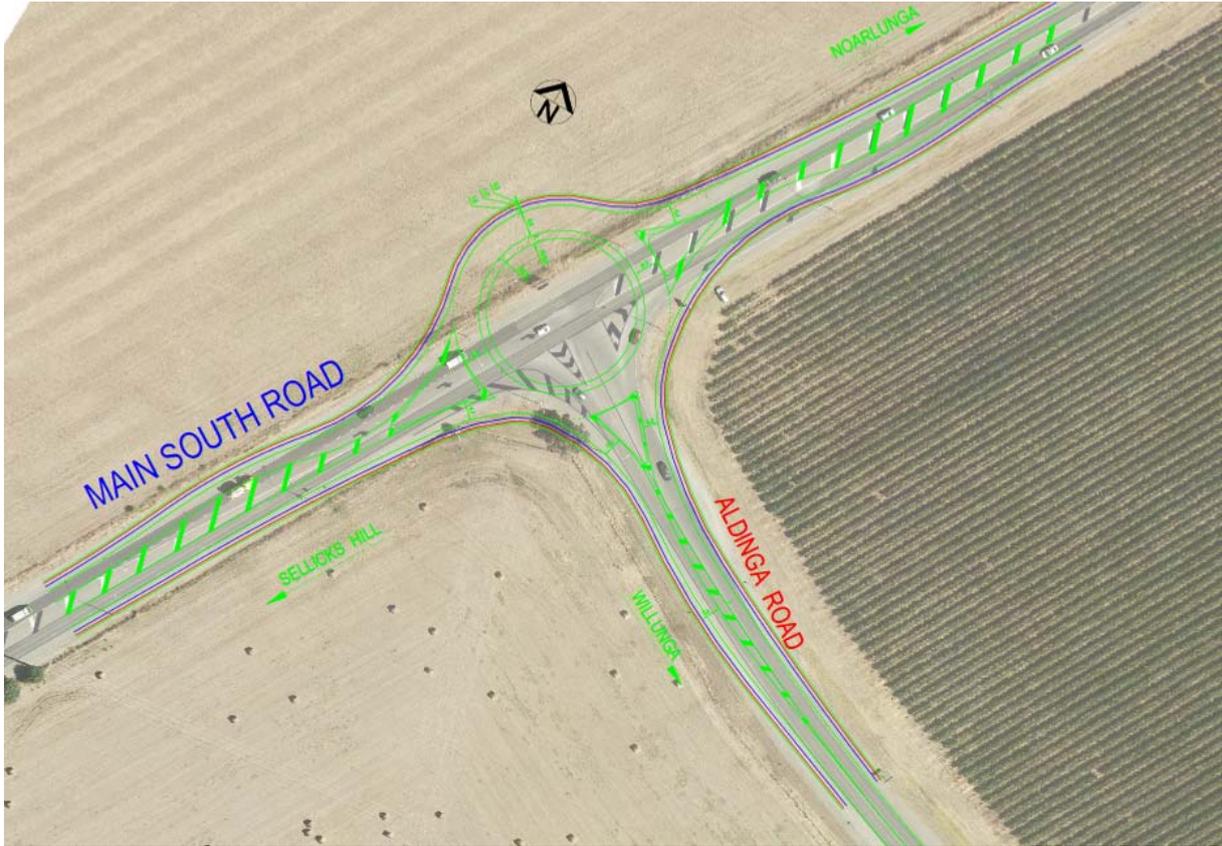
Figure 6-19: Proposed Upgrades for Aldinga Road Intersection: Option 1 Roundabout

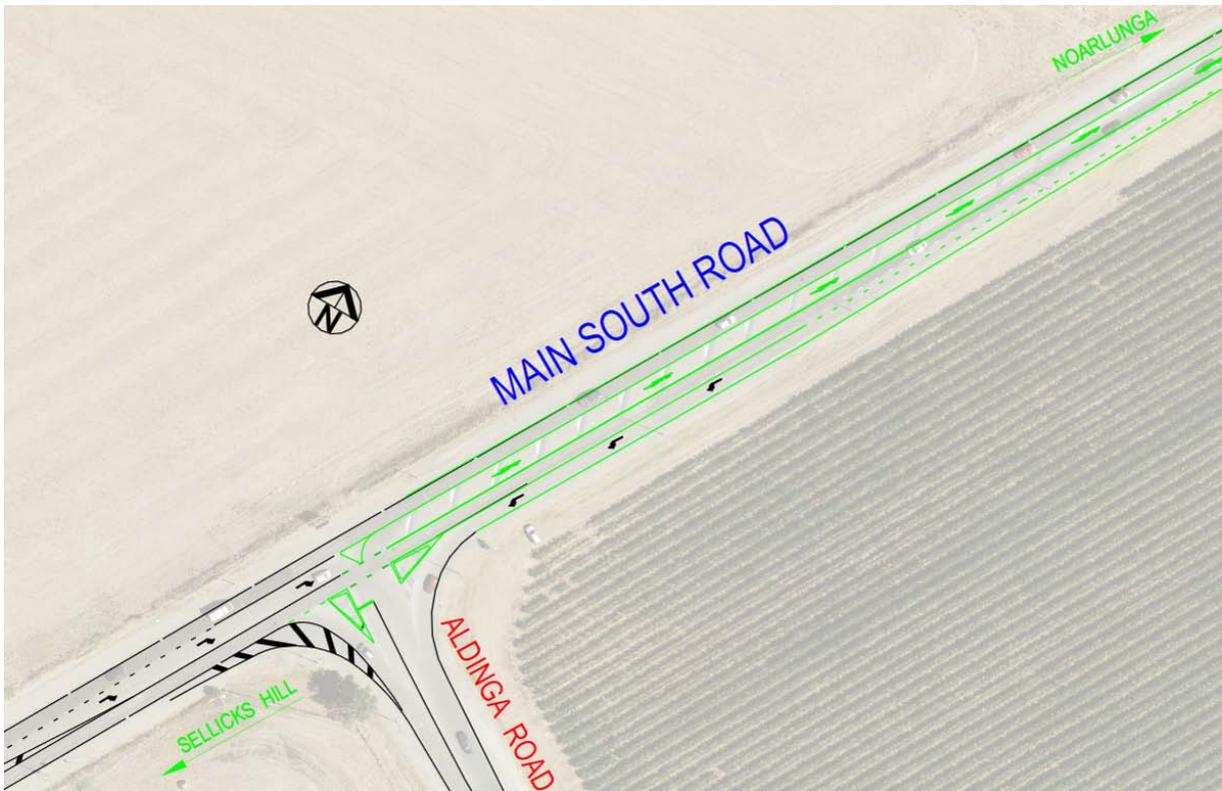
Figure 6-20: Proposed Upgrades for Aldinga Road Intersection: Option 2 Seagull with Central Acceleration Lane and Side Road Splitter Islands (Recommended Treatment)

Option 2 is the installation of a 'seagull' treatment and would be considered a short term treatment. This option involves installing a raised island at the intersection to provide additional channelisation for the right turn movements out of Aldinga Road; allowing motorists to conduct a two-stage turning movement. This is a simpler option compared to the roundabout, but does not provide the same benefits of physically preventing right angle and right turn crashes or reducing speeds on the approach to the intersection. The seagull treatment includes a central acceleration lane for right turning vehicles as shown in Figure 6-20. The acceleration lane allows vehicles to accelerate up to speed to choose appropriate gaps in the traffic to safely merge. To further enhance this treatment, raised side road splitter islands can be installed to slow traffic down on the approach to the intersection.

The recommended treatment for this location is the interim 'seagull treatment' (Option 2). As another short term treatment, the existing line marking at the intersection could be re-painted to enhance delineation. The installation of Raised Reflective Pavement Markers (RRPM) could also be considered to further enhance visibility.

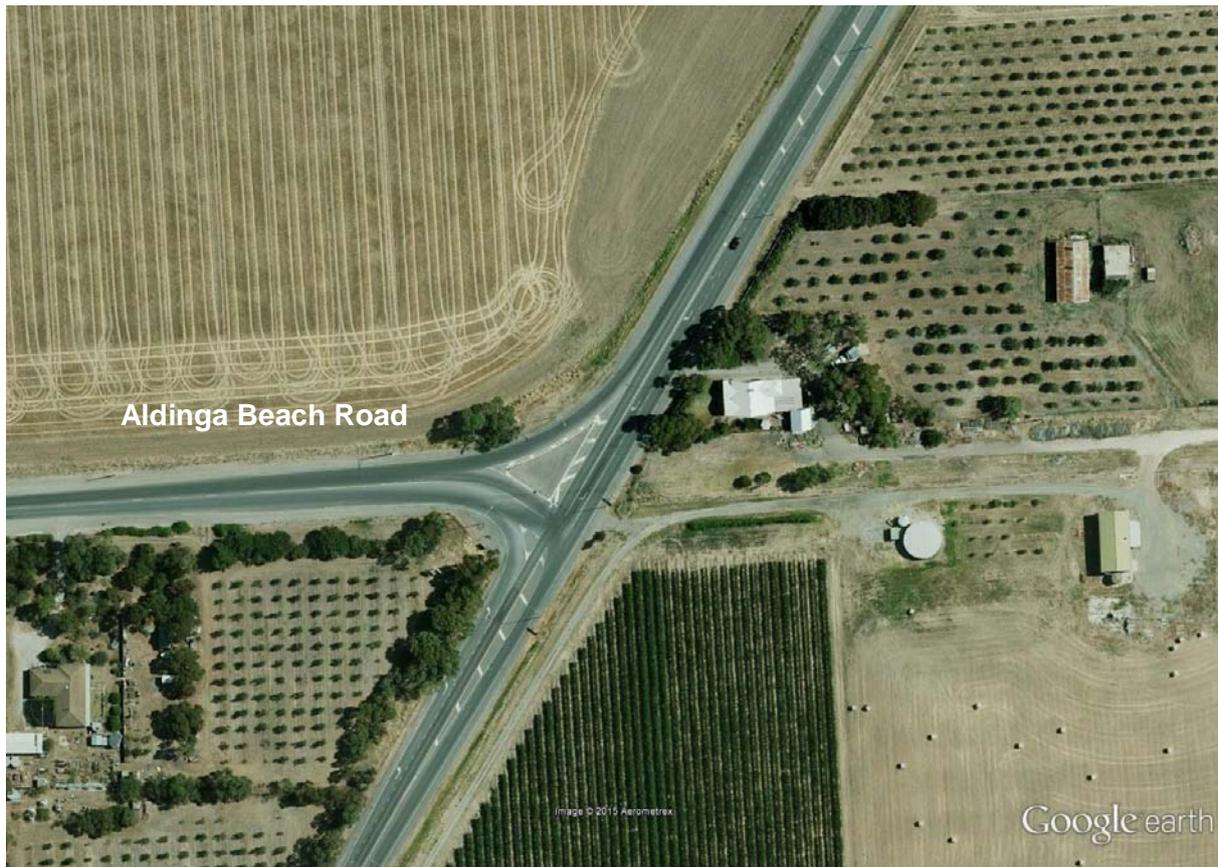
Figure 6-21: Existing Layout of Main South Road/Aldinga Beach Road Intersection

There are stobie poles present on the northern side of Aldinga Beach Road close to the intersection which may present hazards for road users.

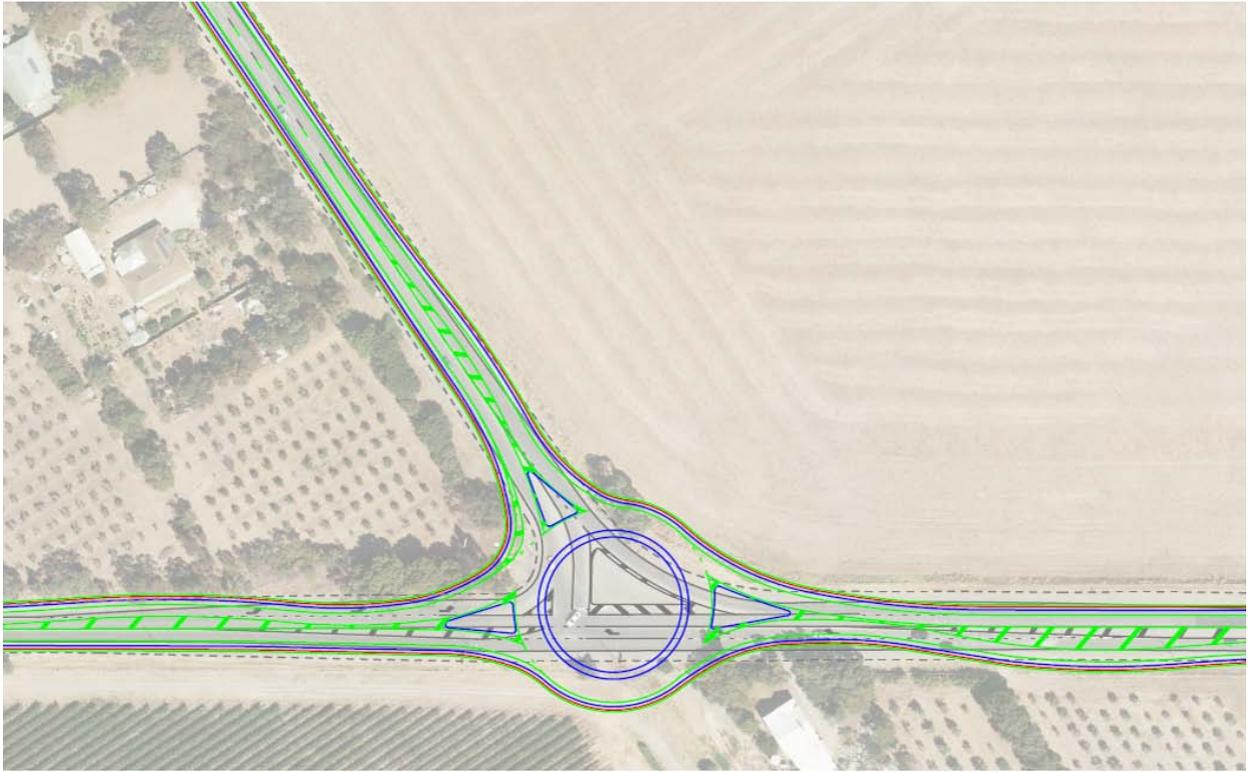
Figure 6-22: Proposed Upgrades for Aldinga Beach Road Intersection

The treatment considered for this location is to install a roundabout at the intersection of these roads. The roundabout provides the benefits of addressing right angle and right turn type crashes and reducing the severity of any crashes that may occur by forcing vehicles to slow down on approach to the intersection. The disadvantage of the roundabout is that it would incur high construction and land acquisition costs. A concept design of the roundabout is shown in Figure 6-22.

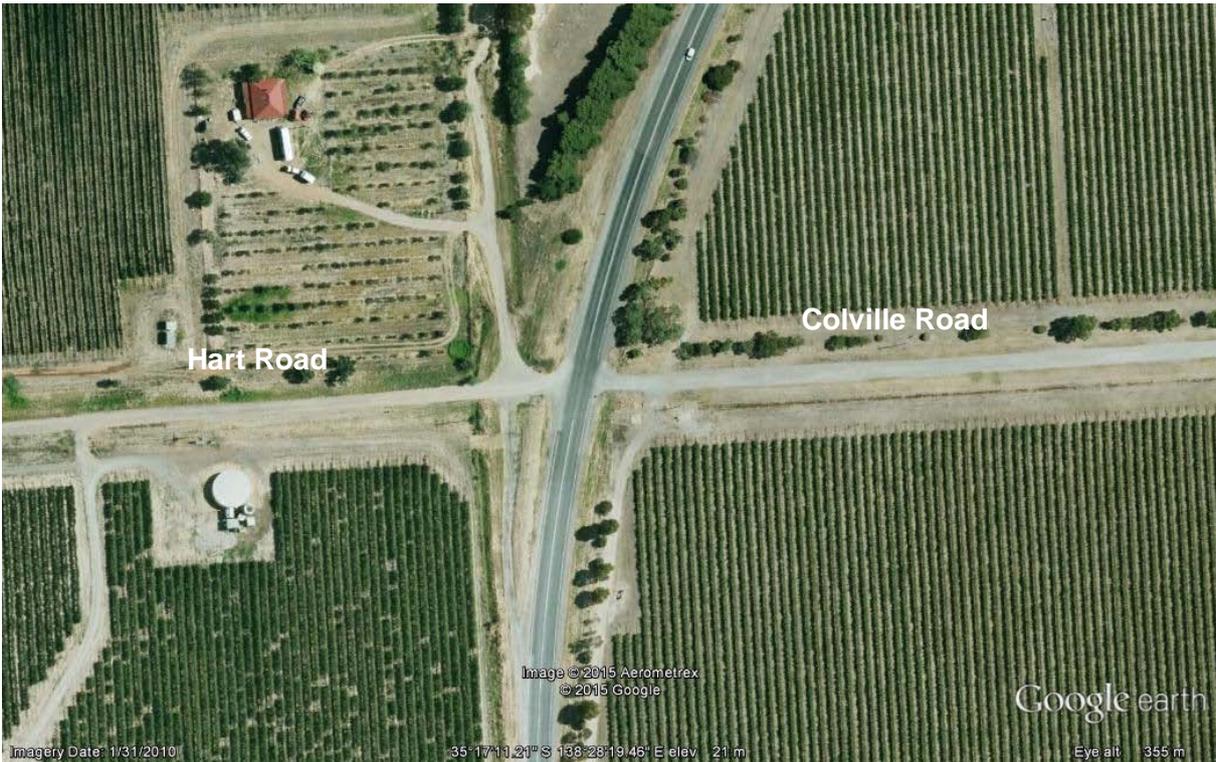
Figure 6-23: Existing Layout of Main South Road/Hart Road/Colville Road Intersection

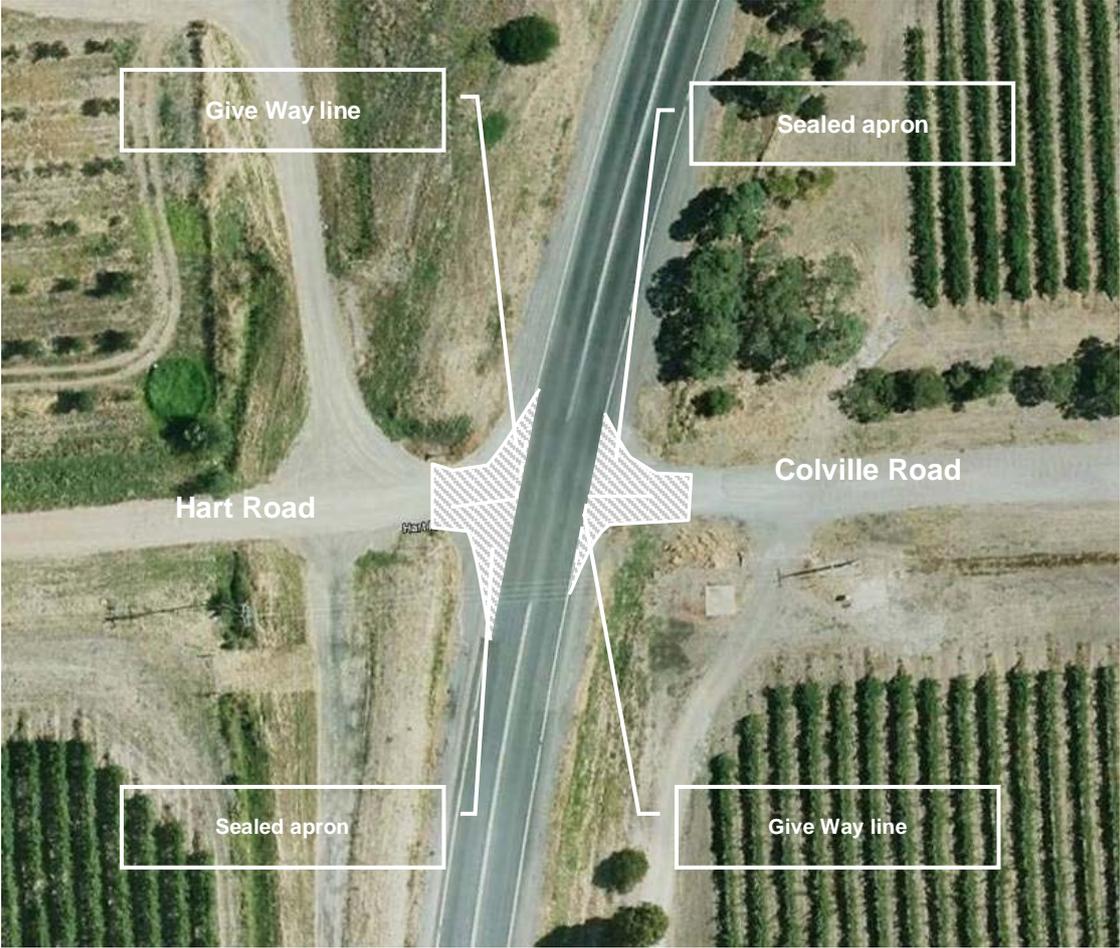
Figure 6.24: Proposed Upgrades for Hart Road/Colville Road Intersection: – Sealed aprons and Give Way lines

Alternatively, should the intersection remain as a four-way intersection, there are still some safety improvements that could be considered. A cost effective option to improve safety at the intersection is to seal the side road aprons and mark "Give Way" lines on the side road approaches. This is shown in Figure 6.24.

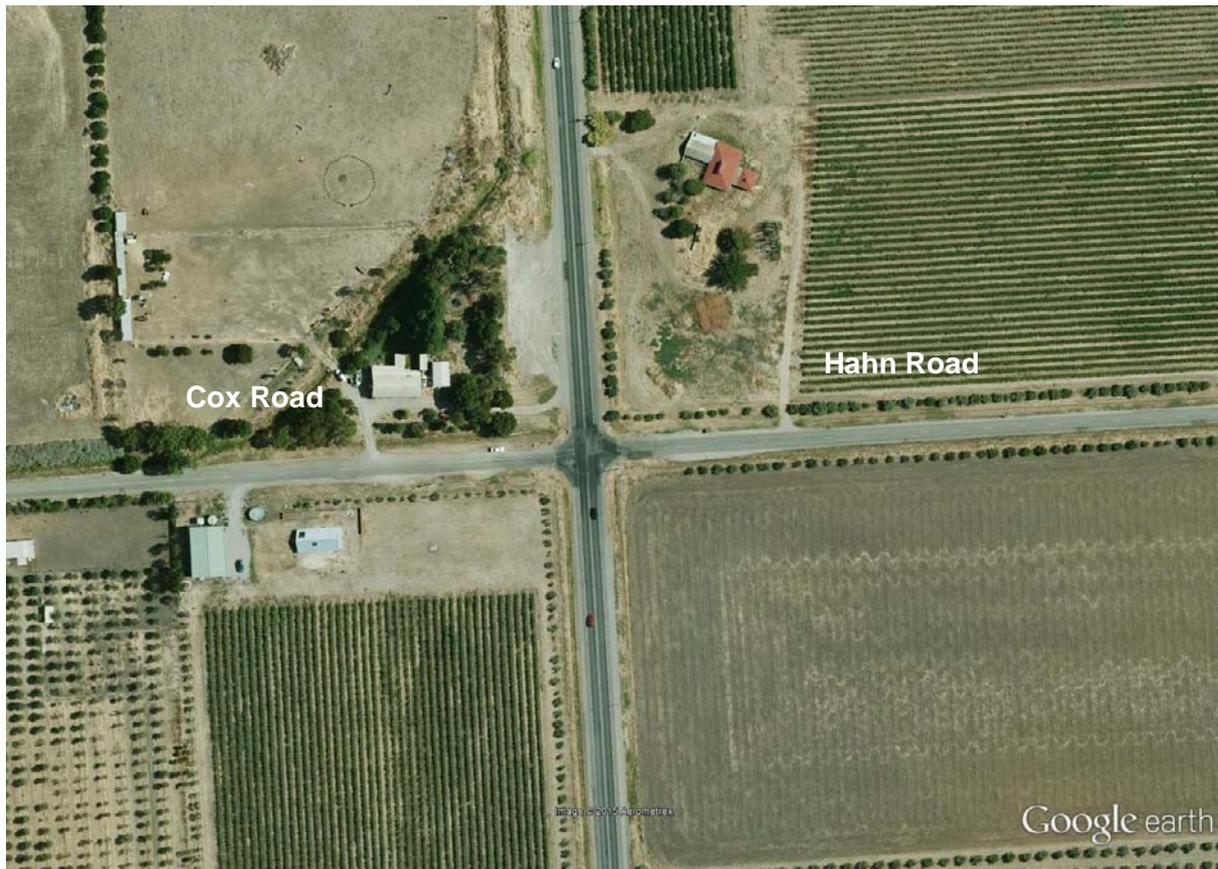
Figure 6-25: Existing Layout of Main South Road/Hahn Road/Cox Road Intersection

There are several possible roadside hazards in the vicinity of the intersection including culvert headwalls on the north eastern and north western corners and a stobie pole on the south eastern corner.

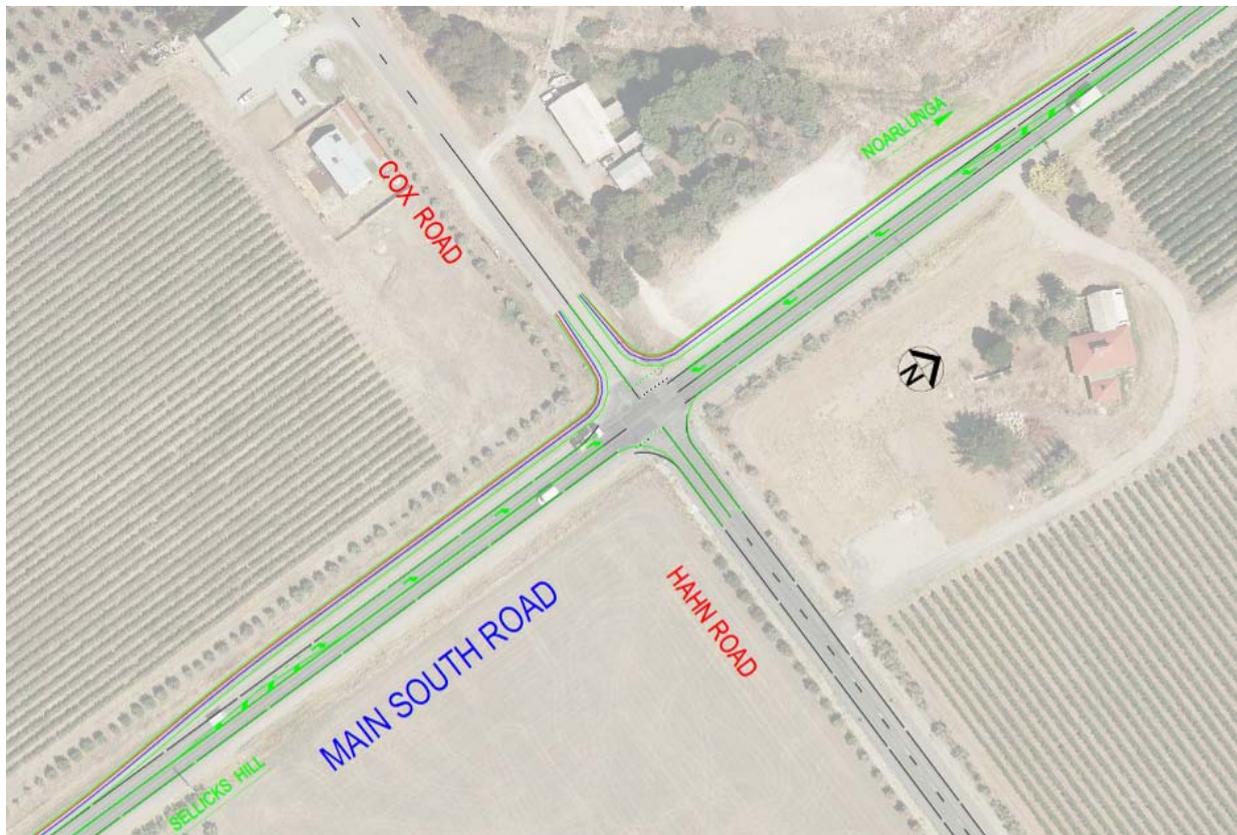
Figure 6-26: Proposed Upgrades for Hahn Road / Cox Road Intersection: – Separated Right Turn Lanes

To reduce the possibility of crashes, separated right turn lanes could be installed on Main South Road to separate the right turning vehicles from the through traffic. A concept of the proposal is shown below in Figure 6-26. The provision of right turn lanes would also provide important improvements should the proposed closures of Colville Road (refer to Section 6.1.11) and Rogers Road (refer to Section 6.1.13) be implemented. This proposal could be further enhanced by repainting the existing line marking and installing Raised Reflective Pavement Markers (RRPM) at the intersection to enhance delineation.

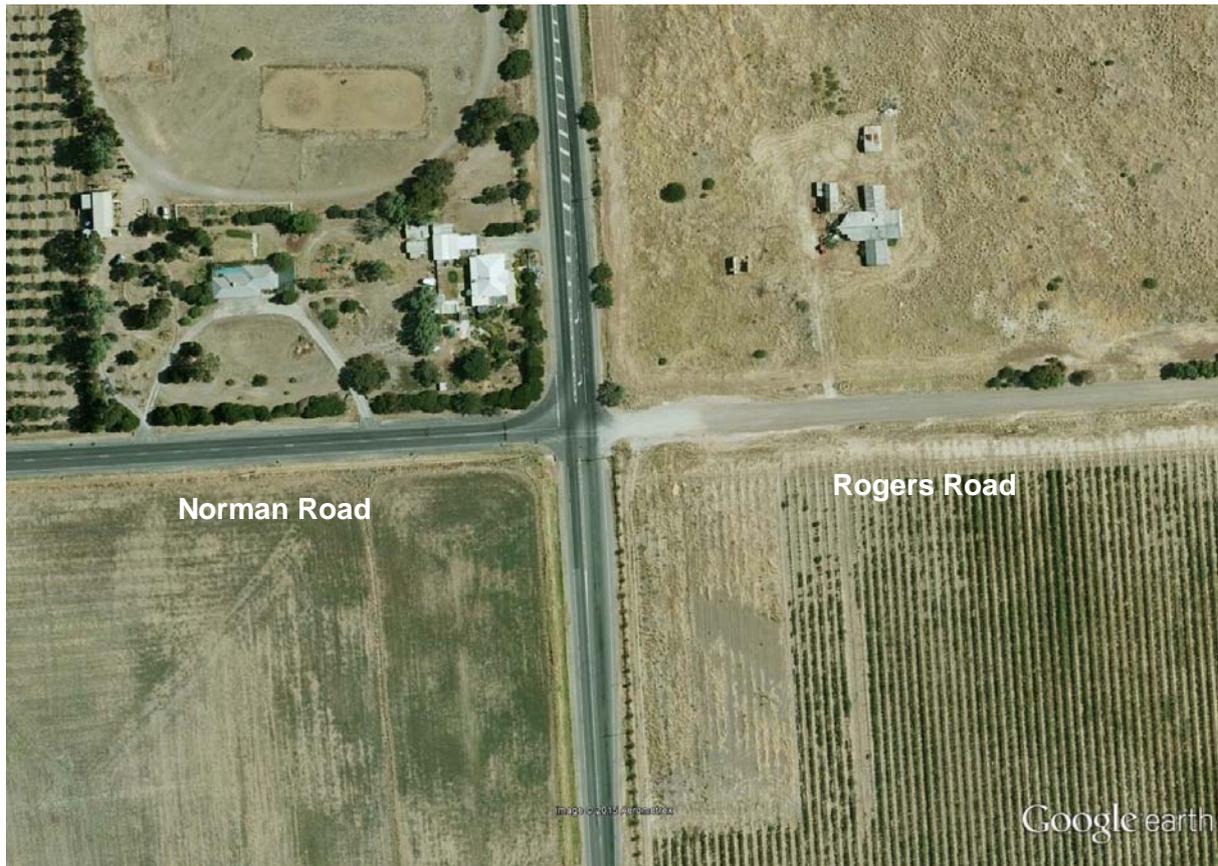
Figure 6-27: Existing Layout of Main South Road / Norman Road / Rogers Road Intersection

Roadside hazards within the vicinity of the intersection include stobie poles on the north western corner and on the eastern side of Main South Road. There are also unprotected culvert headwalls on the north eastern and south western corners as well as a junction box on the south eastern corner.

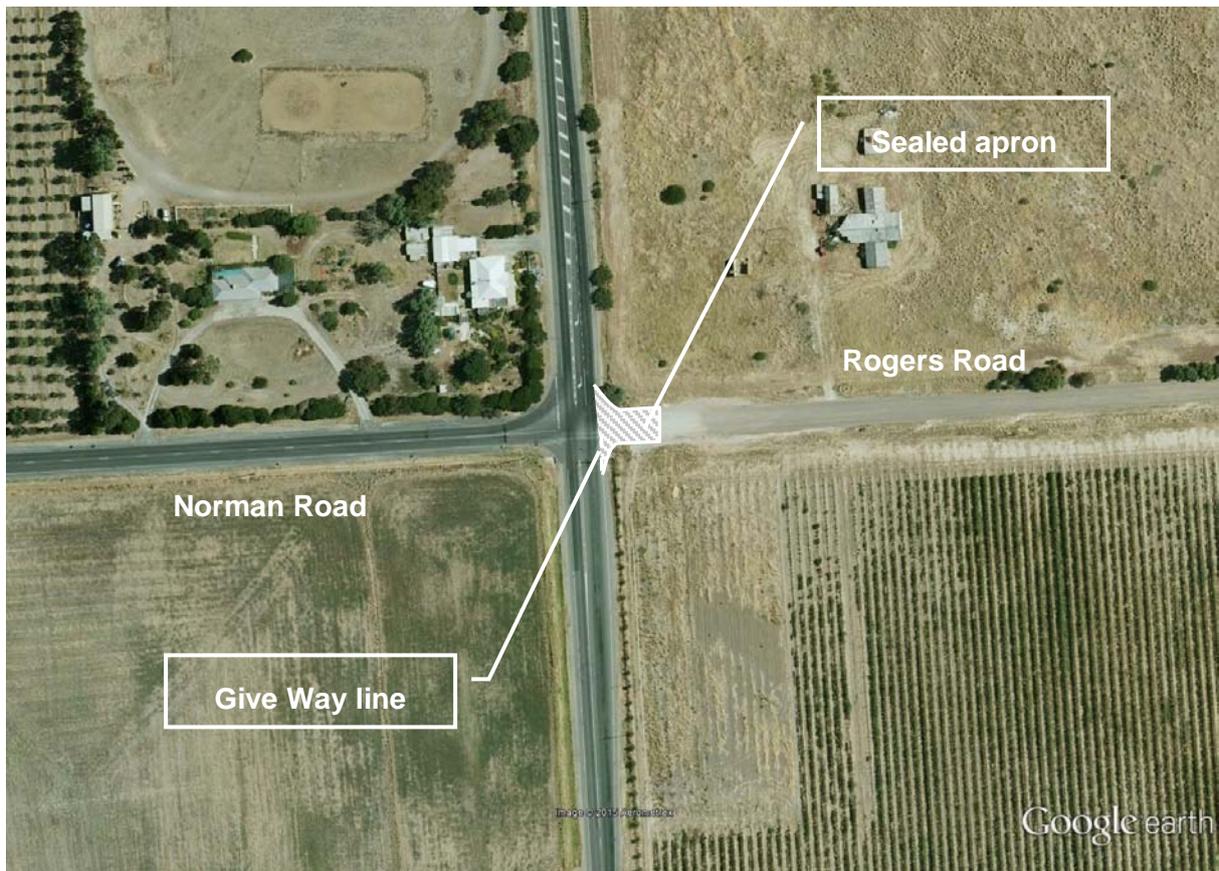
Figure 6-28: Proposed Upgrades for Norman Road/Rogers Road Intersection: Sealed apron and Give Way line

A cost effective interim treatment is to seal the apron of Rogers Road and mark a ‘Give Way’ line. The installation of RRPMS at the intersection could also be considered to enhance visibility and delineation. This is shown in Figure 6.28.

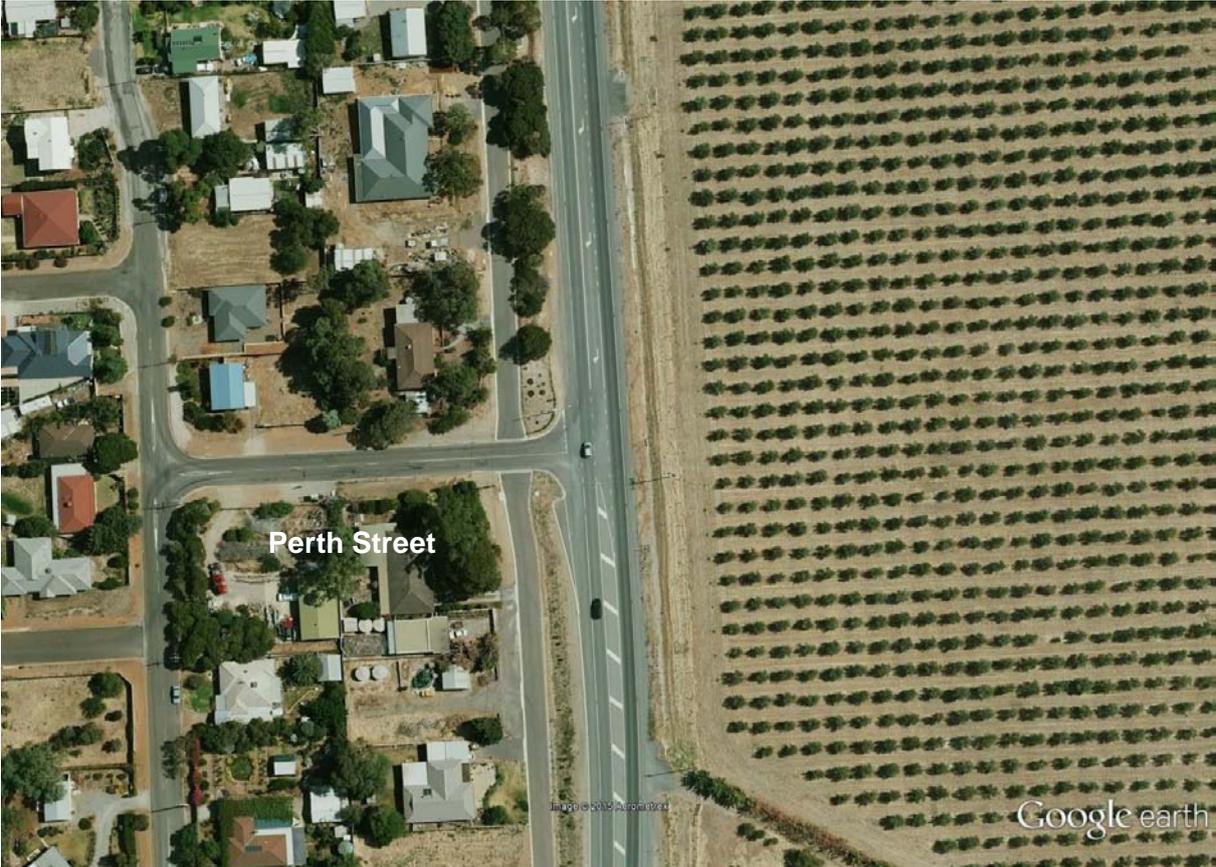
Figure 6-29: Existing Layout of Main South Road / Perth Street Intersection
