ROAD MANAGEMENT PLAN

RN4763 MAIN SOUTH ROAD

(Tatachilla Road to Sellicks Beach Road)

Department of Planning,
Transport and Infrastructure

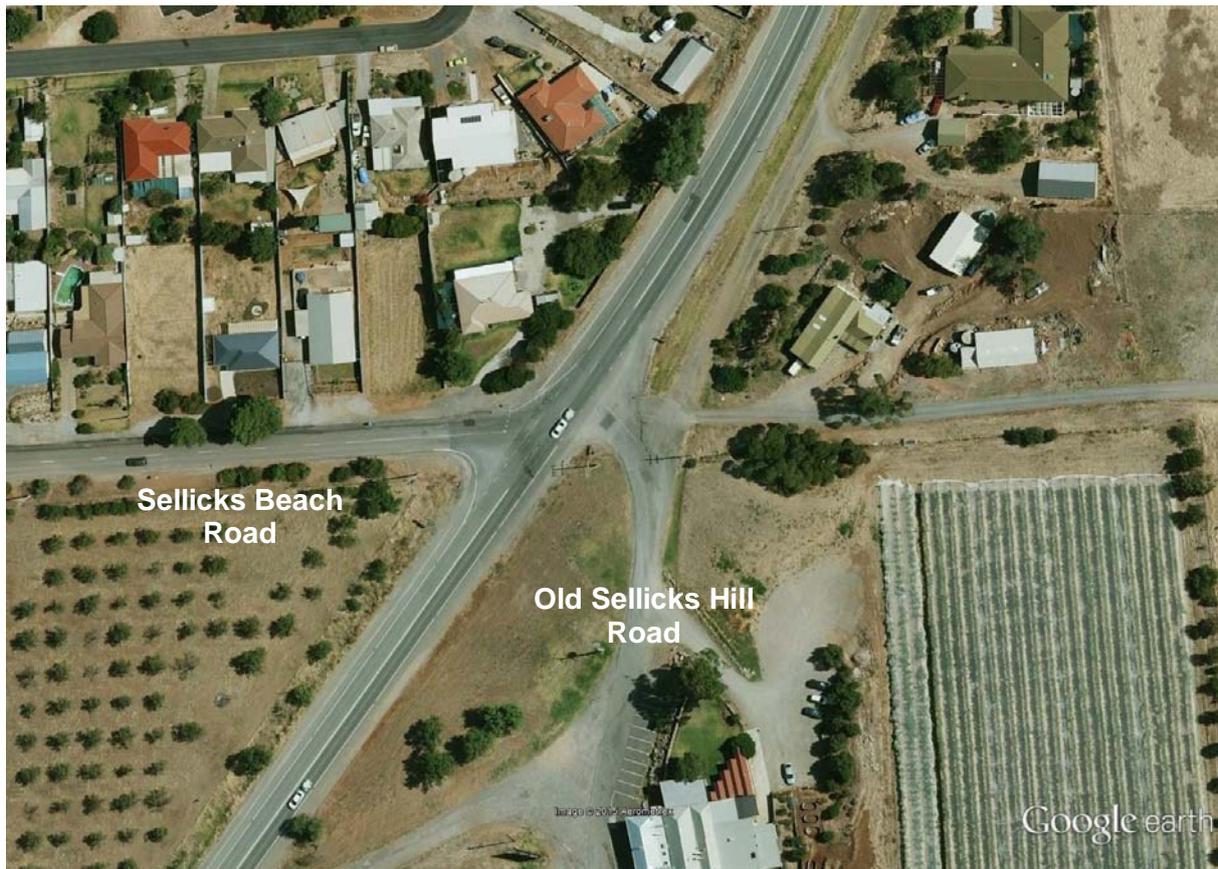
Figure 6-30: Existing Layout of Main South Road / Sellicks Beach Road / Old Sellicks Hill Road Intersection

While this intersection does not have a high number of casualty crashes, it is nevertheless considered a priority for an upgrade because of the restricted sight distance from the side roads and the high speed environment. Therefore a number of recommendations are proposed for this intersection.
