# SAFETY ALERT

Punctured Thumb

July 2016

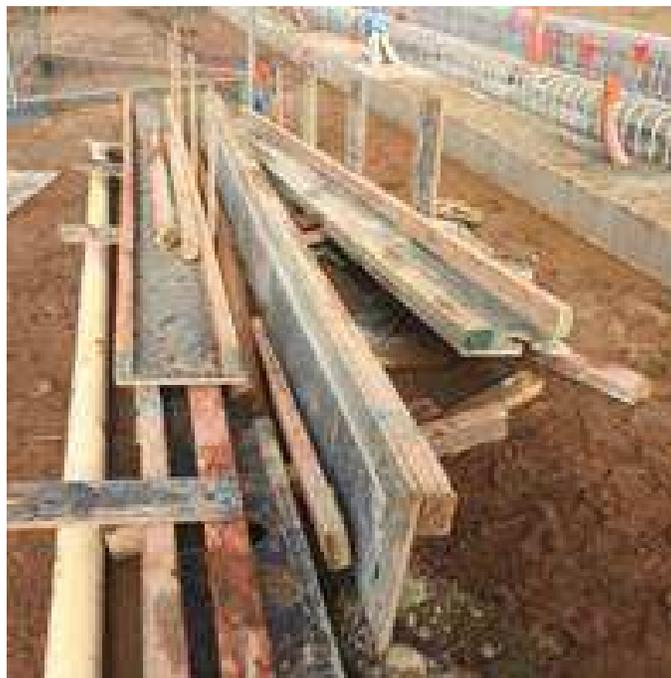
A worker received a thumb puncture injury from a protruding nail when moving a formwork shutter and the nail lodged in his thumb. The worker was wearing general purpose gloves however a check was not undertaken to see if a potential hazard existed.

Contributing factor: formwork was not de-nailed

- Hazard recognition was discussed at the next pre-start meeting.
- A Task Observation Audit will be undertaken by the worker's manager.
- Work crews were reminded of the task specific SWMS regarding systematic removal of all nails from formwork before it is moved or stripped.
