**South Road Tram Overpass Shared
Path Bridge**

Incident Investigation Report

**Department of Planning, Transport and
Infrastructure**

**18 February 2017
Revision: 1
Reference: 255258**

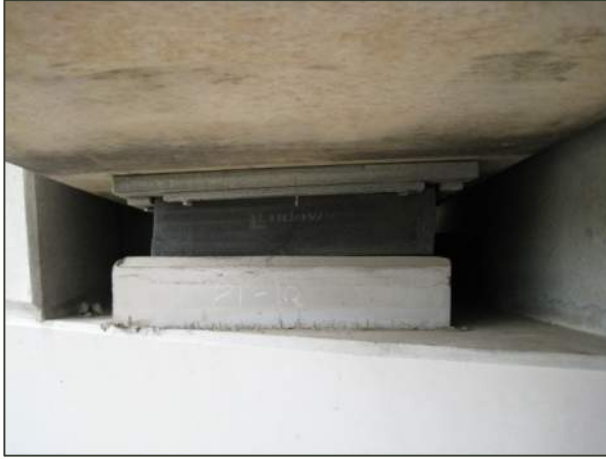
Figure 12 Girder rotation and bearing movement evident

Figure 12 above shows the bearing at Pier 1 west. Clear evidence of bearing deformation, uplift/separation from supported surfaces and movement of the bearing to the south is observed and is typical of the bearings at the other piers. At this location, a clear gap between the top surface of the bearing and the beam soffit can be observed.

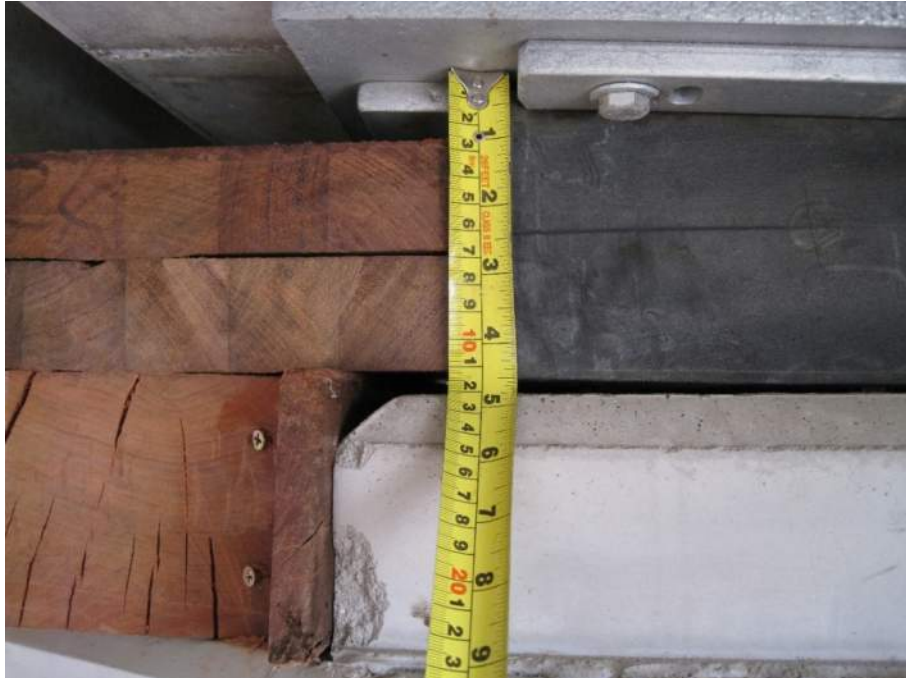
P1 East Rotation

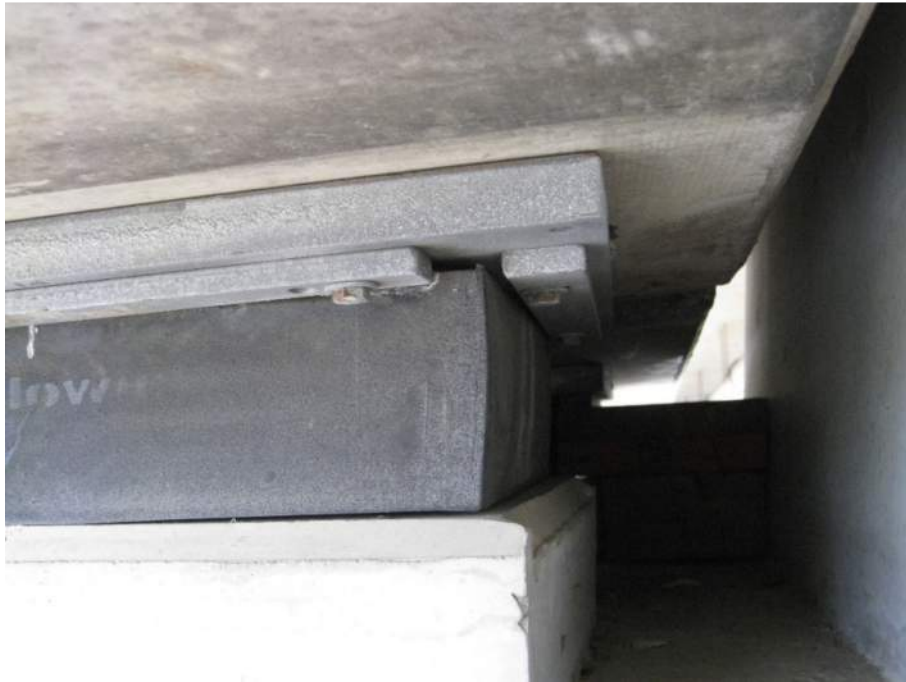
P1 West Bearing Rotation

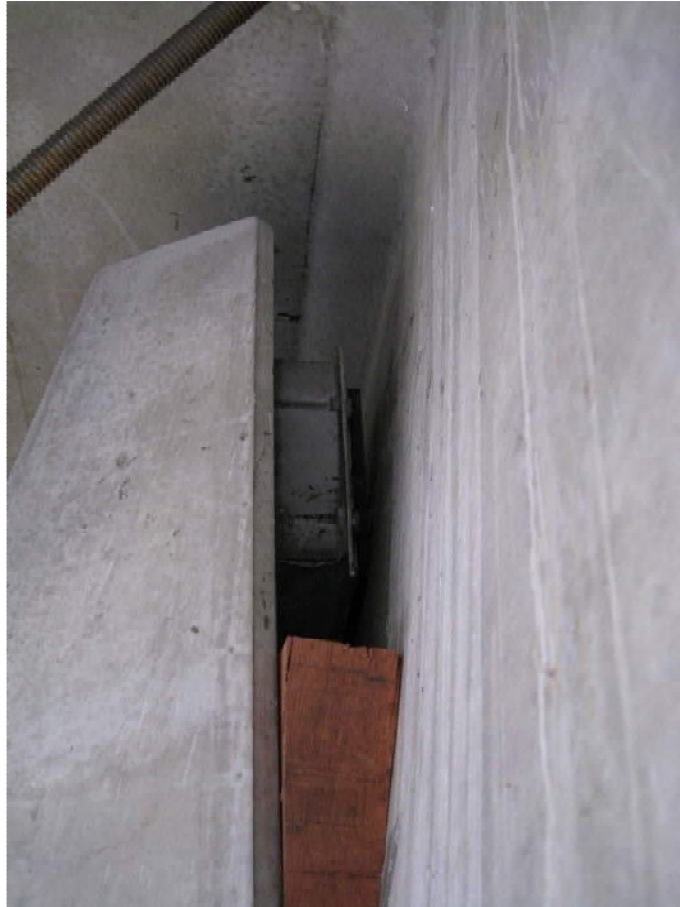
P4 East Side Bearing Separation

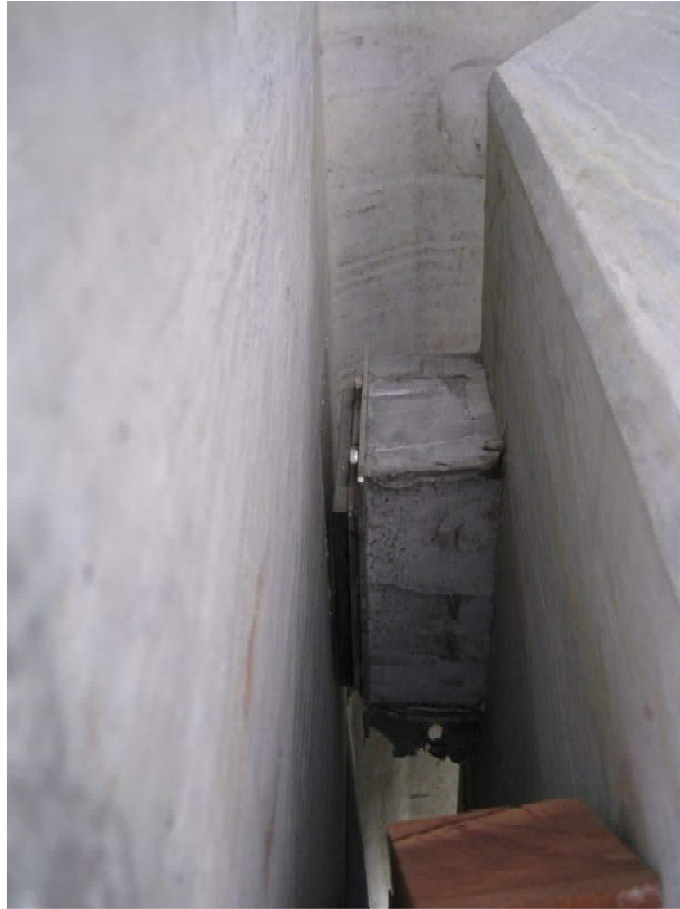
P5 West Side Bearing

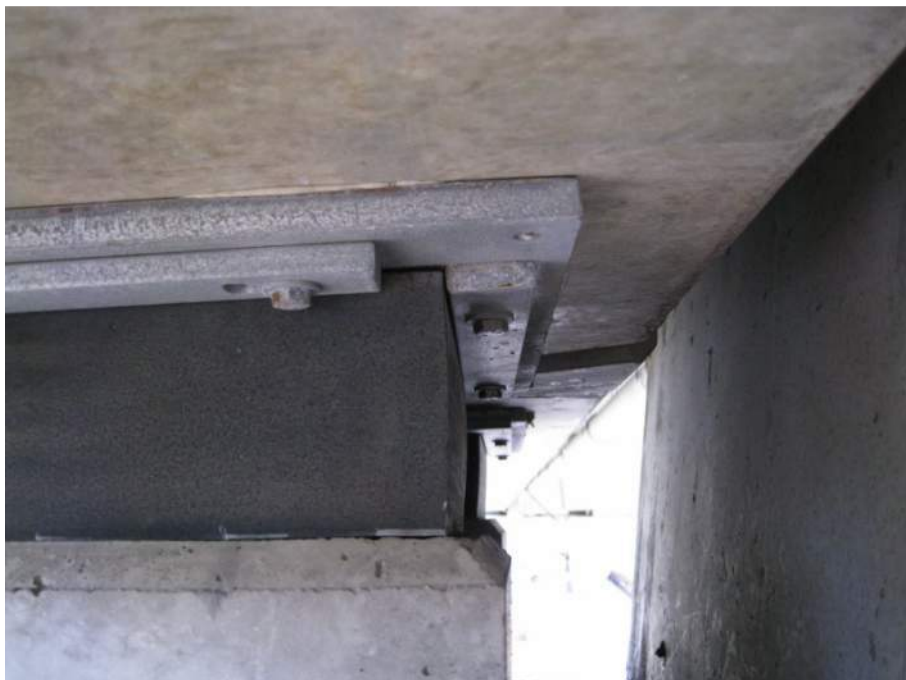
P6 West Bearing Rotation

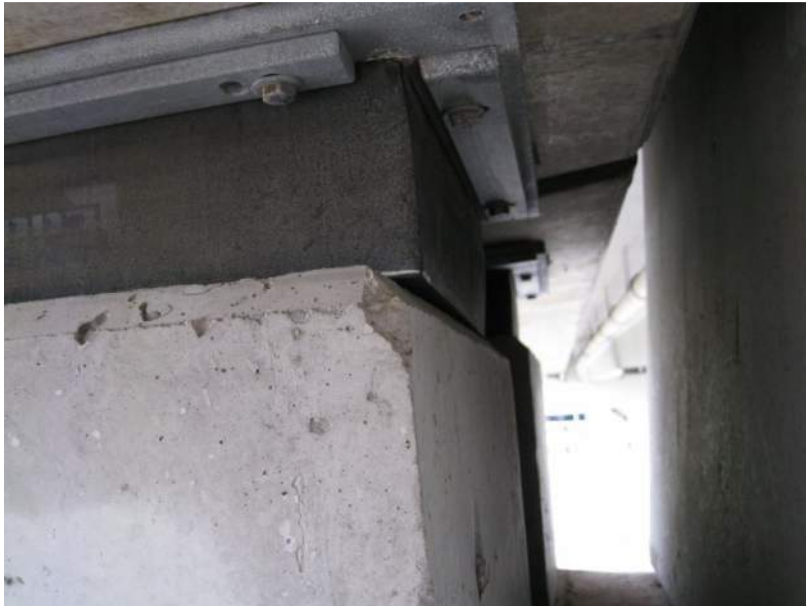
P7 West Bearing Displacement

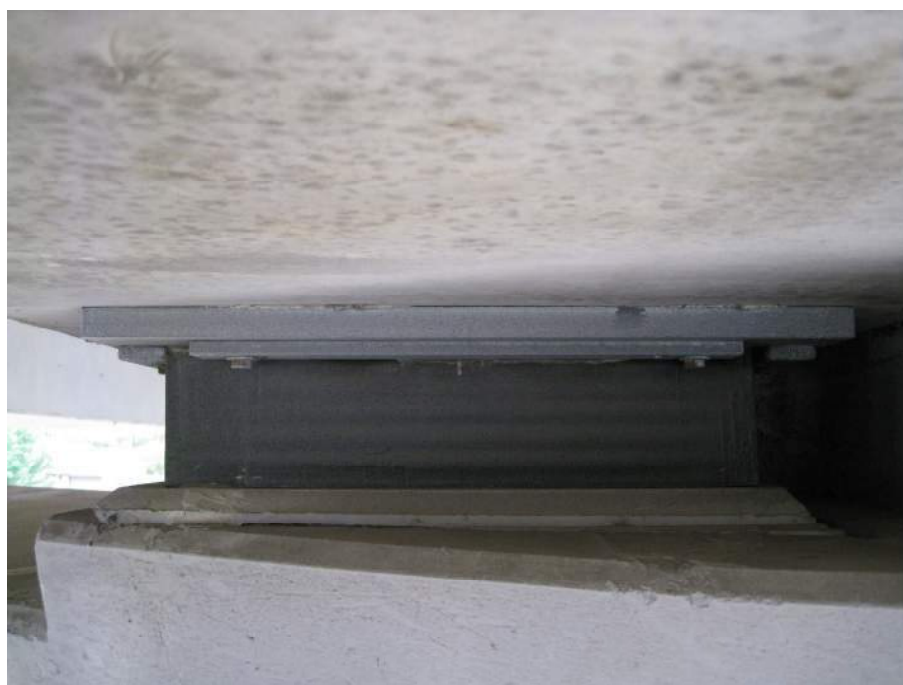
Pier 2 West Bearing 9 on Tram Bridge

This photograph does not depict any part of the Shared Path Bridge and is included for comparison purposes only.
